## 2027 Bolt State of Charge and NACS Charging Tips

# 2027 Bolt State of Charge and NACS Charging Tips

# Inoperative PTO on Silverado Medium-Duty Trucks

# Rear Leaf Spring Noise and Possible Fuel Contamination

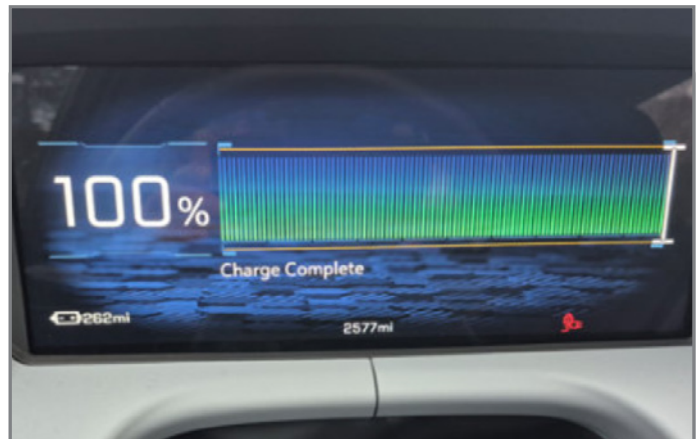
These conditions may be due to state of charge error growth after several cycles of usage without obtaining a complete charge at 100% SOC. Due to the flat voltage curve of the LFP battery, the Battery Management System needs to regularly obtain 100% SOC and Charge Complete status in order to learn and accurately maintain SOC. Charging the high-voltage battery to 100% SOC and Charge Complete status will correct these symptoms.

100% SOC and Charge Complete status

It's recommended to charge to 100% at least once per week. It is OK to keep the charge limit at 100% even for daily use. An 80% charge limit is recommended only when driving in mountainous terrain.

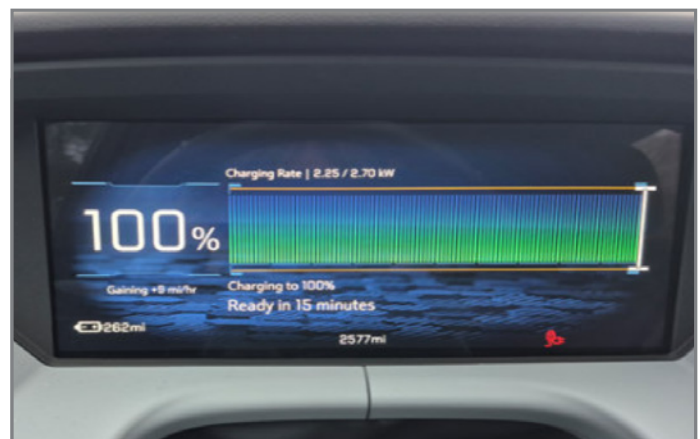
Do not stop charging until the Charge Complete message is shown.

**TIP:** Do not stop charging until the Charge Complete message is shown. The instrument cluster display may indicate 100% SOC for several minutes while the SOC error is corrected.

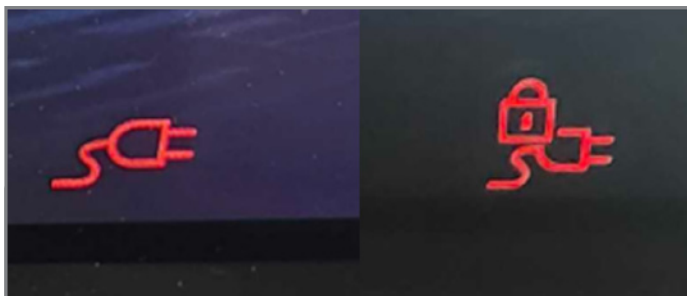
Left icon: Cord plugged in partially or blockage present, pin not locked.

Right icon: Cord plugged in fully, pin engaged/locked.

These conditions may occur if the charge coupler/adaptor is not fully inserted into the charging port. The weight of the charge cord, or possible blockage in the port interface, may prevent the charge coupler/adaptor from fully seating properly.

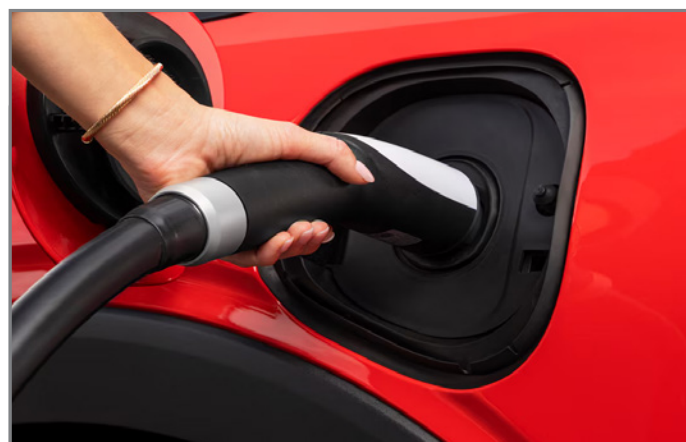
Lift up slightly on the cord to help fully seat it and allow the pin to lock.

If the weight of the charge cord is causing the coupler/adaptor to not stay seated, lifting slightly on the cord will help fully seat it and allow the charge lock pin to lock to initiate the charge. If the charge port lock motor is heard cycling on/off, it means the coupler/adaptor is not fully seated.

In addition, always check to make sure debris, snow, or anything else is not inside the coupler/adaptor or charge port, which may prevent the couple/adaptor from fully seating.

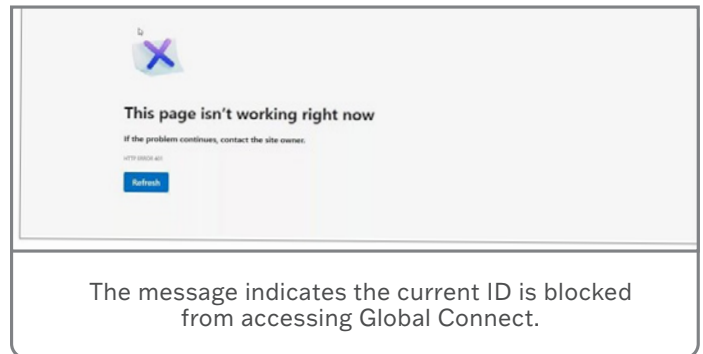
The message indicates that the current ID is blocked from accessing Global Connect. This can be for several reasons but typically is due to a counterfeit MDI device.

To unblock the account, reach out to TCSC via CX Connect with the following information:

TCSC will be able to reach out to the Cybersecurity team that will be able to determine the cause of the block and may be able to unblock the account. In the case of a counterfeit MDI, the counterfeit tool must be destroyed, and a legitimate Bosch device must be used to ensure the ID is not blocked again. Repeat offenders may not be unblocked from access.

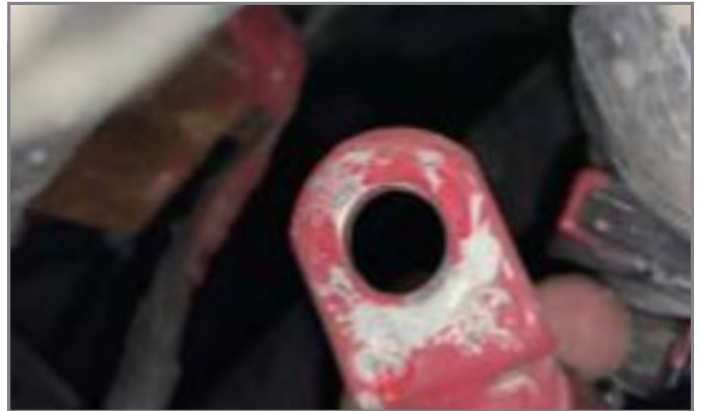
G120 (Main PTO ground on the left side of the engine) – Inspect ground bolt length and the ground eyelet for proper clamp load. Check for red anti-corrosion paint between the block and eyelet.

Inspect red anti-corrosion paint between the eyelet and engine block.

The intermittent PTO operation may be due to a vehicle ground issue. Before replacing the PTO switch, check and clean the vehicle grounds.

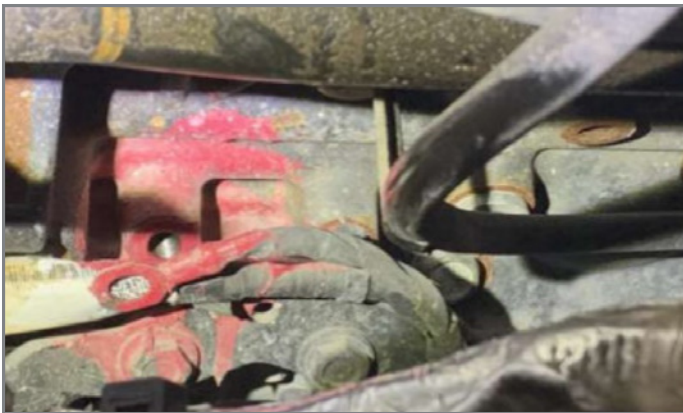
G198 and G199 (Main body-to-left frame rail ground) – Look for proper eyelet clamp load and red anti-corrosion paint between the bolt head and eyelet and the engine block or body stud.

Red anti-corrosion paint.

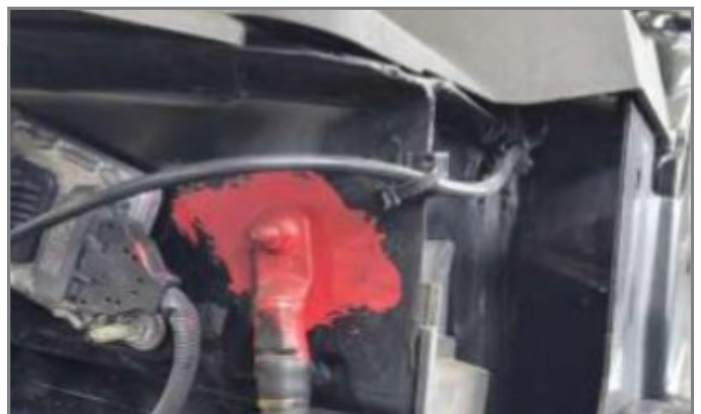
G108 and G110 (Main engine to frame ground on the right front inner frame rail, G108, and on the right side of the engine,

Check eyelet clamp load and red anti-corrosion paint

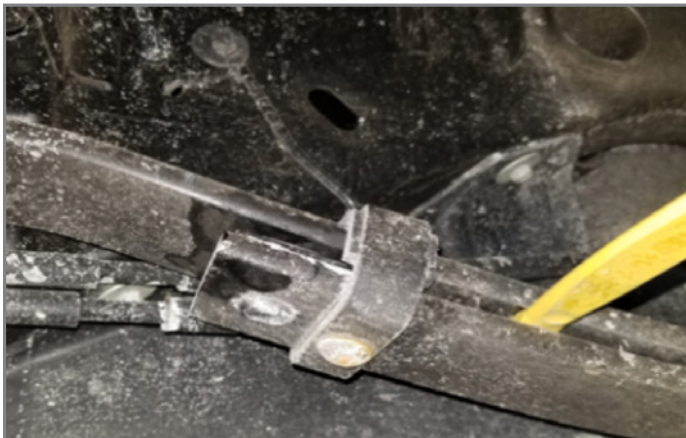
Some 2020-2026 Silverado 1500 and Sierra 1500 trucks equipped with the 3.0L diesel engine (RPO LM2, LZ0) may have a squeak or clunk sound coming from the rear of the vehicle, usually at low vehicle speeds or when the suspension is cycling through movement. The noise may be caused by the rear leaf springs. In some cases, the left rear leaf spring insert may have been contaminated with diesel fuel during refueling.

The left rear leaf spring insert may have been contaminated during refueling.

If fuel contamination is found, the left leaf spring insert should be replaced. In addition, if the foam seal around the fuel filler pipe is damaged or missing, a new foam seal should be installed.

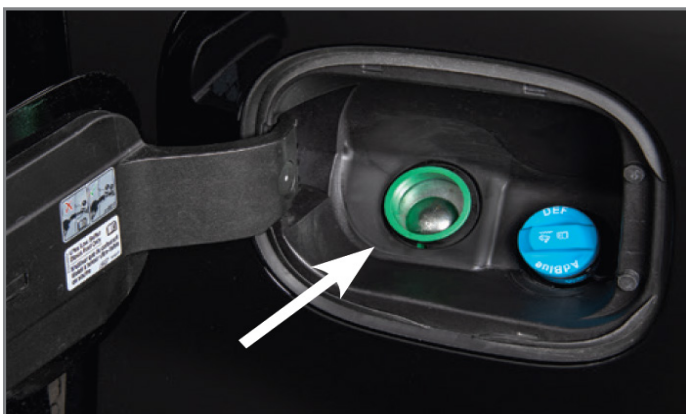
Diesel fuel may have run down the fuel filler pipe from any fuel kick back or when the fuel pump nozzle was removed.

While refueling the vehicle, diesel fuel may have run down the fuel filler pipe from any fuel kick back or when the fuel pump nozzle was removed. As a result, diesel fuel may contaminate the left rear leaf spring insert in the spring eyelet.

When contamination occurs, or if there are any substances or material in the leaf interface, the interaction between the leaf spring elements changes, leading to noise as the components move over each other.

Before performing any repairs, inspect the left rear leaf spring. Check the front half of the leaf spring for signs of diesel fuel contamination, including visible residue or a wet condition at the front leaf spring insert.
