Gemini OTA Update for Google built-in

TCSC Top Issues This Week

Unable to Learn Trailer TPM Sensors

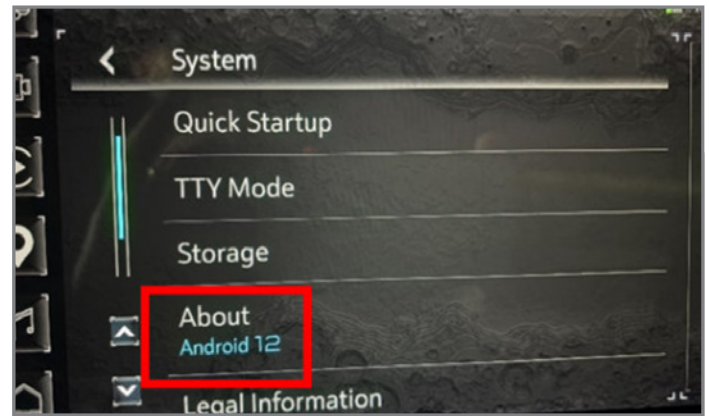
The Infotainment software for the Gemini update must be Android 11 or higher.

Check the software level by going to Settings > System > About. If the software level is Android 10 or below, a software update is needed.

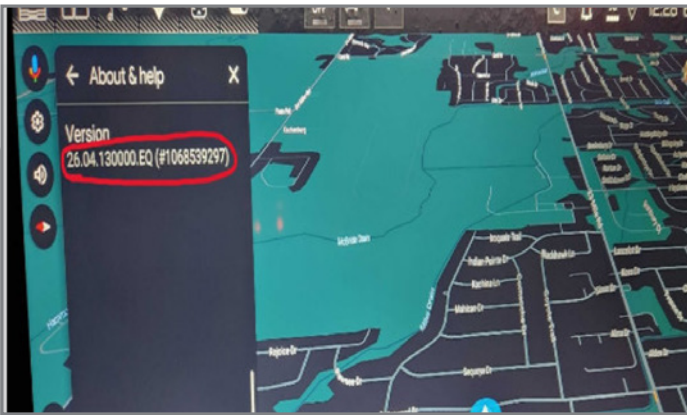
The Google Maps version must be 26.02.160000.E or higher.

Google Maps is updated via the Play Store. However, you cannot search for it in the Play Store. To check the Maps version and force an update, open the Maps app, tap the Settings gear icon, and go to About & Help > Version. Tap the version number to open the Maps page in the Play Store and update the app, if available.

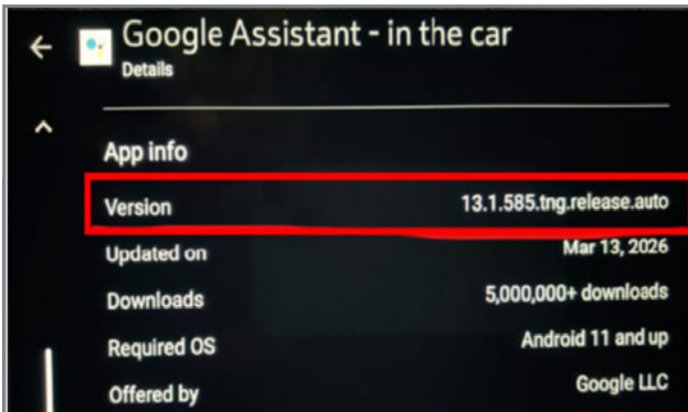
The Google Assistant app version for the Gemini opt-in must be 13.1.618.RC09 or higher. The example shown requires an update.

The Google Assistant app version for the Gemini opt-in must be 13.1.618.RC09 or higher. Update the app if needed.

If the version number is lower than 13.1.618.RC09, and an update is not available, the customer's Google Account has not been added to the ramp up yet. Overall timing may change and is not determined by GM. Play Store apps will automatically update in the background. Once the app is updated, the opt-in screen for Gemini will appear on the next ignition cycle. App Downloads and Auto-Update Apps should be set to "Over any network" in the Play Store settings.

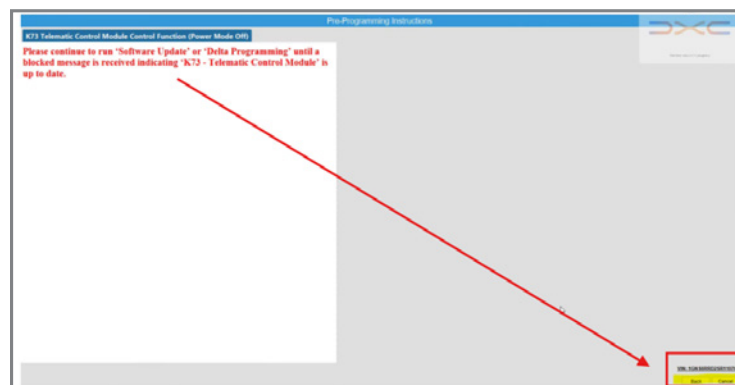
Pre-programming instructions for OnStar may indicate to run Delta programming multiple times until SPS2 indicates a same-calibration block. However, users are seeing that the Next button disappears after Delta programming instead of providing a same-cal-block message as indicated. As a result, it's not possible to proceed with further programming.

The missing Next button indicates that the OnStar Delta programming is up to date and the next programming steps can be attempted.

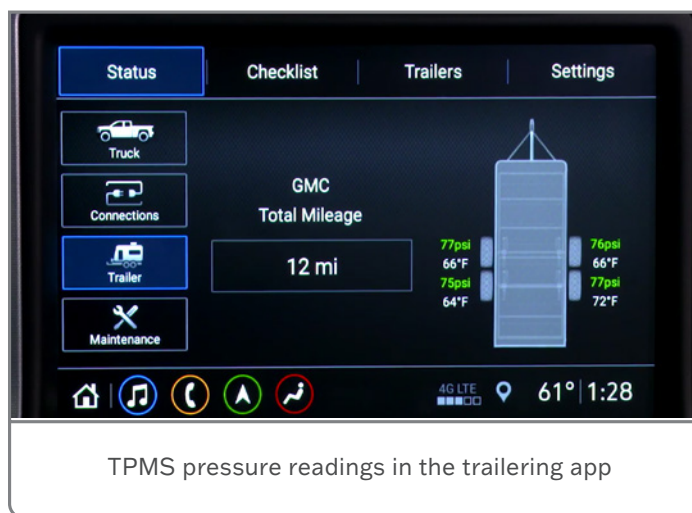
It may not be possible to learn the Trailer Tire Pressure Monitor (TPM) sensors to some 2024-2026 Silverado 2500HD/3500HD and Sierra 2500HD/3500HD trucks or the TPMS pressure readings may not appear consistently in the trailering app on the infotainment screen.

These conditions may be due to the animated tail lamps on the truck, which may cause radio frequency interference with the Trailer TPM system.

If the cause of the Trailer TPMS malfunction is not found, confirm that the truck currently has the animated tail lamps, and then replace the tail lamps with the parts included in Bulletin #26-NA-143. The tail lamp animation of the new LED-style tail lamps will be different from the original tail lamps.

Replacing the tail lamps will require Body Control Module (BCM) and K219 Lighting Control Module (ELM) reprogramming for proper operation. Contact the Techline Customer Support Center for the BCM and ELM calibrations. Refer to the appropriate Service Information for instructions.

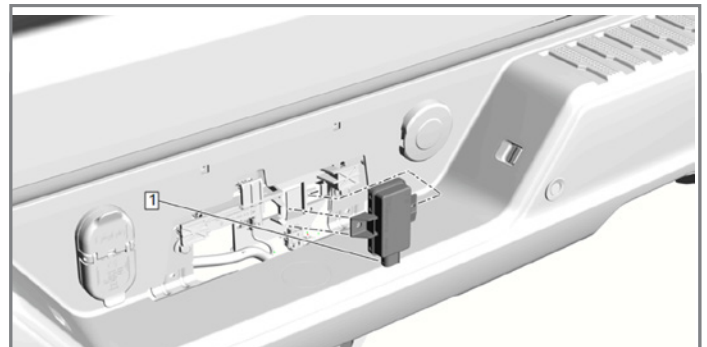
Trailer tire pressure indicator module located in the rear bumper

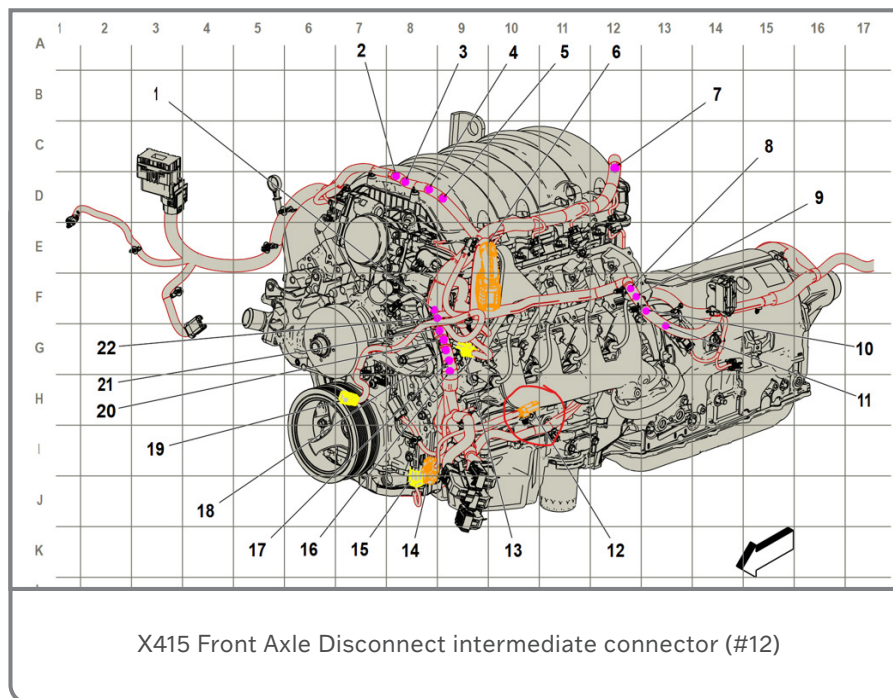
GM Engineering has identified a previously missing connector interface that requires inspection and circuit verification if a vehicle is serviced for any of the 4WD Front Axle Disconnect DTCs that may set on 2020-2026 Silverado 2500HD/3500HD and Sierra 2500HD/3500HD models and 2023-2026 Colorado and Canyon models.

- On Silverado and Sierra models, the X107 inline harness connector interface has been added to Service Information.
- On Colorado and Canyon models, the X415 inline harness connector interface has been added to Service Information.

Front Axle Disconnect DTC update in SI.

Wiggle the harness and connector of the specified components while monitoring the All Wheel Drive and AWD Input-Output Circuit Status parameters on the scan tool. The parameters should not change while wiggling the harness and connector. If the parameters change, repair the wiring or connector as needed.
