## Guided Diagnostics

### The Next Step in a More Focused Repair Path

# TCSC Top Issues This Week

# Oil Pan Wiring Harness Diagnostic Tips

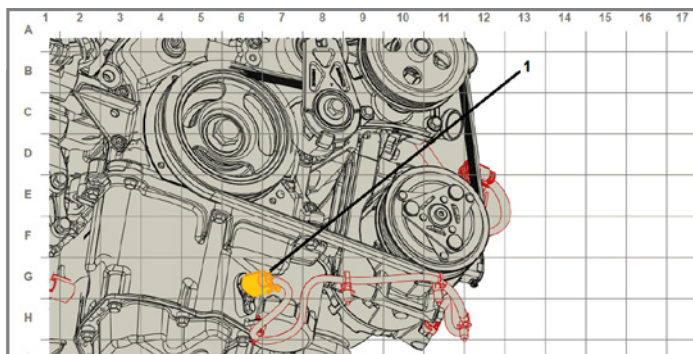
If these conditions are found, verify the oil level and condition. DTC P06DA indicates a circuit issue and DTC P06DD indicates that the oil pressure is higher than expected. An open circuit to the control valve can drive the oil pressure higher than expected.

Next, inspect the wiring harness from X111 (oil pan pass-through connector) and follow the harness through the series of zip ties toward the frame underneath the air conditioning compressor. Open the harness and inspect the wiring at the zip tie areas using a tug test to check if the wire is broken inside the insulation.

On AWD models, circuit 179 (BU) and 5293 (VT/BU) have been known to separate internally due to engine movement and the clamp load of the zip ties. Make any wiring repairs as needed.

For more information, refer to #PIP6125.

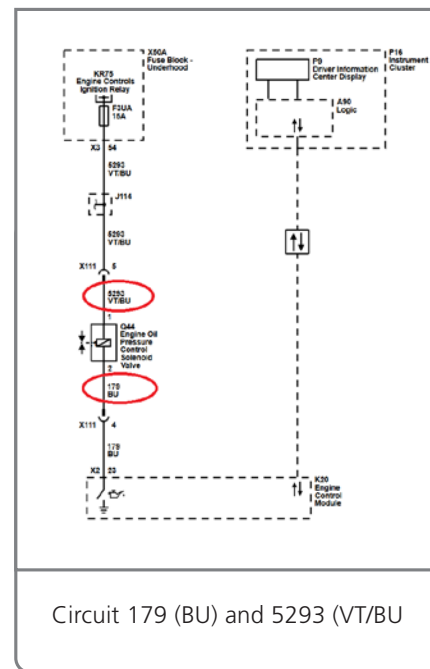
Circuit 179 (BU) and 5293 (VT/BU)

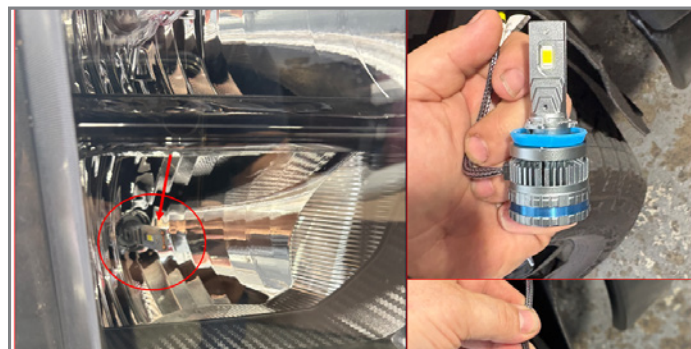
Several recent cases have shown aftermarket LED lighting, including headlights, parking lights and similar components, also may affect the operation of the Park Assist system.

Example of aftermarket LED lighting

Before replacing any components or performing indepth diagnostics, inspect the vehicle for aftermarket LED lighting. If any aftermarket LED bulbs are present (headlights, parking lights, turn-signal lights, etc.), reinstall the original factory bulbs and evaluate the system's operation.

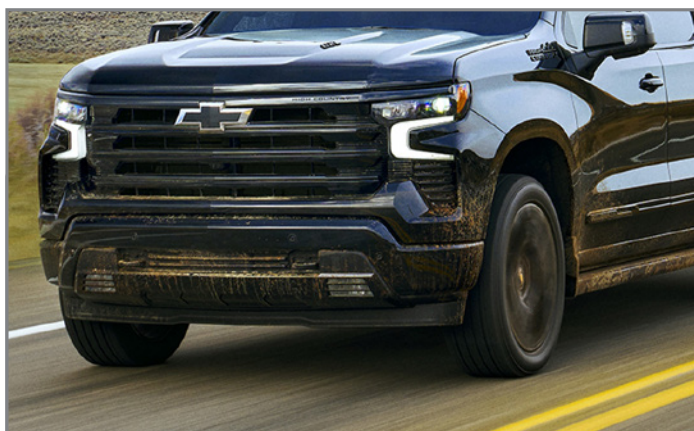
In many cases, a false alert may be caused by the sensors being obstructed by mud, dirt, snow, ice, or slush.

A sensor obstructed by mud on the bumper may cause a false alert.

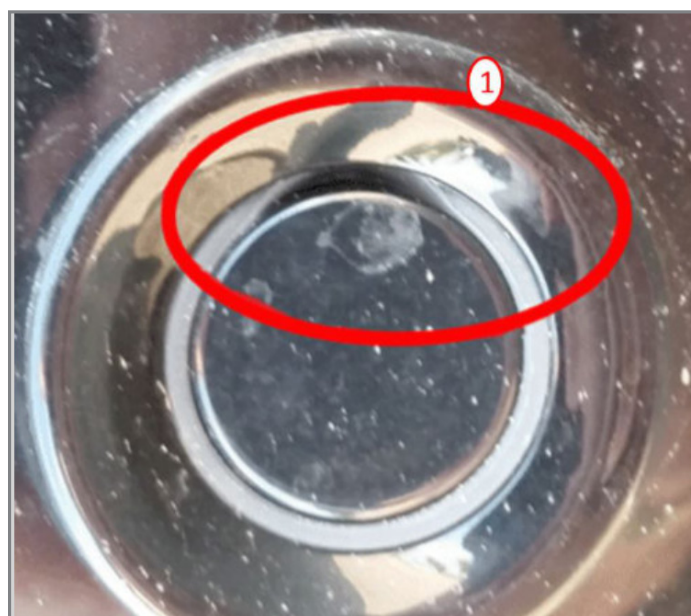
On some vehicles, unwanted or false alerts may result from burrs or excessive paint at the sensor openings in the bumper or

incorrectly installed isolator rings on the sensors. If an issue exists with the way the Park Assist sensor and/or bezel is mounted or painted, the sensor can ground out or be squeezed and pick up normal vehicle vibrations. These normal vibrations, which would not ordinarily be picked up by the sensor when properly mounted and isolated from the vehicle, could be interpreted by the Park Assist sensor as an object. Since the sensor is working normally, there will not be any DTCs set.

Silicone ring not properly installed.

Perform a visual inspection of the Park Assist sensor(s) and bezel(s). Look for any stone chips, dents, paint chips, damage, etc., as well as any issues with the installation of the silicone ring. If any issues are found, repair as necessary.

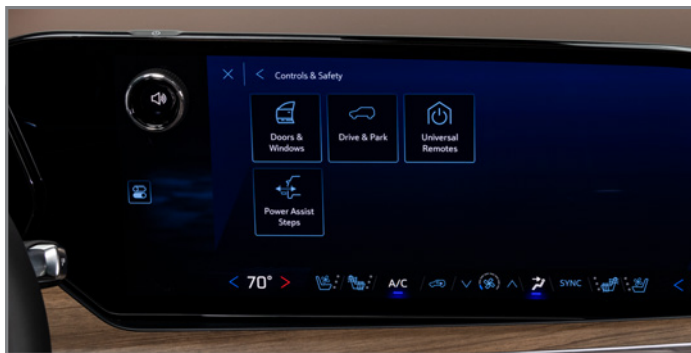
A Service Door Latch System message may be shown on the Driver Information Center (DIC) of some 2025-2026 Tahoe, Suburban, Yukon and Escalade models. In addition, the rear child door lock safety feature may be out of sync or mismatched between the left and right rear doors, resulting in malfunctioning locks. This condition may or may not continue over key cycles.

The rear child door lock safety feature may be out of sync.

On all models, the Body Control Module (BCM) should be reprogrammed with the latest calibrations listed in SPS.

After reprogramming the BCM, try to resync the rear door child safety locks by first opening all doors, leaving them open, and then cycling the child safety locks on/off using the controls on the infotainment screen. Go to Controls > See More Controls > Doors & Windows < Child Safety Locks > On and Off.

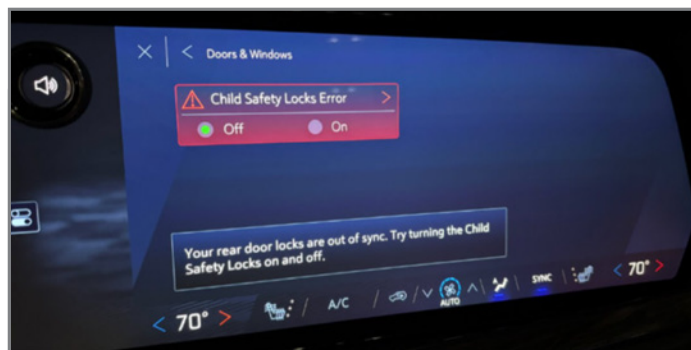
Go to Controls > See More Controls > Doors & Windows < Child Safety Locks > On and Off.

**TIP:** There are two different menus on the infotainment screen where the child safety locks can be cycled on and off. The locks must be cycled from the screen shown above or it will not cycle the child safety lock actuators, which will be shown grayed out

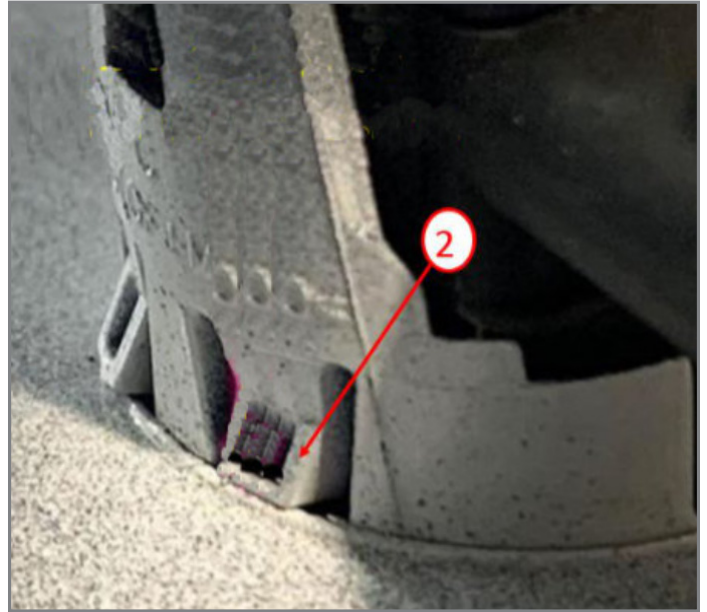
Mounting tab not fully engaged.

In addition, check that the Park Assist sensor bezel(s) are properly mounted in the bumper hole. If the bezel is not properly mounted, it can lead to a sensor grounding out or the sensor getting squeezed. The bezel has four locking tabs that secure the bezel to the bumper. Ensure all four mounting tabs are fully engaged.

Refer to Bulletin #22-NA-068 for more information, including several conditions that may prevent the bezel mounting tabs from fully engaging.
