# Unable to Learn Tire Pressure Monitor Sensors

# Fuel Pump Power Control Module Internal Short

# Fuel Injection Pump Installation and Diesel Engine Timing

## TECH LINK

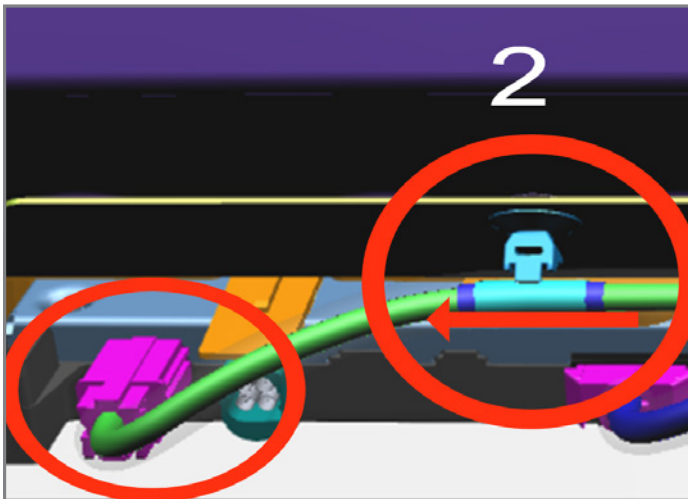
The cause of these conditions may be the connector at the Telematic Control Module (OnStar). The module may have a poor connection due to the wiring pulling on the connector.

Poor connection due to wiring pulling on the connector.

Begin diagnosis by following the procedures in the appropriate Service Information for each DTC. If the repairs do not correct the issue, inspect the Telematic Control Module connector and lessen the tension on the connector by pulling the wiring through the harness retainers.

At the right-side retainer, move the connector wiring to the left through the wiring retainer until the retainer is on the right end of the harness tape. It may be necessary to remove the retainer from the body hole to work through the harness.

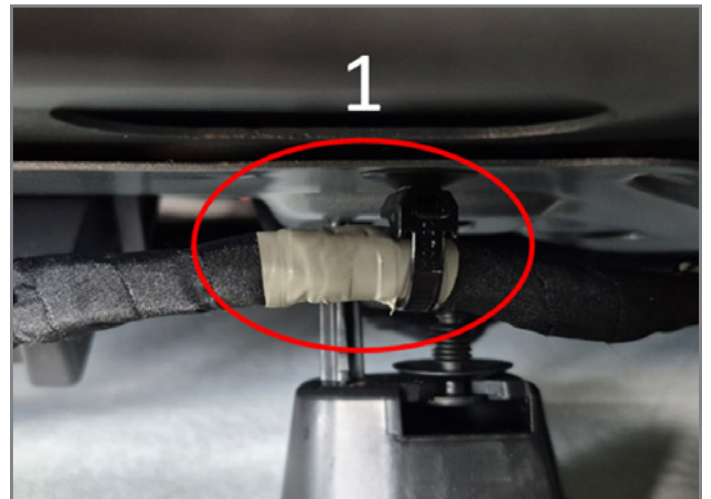
At the right-side retainer, move the connector wiring to the left through the wiring retainer.

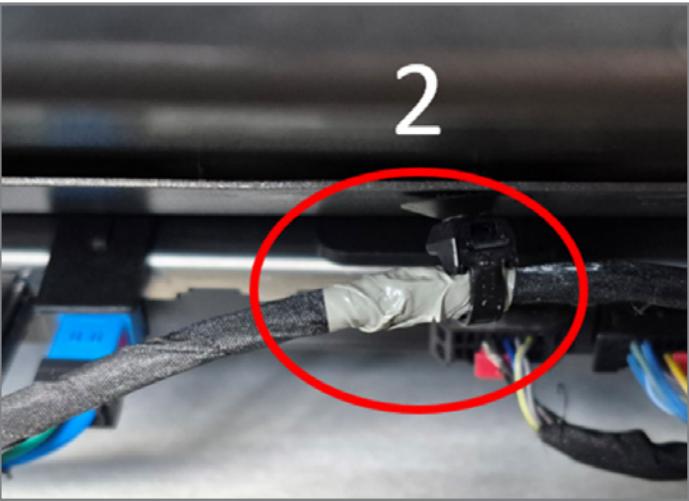
At the left-side retainer, move the wiring to the left until the retainer is at the right end of the harness tape.

At the left-side retainer, perform the same procedure, moving the wiring to the left until the retainer is at the right end of the harness tape. Remove the retainer from the body hole if needed. Reinstall the retainers if removed.

Once the wiring is repositioned, confirm that the connector is seated properly and is not being pulled out by the wiring harness tension.

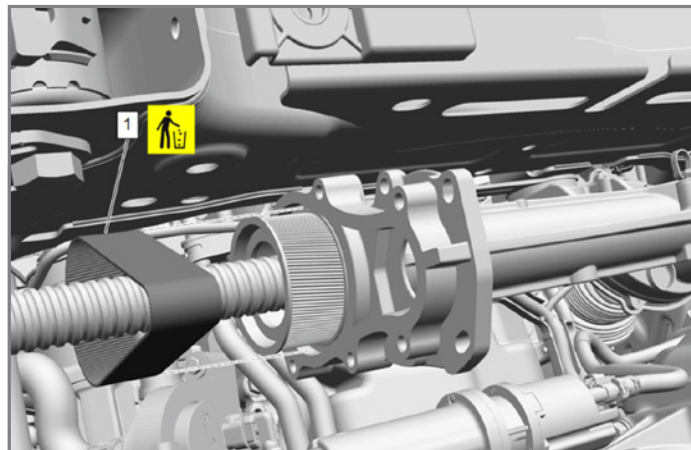
Electric belt drive rack and pinion steering gear belt

Inspect the steering gear housing and power steering assist motor shaft for signs of water intrusion or corrosion. Replace the entire steering gear if there is any water or corrosion present.

Also remove the electric belt drive rack and pinion steering gear belt and discard it.

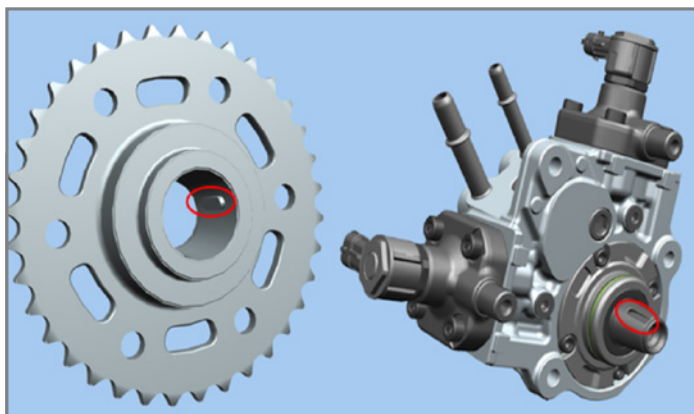
An engine no start condition may occur or low fuel pressure DTCs may set after replacing the fuel injection pump on some 2019-2026 Silverado 1500, Sierra 1500; and 2021-2026 Tahoe, Suburban and Yukon models equipped with the 3.0L diesel engine (RPO LM2, LZ0). These conditions may be caused by the fuel injection pump not being properly timed to the crankshaft and camshafts of the engine.

Injection pump input shaft keyway aligns with key in the timing gear.

When replacing the injection pump, ensure the keyway on the pump input shaft on the engine aligns with the key in the timing gear.

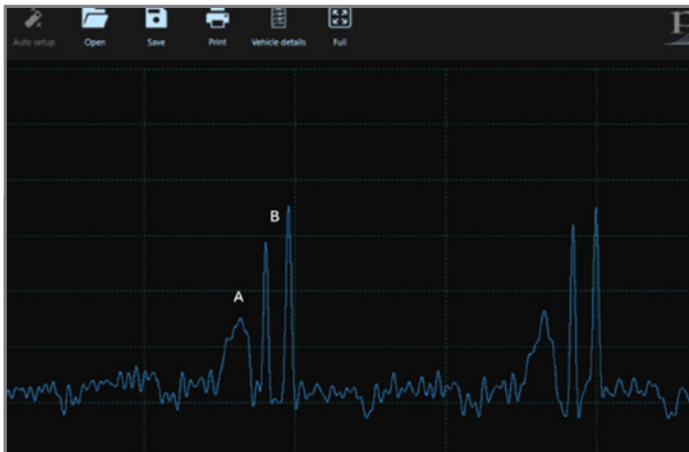
Improperly timed engine

On an improperly timed engine, the injection pump pulse will not be aligned with the fuel injector pulse.

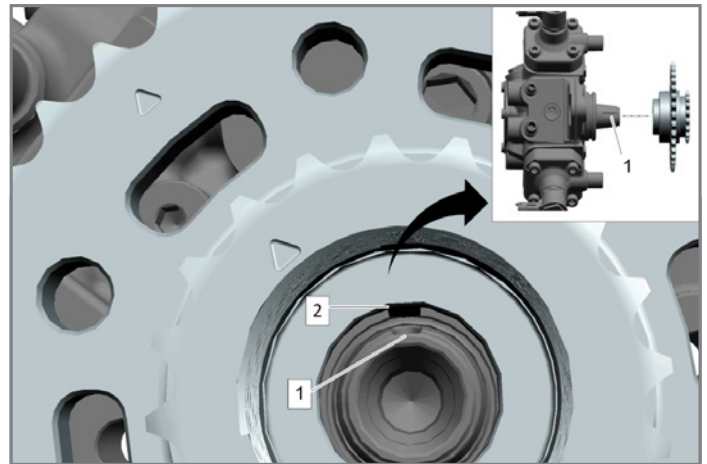
Align the marks on the pump shaft and the sprocket to install the fuel pump (#1).

To aid installation, mark the new fuel pump shaft in the same position as the marks on the old fuel pump to ensure it is timed correctly with the engine timing. Use the marks on the pump shaft and the sprocket to align and install the new fuel injection pump.
