# GM TECHNICAL ASSISTANCE CENTER (TAC)

## Dealer Tips and New Information Newsletter

AUGUST 24, 2026

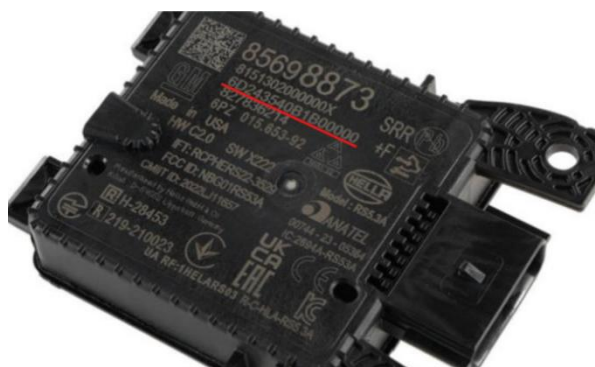
False/ghost left or right Side Object Detection alerts while driving with no objects around the vehicle may be caused by a software anomaly in the Short Range Radar Modules. This condition affects factory as well as service parts.

Create a TAC case and provide the Trace Data Identifier or add a picture of the Short Range Radar Module to the case so TAC can verify if the suspect Short Range Radar Module is affected by this software anomaly.

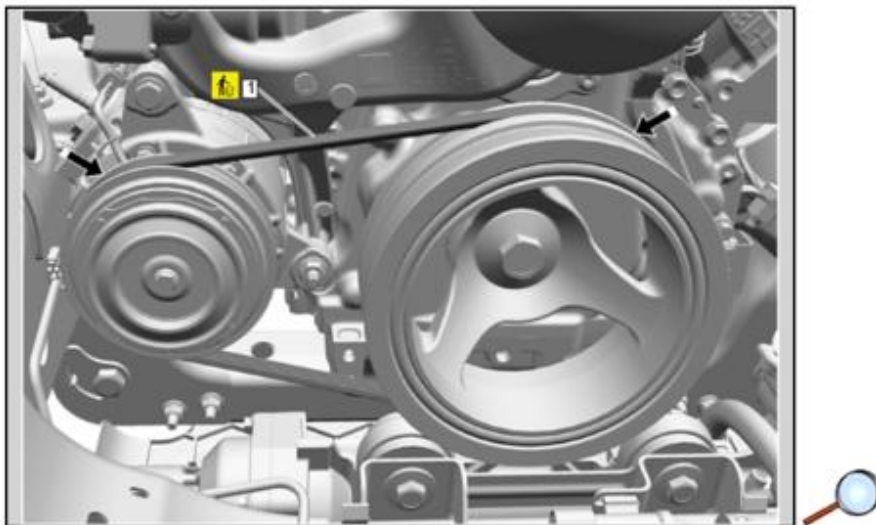
Upon review of the Engine Removal and Installation service procedure and to help prevent bearing damage, the Engine Prelubing step has been moved before the installation of the accessory drive belts. The reason this change was made is to ensure the lower crankshaft bearings and journals have an adequate amount of oil before rotating the engine dry during drive belt installation.

**Caution:** Refer to [Engine Prelubing Caution](#).  
231. Prelube is necessary if the engine is replaced or overhauled. [Engine Prelubing](#)

**Note:** The OEM replacement accessory drive auxiliary belt (1) is packaged with a disposable installation tool and installation instructions.  
232. Install the accessory drive auxiliary belt (1) following the instructions included with the accessory drive auxiliary belt.  
233. Inspect the accessory drive auxiliary belt (1) for proper installation and alignment.

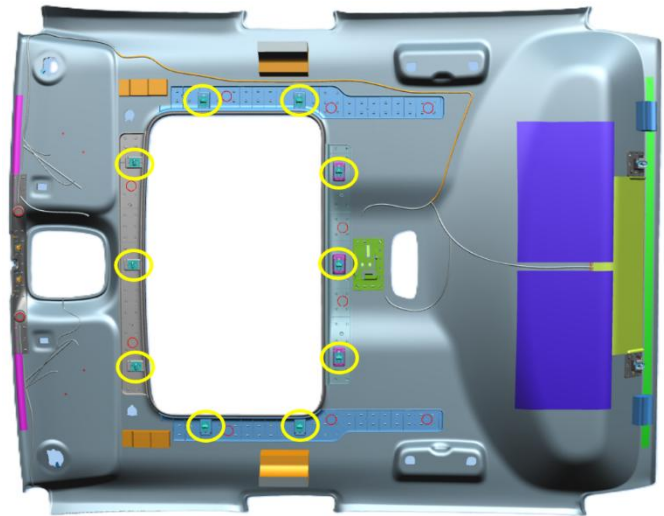
The headlining trim panel retainers may not have the proper retention, or there may be a material compatibility issue. Replace the current headlining trim panel retainers with the updated design parts. Do not replace the headliner.

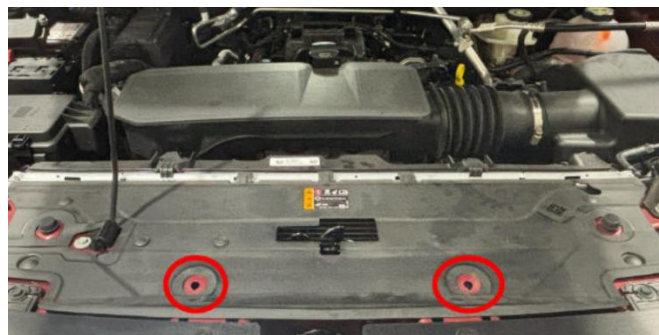
Engineering has confirmed that the non-adjustable Hood Front Bumpers do not impact the performance or long-term durability of the hood system or the truck and are not required.
