## New GM Parts Connect Delivers Smarter, Faster Parts Lookup

### 1.3L Engine Coolant Control Valve Failure

### Gear Shift Control Module Contamination

## TECH LINK

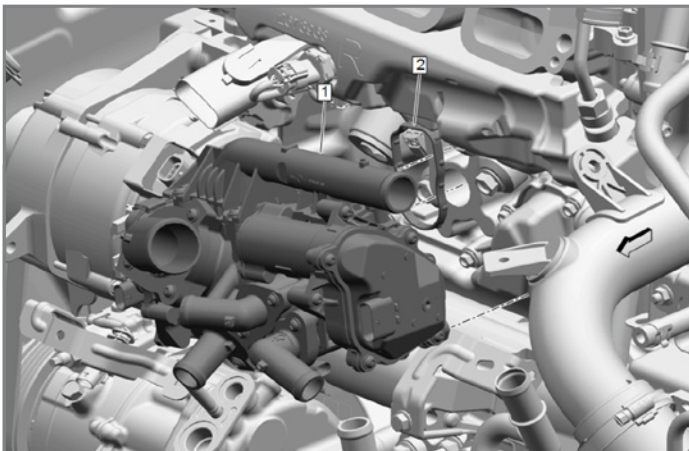
Some 2020-2025 Encore GX and 2021-2026 Trailblazer models equipped with the 1.3L engine (RPO L3T) may have an illuminated Check Engine MIL and DTCs P3075 (Engine Coolant Flow Too Low) and/or P0128 (Engine Coolant Temperature (ECT) Below Thermostat Regulating Temperature) or P1098 (Engine Oil Temperature Sensor 1 Circuit High Voltage) set due to failure of the Engine Coolant Flow Control Valve (CCV).

Engine Coolant Flow Control Valve (#1)

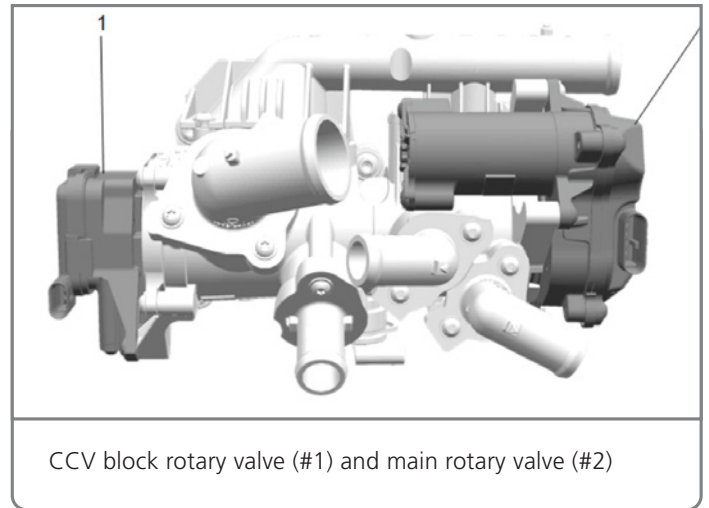
If these DTCs are set, inspect the CCV main rotary coolant valve (ball valve) using a borescope. It should cycle smoothly.

CCV block rotary valve (#1) and main rotary valve (#2)

With a borescope in position to view the CCV ball valve, cycle the CCV from 0 degrees to 300 degrees using the Coolant Control Valve Actuator Special Function in GDS. If the CCV cycles smoothly, reprogram the Engine Control Module (ECM) using the latest calibrations available.

If the CCV does not cycle or will not cycle smoothly, replace the CCV and reflash the ECM.

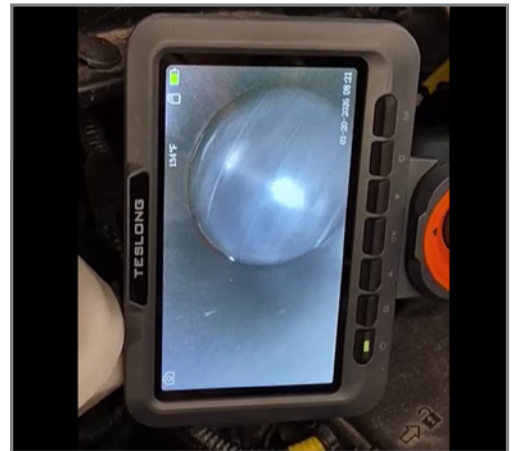
The CCV ball valve should cycle smoothly.

Refer to Engine Coolant Flow Control Valve Replacement L3T in the appropriate Service Information. After replacing the CCV, perform the CCV learn procedure and the Engine Coolant Pump data reset procedure.

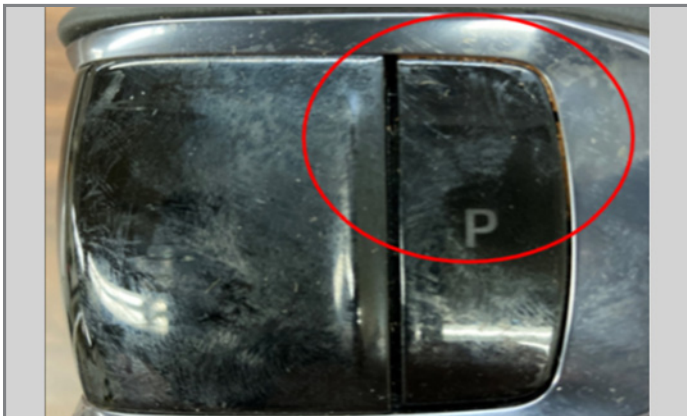
If one of the Gear Shift Control Module buttons is stuck on a 2022-2026 Silverado 1500, Sierra 1500 or HUMMER EV, check for any liquid spills that may have contaminated the shift lever.

Contamination of the Gear Shift Control Module also may result in an illuminated Check Engine MIL along with DTCs P17F4 (Transmission Range Selector Enable Switch A/B Circuit Stuck On), P189D (Transmission Park Position Switch A/B Circuit Stuck Off), P07B2 (Transmission Park Position Sensor/Switch A Circuit/Open), and/or P07B8 (Transmission Park Position Sensor/Switch B Circuit/Open) set in the Engine Control Module. Any of these DTCs may be caused by contamination if liquid has penetrated the buttons or internal components of the shifter. If the shifter has been cleaned, evidence of a spill may not be easy to identify.

Liquid may contaminate the buttons or internal components.

Inspect the gear shift lever for signs of liquid contamination, including the top edges as well as the base of the shifter. Clean the contaminated areas with a microfiber towel.

After cleaning the affected areas, cycle the shift lever through each selection multiple times, including the side release button and Park button with the ignition/power on and engine off (Silverado and Sierra models). Cycle the shifter a minimum of 10 times. Use a scan tool to clear the DTCs and monitor for any codes setting.

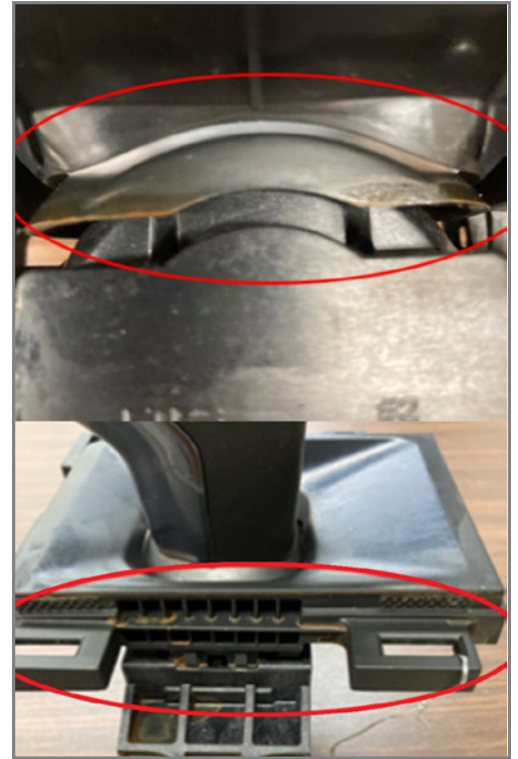
Evidence of liquid contamination

If either button is still stuck or if codes return, the Gear Shift Control Module should be replaced. Refer to Gear Shift Control Module Replacement in the appropriate Service Information.

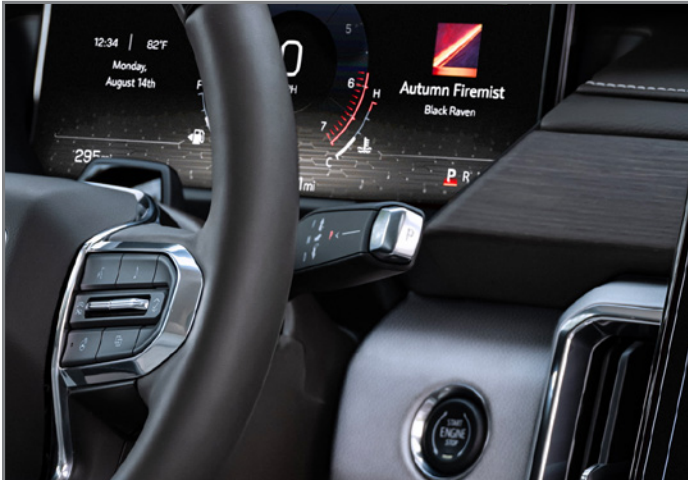
The transmission may get stuck intermittently in 1st gear on some 2024-2026 Traverse, Acadia; and 2025-2026 Enclave models equipped with the 8-speed 8T65 automatic transmission (RPO MF8). If this occurs, it will be necessary to stop the vehicle and shift to Park to correct the issue.

If the transmission gets stuck in 1st gear, it may require shifting to Park to correct the issue.

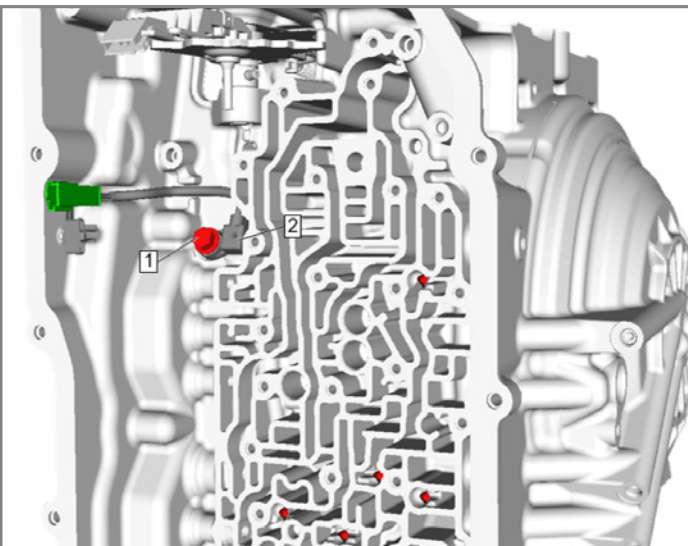
The output speed sensor may briefly send an incorrect signal, which may cause the vehicle to follow an irregular shift pattern and get stuck in 1st gear until a shift-to-Park event is performed.

Output speed sensor (#2)

Once it has been verified that no DTCs set and that the transmission gets stuck in 1st gear, replace the output speed sensor in the transmission. Refer to Automatic Transmission Output Speed Sensor Replacement in the Service Information.

The output speed sensor is located behind the control valve solenoid body. Remove the control valve body cover, wiring harness, Park inhibitor solenoid, control valve solenoid body, and fluid transfer pipe to access the output speed sensor.

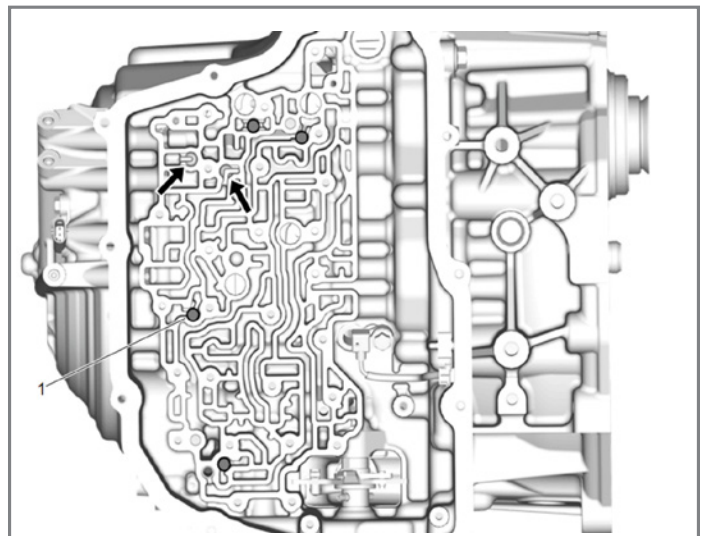
Do not place check balls in the pockets indicated by arrows.

After installing the new output speed sensor, use DT-36850-A Transjel Lubricant to install the four control valve body ball check valves. Do not place check balls in the pockets indicated by arrows in the installation procedure. If check balls are placed in these locations, there will be shift quality concerns.

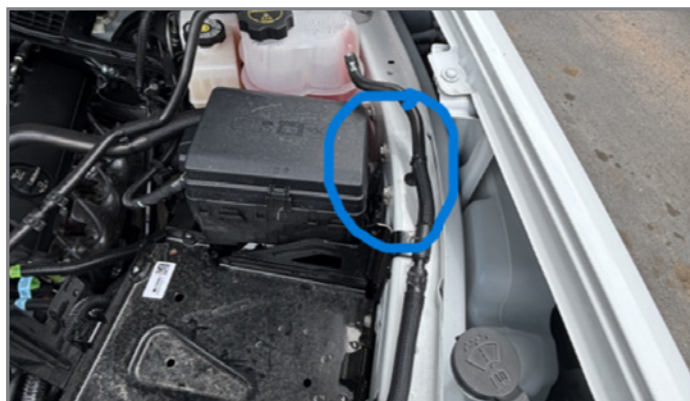
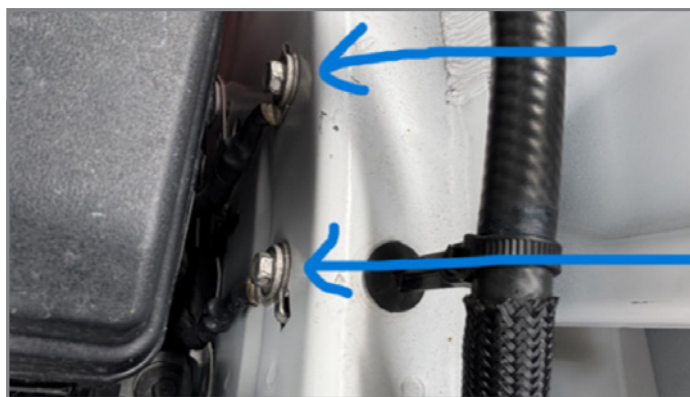
Grounds G103A and G103B

Some 2024-2026 Silverado 2500HD/3500HD and Sierra 2500HD/3500HD trucks may have several communication issues and CAN Bus errors as well as multiple illuminated warning MILs and messages on the Driver Information Center while the vehicle is running/driving/idling. The vehicle also may lose communication with the Electronic Brake Control Module. Several DTCs may be set, including DTC B1980 (No Environment Identifier Received From Brake System Control Module 1) and communication DTCs U1610, U0121, U2418, U2419, U160F, U0101, U0131, U1611 and U0401.

These conditions may be caused by high resistance to ground on grounds G103A and G103B of the body wiring harness. These grounds are located under the hood on the inboard side of the left body structure of the HD trucks, next to the X50A Engine Wiring Harness Junction Block.

Clean the mating surface on the body structure for these grounds and confirm proper system operation.
