## Ethernet Cable Overlay for Telematic Control Module Interference

# Ethernet Cable Overlay for Telematic Control Module Interference

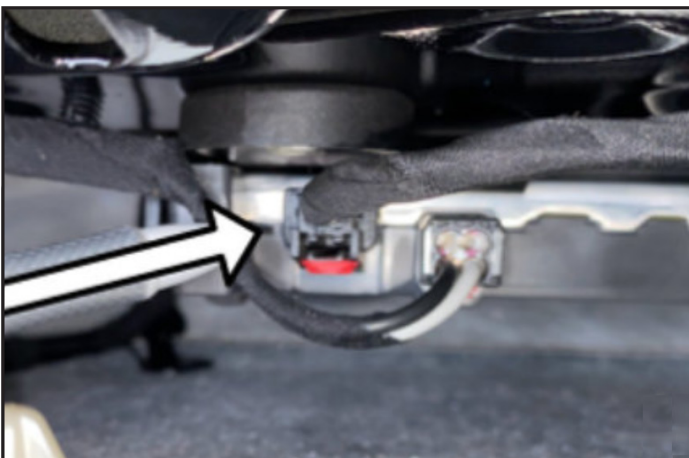
Telematic Control Module (OnStar module)

Next, disconnect the X7 Ethernet cable connector from the Telematic Control Module in the headliner.

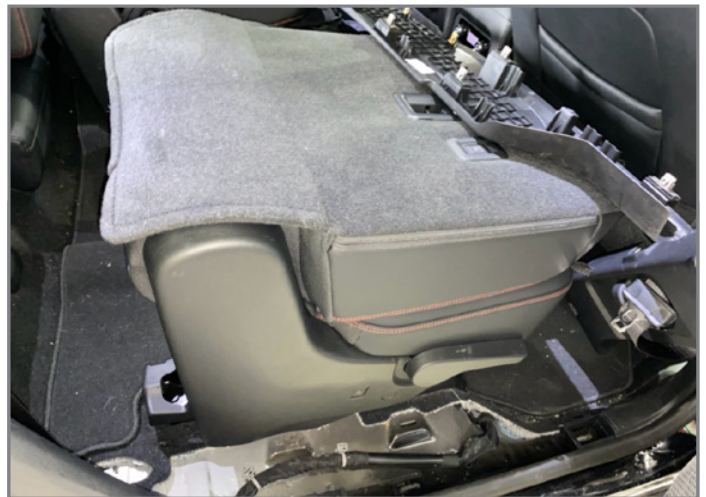
Remove the necessary interior trim pieces to access the Ethernet cable.

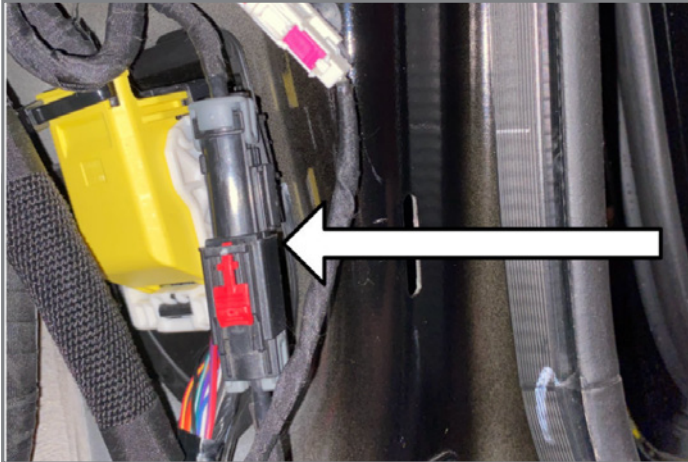
X205 connector

At the lower right side of the front passenger compartment, disconnect the X205 Ethernet cable connector.

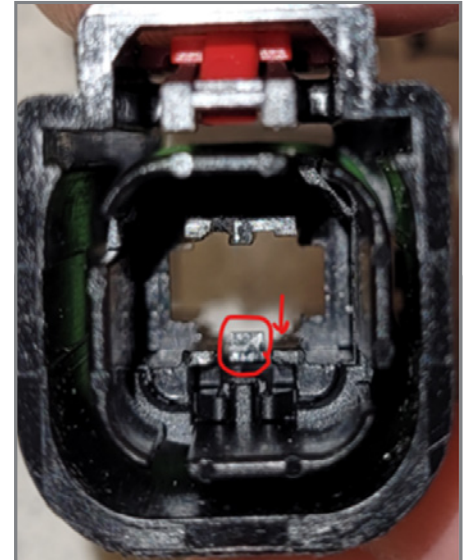
Release tab on the terminal housing

The release tab on each terminal housing is difficult to see with the cable installed. Follow the middle ridge to the back of the housing where it locks onto the cable. Lightly press the tab to release the cable.

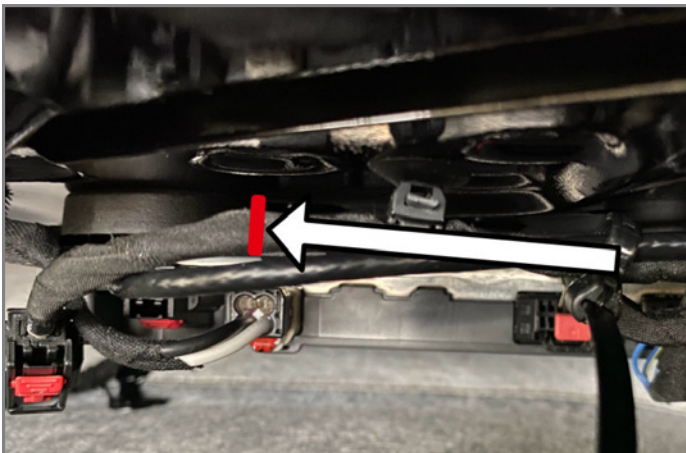
Cut both ends off the existing Ethernet cable at X205 and X7 (shown).

The existing Ethernet cable is bundled with the body wiring harness. The service Ethernet cable will be routed next to the body wiring harness. The terminals must be removed from the existing Ethernet cables to ensure they are not used in future repairs. Cut both ends off the existing Ethernet cable at X205 and X7 of the Telematic Control Module. Wrap PVC electrical tape around both ends of the cable. The unused cable can remain bundled with the body wiring harness.

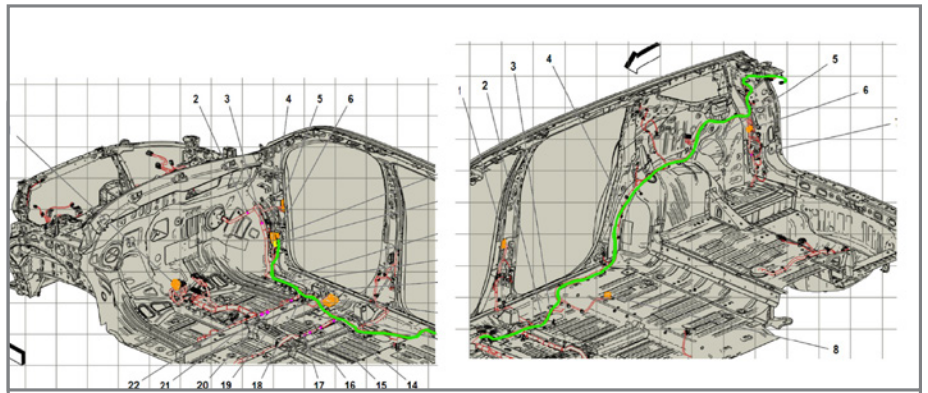
Replacement Ethernet cable routing

The replacement Ethernet cable routing is shown in green.

To route the new service Ethernet cable, start at X205 and follow the body wiring harness back toward the Telematic Control Module. Use extreme care when handling the new service Ethernet cable. Avoid kinks, sharp bends, pinch points and excessive wire tie tightness.

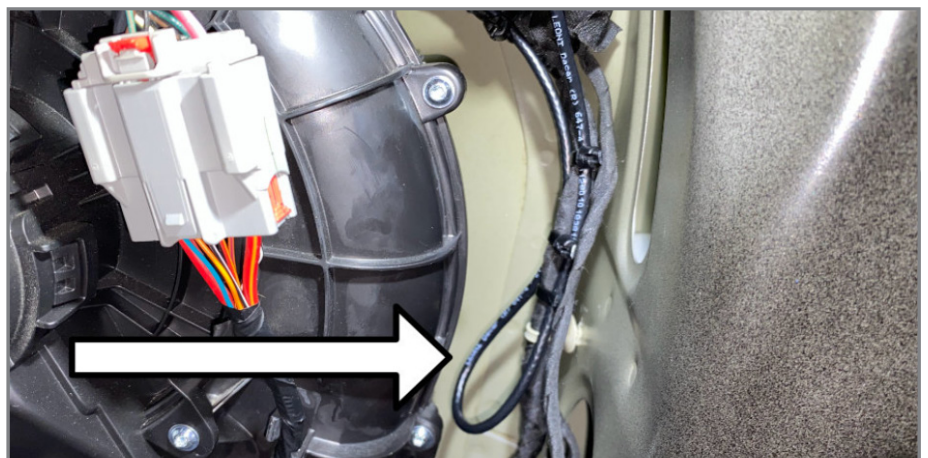
Make a loop in the cable for extra slack if needed.

While routing the cable, be sure to leave plenty of slack so that the cable will not pull on the X7 connector at the Telematic Control Module. Make a small loop to remove some of the excess cable and secure with a wire tie near the Rear HVAC area. This extra cable can be used if there is not an adequate slack in the cable when connecting to the X7 connector.

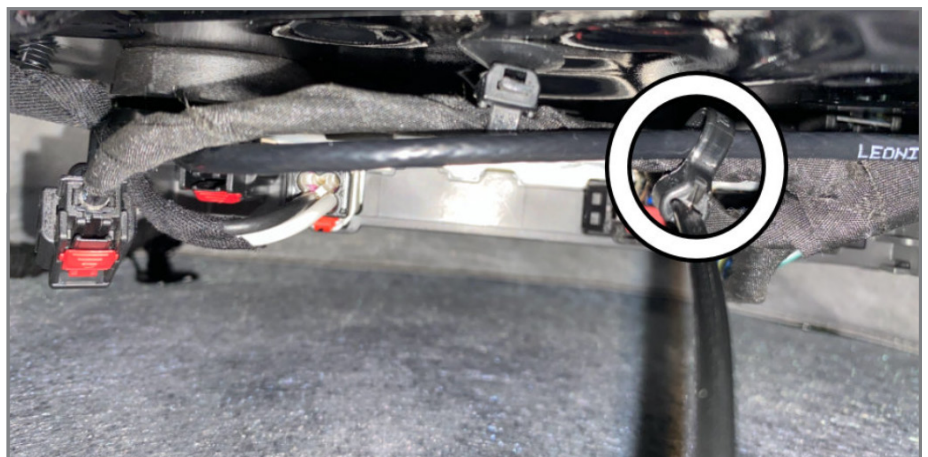
Add a wire tie around the old cable harness and the new replacement cable.

Once the replacement cable is routed, connect to X7 of the Telematic Control Module. Secure the replacement cable to the body wiring harness with wire ties as needed to ensure the replacement cable does not move or rattle.

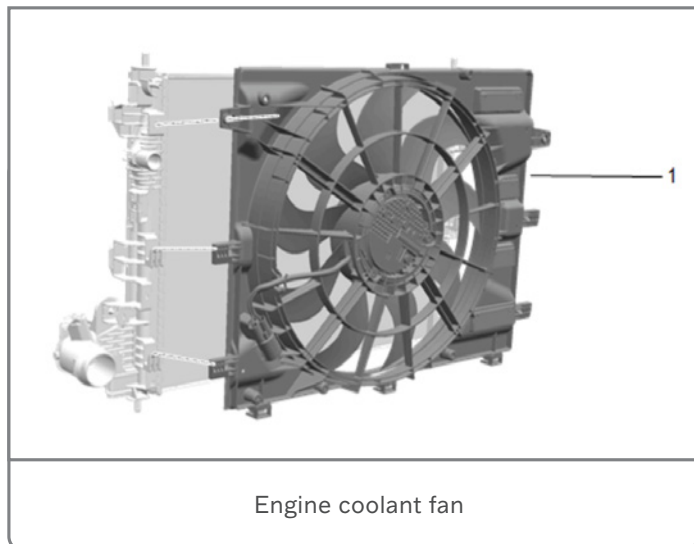
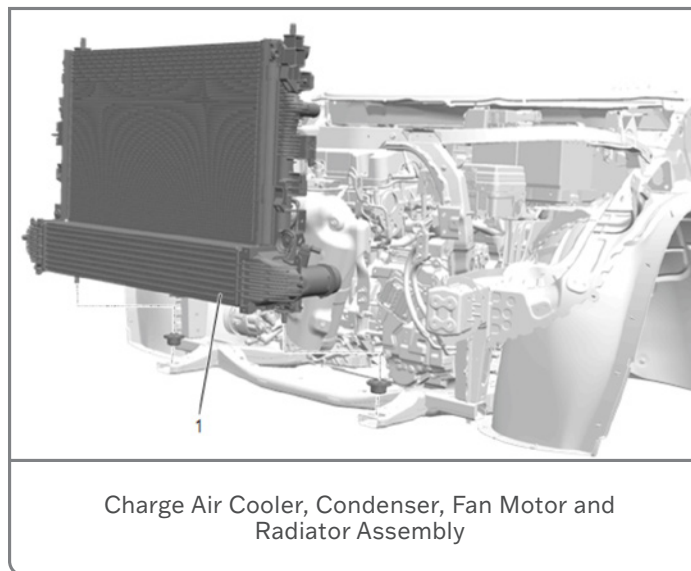
Some 2024-2026 Equinox and Terrain models may exhibit several engine cooling and air conditioning issues, including engine overheating, an inoperative cooling fan and inoperative air conditioning. DTC P0494 (Cooling Fan Speed Too Low) also may be set in the Engine Control Module (ECM)

If the engine cooling and A/C issues are present, there may be an internal cooling fan failure. Replace the G10 Cooling Fan Motor with the latest part number, which has an internal update.

Refer to Engine Coolant Fan Replacement in the appropriate Service Information. The cooling fan is located on the rear of the Charge Air Cooler, Condenser, Fan Motor and Radiator Assembly.
