# GM TECHNICAL ASSISTANCE CENTER (TAC)

## Dealer Tips and New Information Newsletter

SEPTEMBER 24, 2026

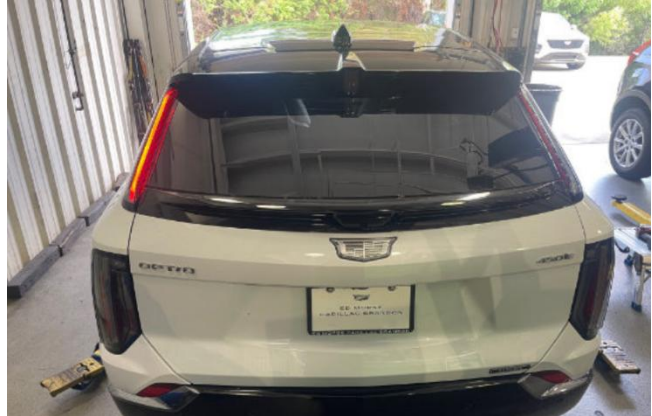
## 1) #PIC6661: Diagnostic Tip - Tail Lights Stay on After Vehicle is Shut Off

If the tail lights stay on after the vehicle is shut off, check for possible water intrusion in the rear tail lamp connector.
