August 2020, Volume 22, No. 15

The Diesel Exhaust System

DPF Soot ccumulation

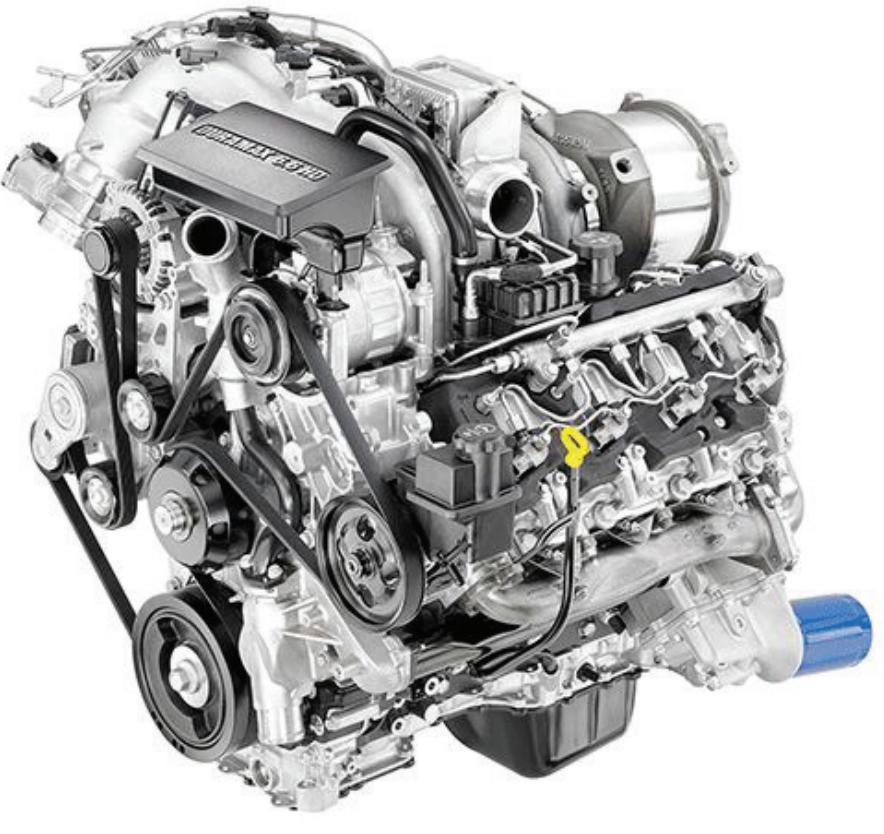
When DTC P2463 sets, the ECM will no longer try to perform a driving regeneration and the vehicle will require the more controlled service regeneration. There are a number of factors that can cause the code to set, including:

- The driver ignoring the keep driving messages
- Leaks from intake or exhaust system
- Poor fueling in the engine
- Contaminated or bad fuel
- Externally damaged or worn components.
- Loose or improperly installed components
- Dirty components (air filter or TMAP sensor)
- Driving style, such as binary driving (frequently on/off accelerator or brake)

Cleaning Exhaust Filter Continue Driving

Continue Driving message on the DIC.

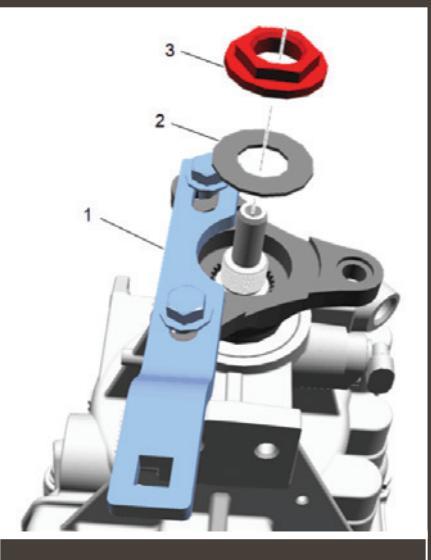
Some 2016-2019 ATS models and 2016-2020 Camaro models equipped with the 6-speed manual transmission (RPO M13) may have an illuminated Check Engine MIL and DTC P17A2 (Transmission Clutch Slip Detected) may be set in the Engine Control Module (ECM). These conditions may be the result of the output speed sensor reluctor wheel slipping on the shaft due to improper torque of the output shaft nut.

J-45012 Holding Fixture
Output shaft flange thrust washer
Output shaft flange nut

Remove the output vehicle speed sensor and use a small tool to lightly pry on the speed sensor reluctor wheel. If the reluctor wheel moves, install a new output shaft flange thrust washer and nut and torque to specification. If the reluctor wheel does not move, refer to the appropriate Service Information to continue diagnosis.

remove the two-piece propeller shaft. Install the J-45012 Holding Fixture and remove the output shaft flange nut and thrust washer.

Install the new output shaft flange thrust washer and nut. Torque the nut to 145 Nm (107 lb.-ft.)

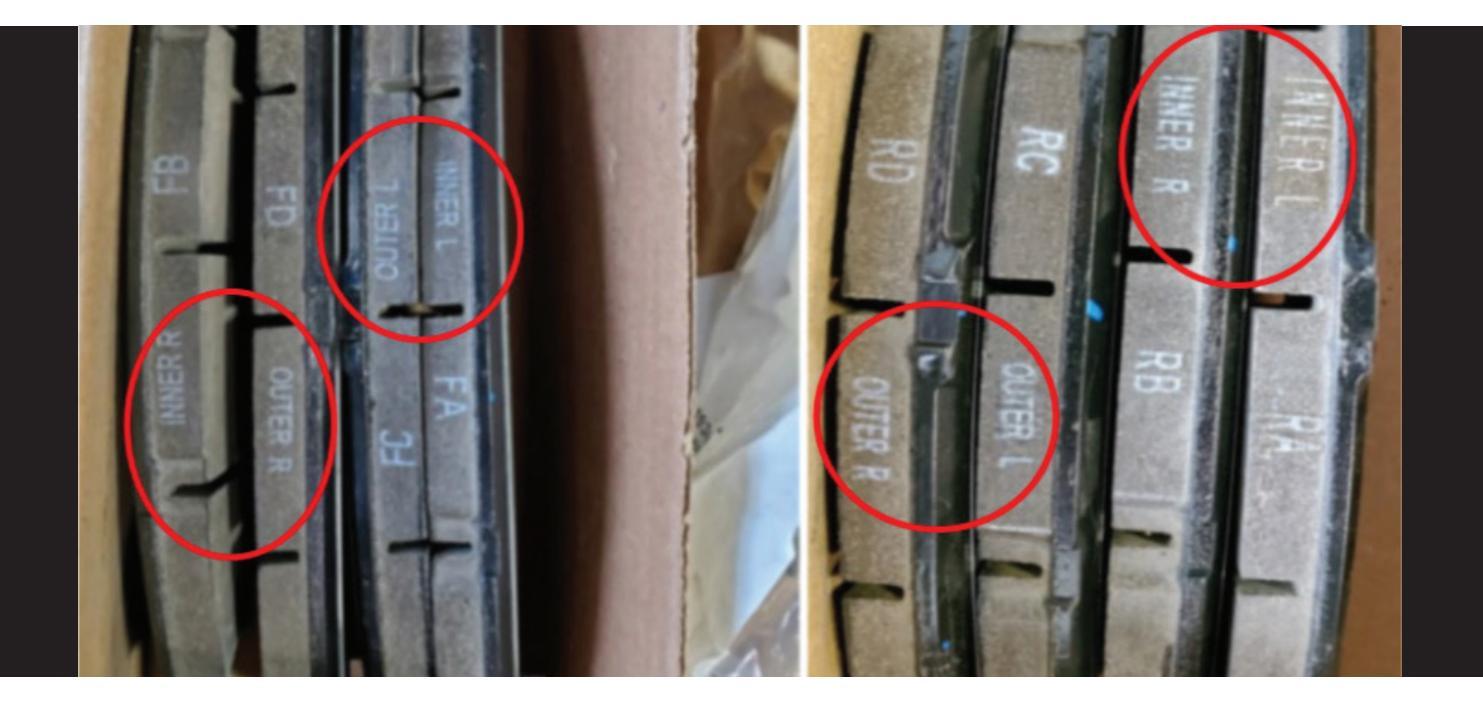
Each brake pad has an Inner or Outer label.

Some 2020 Silverado 2500/3500 and Sierra 2500/3500 models may have a brake squeal condition caused by the low scorch friction material used on the original brake pads.

New brake pads are available that have a high scorch friction material to reduce the potential for noise. Replace the front and rear brake pads with the new pads.

TIP: Each brake pad has an Inner or Outer label to indicate where it should be installed.

If the pads are replaced and the squeal sound continues, check the orientation of the pads. If the inboard and outboard designation on the pads indicate the pads are installed in the wrong location, the squeal sound may persist.

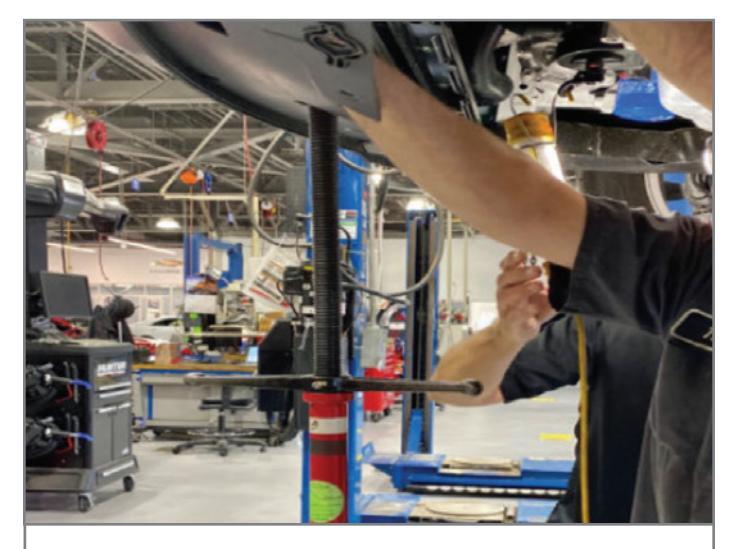
A boom sound or flutter vibration may be noticed on some 2020 Encore GX models equipped with the 1.3L engine (RPO L3T) at low speeds with light throttle input. If these conditions are found, replace the lower radiator mount bushings.

Push up on the CRFM to move the bushing holder forward and then out the bottom.

To replace the bushings, first remove the front compartment insulator. With the insulator removed, remove the six front bumper fascia extension bolts and the two front bumper fascia extension retainers.

Next, push up on the condenser, radiator and fan module (CRFM) slightly in order to move the bushing holder forward within the vehicle, and then out the bottom.

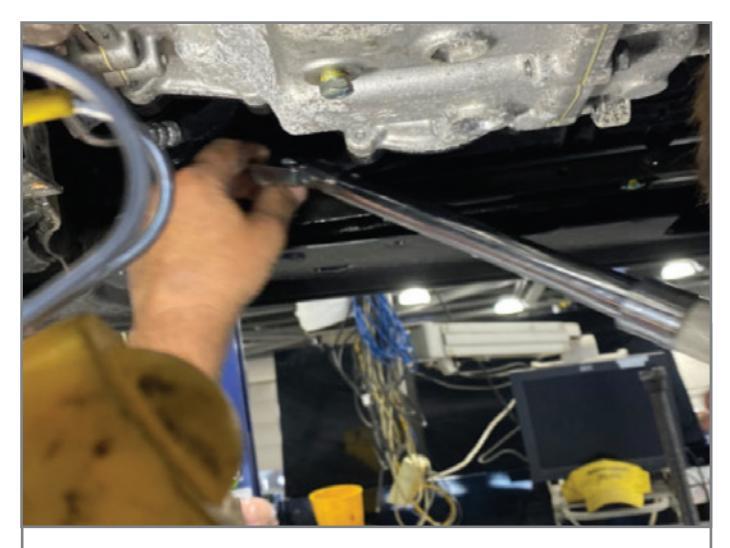
Replace the lower radiator mounts.

The lower radiator mounts can now be removed and replaced. Be sure to tighten the fasteners for the new mounts to 22 Nm (16 lb.-ft.).

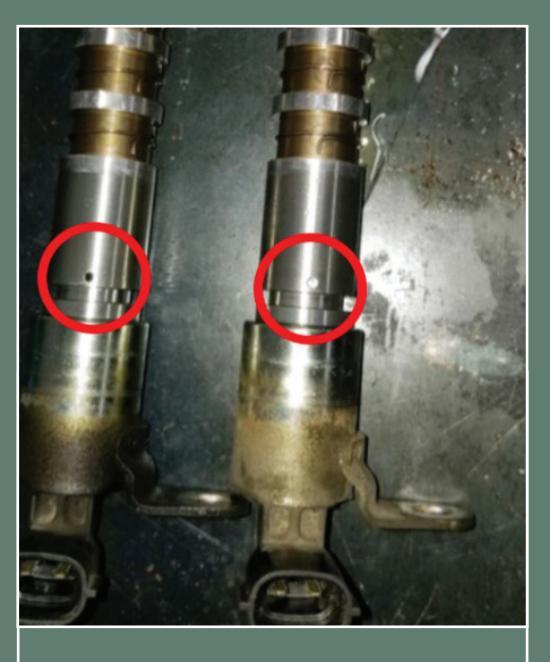
For example, a stuck solenoid pintle in a bad camshaft actuator solenoid is indicated by an open hole visible in the body of the solenoid compared with a good actuator solenoid.

Stuck solenoid pintle in a bad camshaft actuator solenoid (left) vs. a good camshaft actuator solenoid (right).

If a misfire or DTC is found after engine installation, follow the diagnostics in the appropriate Service Information. Verify that the misfire or DTC is not caused by ignition, fuel, or electrical components that were not part of the replacement engine assembly.

If diagnostics do not help identify the cause of the drivability concern, call the GM Technical Assistance Center for a recommendation on next steps before removing the timing cover or cylinder heads.

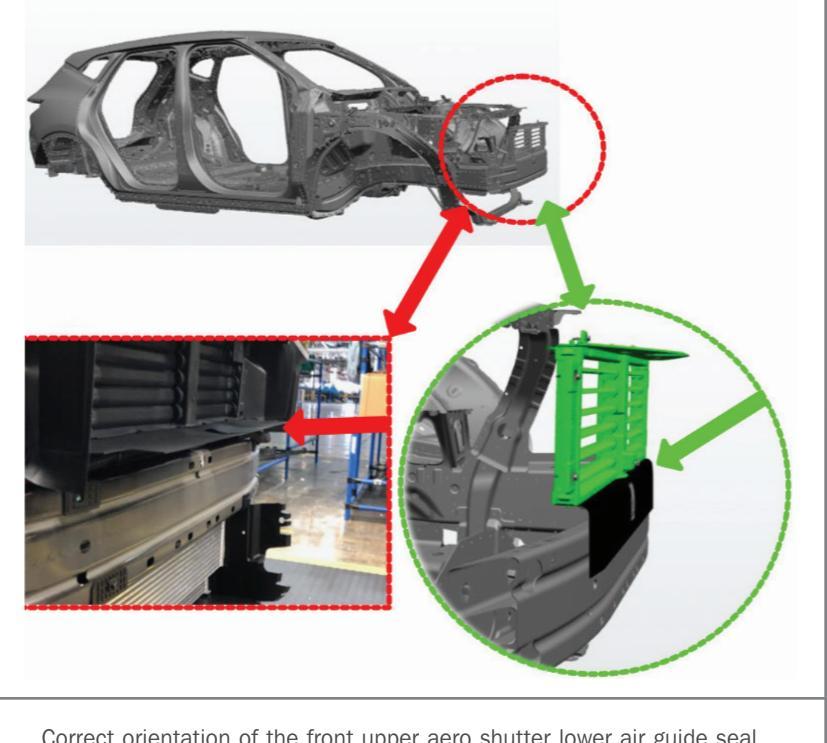
Check the front upper aero shutter lower air guide seal. The seal may not be properly nested between the front impact beam and the front fascia grille blocker/EA foam.

The lower air guide seal may not have the proper preform, which allows it to lay on top of the front fascia grille blocker/EA foam. If the rubber seal is not tucked between the grille blocker and front impact beam, it may produce the rattle or whine sound when exposed to highway speed winds.

Correct orientation of the front upper aero shutter lower air guide seal (green) and the incorrect orientation (red).

To correct the condition, remove the front fascia assembly and manually roll the lower air guide seal over and down the top of the impact beam.

When reinstalling the front fascia assembly, ensure that the lower air guide seal is positioned between the front impact beam and the fascia assembly. It may help to apply adhesive tape to the forward edge of the seal to hold it in proper position before installing the front fascia assembly.
