Mid-November 2020, Volume 22, No. 22

Battery Testing Guidelines Using the GR8 Battery Tester/Charger or
Diagnostic Charge Battery Station 2
Check the Sales Order Guide Before
Changing Tire and Wheel Sizes5
Hood Latch Replacement 7
FSE Technician Recognition
Awards – 4th Quarter 2020 8
Fuel Odor from Engine
Compartment
Coolant Flow Control Valve Actuator
Harness Connector Corrosion 11

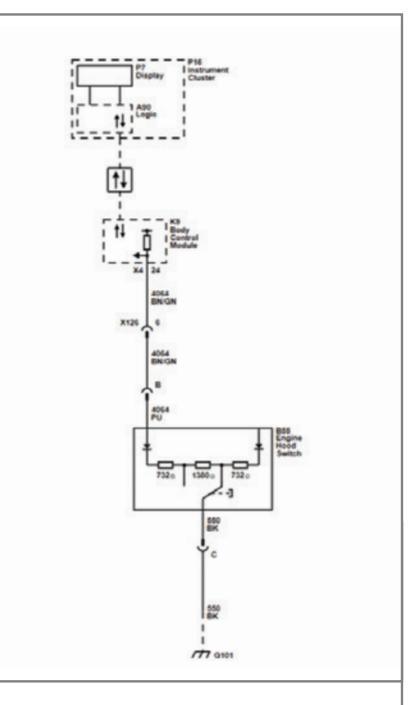
When replacing the hood latch on 2016-2018 Camaros, the service replacement hood latch will require the use of a new connector. The new service latch has a three-wire connector while the original latch on 2016-2018 models only has a two-wire connector.

The original hood latch has a two-wire connector.

The schematic in the Service Information shows a purple wire on the original hood latch.

Obtain the new connector from the GM Electronic Parts Catalog. Remove the yellow wire and terminal from the new connector. It is also acceptable to cut the wire 1-2 inches from the connector and tape off the end of the wire.

The schematic in the Service Information shows a purple wire on the hood latch; on the new connector this is a red wire. Connect the red wire on the connector to the BN/GN wire in the vehicle harness. Connect the black wire on the connector to the black wire on the vehicle harness.

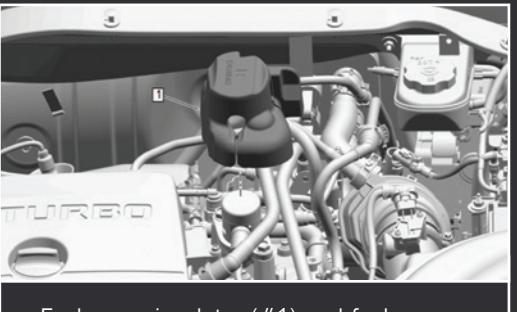
A fuel odor from the engine compartment may be found on some 2020-2021 Encore GX and 2021 Trailblazer models equipped with the 1.3L engine (RPO L3T).

Fuel pump insulator (#1) and fuel pump.

Replace any fuel system components where leakage is found

following the procedures in the appropriate Service Information. The noise canceling foam component of the fuel injection fuel rail insulator also must be replaced if it has been exposed to engine fluids. Confirm the proper operation of the fuel system following repairs.

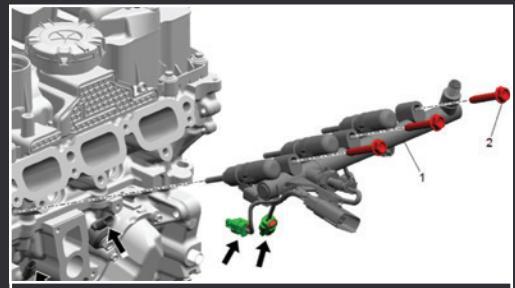
Inspect the high pressure fuel rail feed pipe and fuel injector connections for any signs of the leak dye or fuel leakage.

Inspect the high pressure fuel rail feed pipe and fuel injector connections.

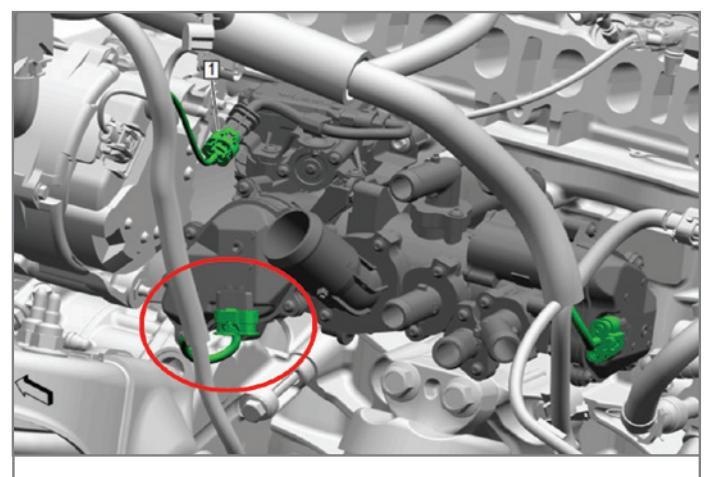
The 3.0L Duramax diesel engine (RPO LM2) on some 2020-2021 Silverado and Sierra models may have possible terminal corrosion in the coolant flow control valve actuator harness connector. The Check Engine MIL may be illuminated and DTC P2B60 (Engine Coolant Flow Control Valve Position Sensor Circuit Performance) may be set.

Check for corroded terminals at the flow control valve actuator connector. If there is corrosion on the terminals, replace the harness connector.

Coolant flow control valve actuator harness connector

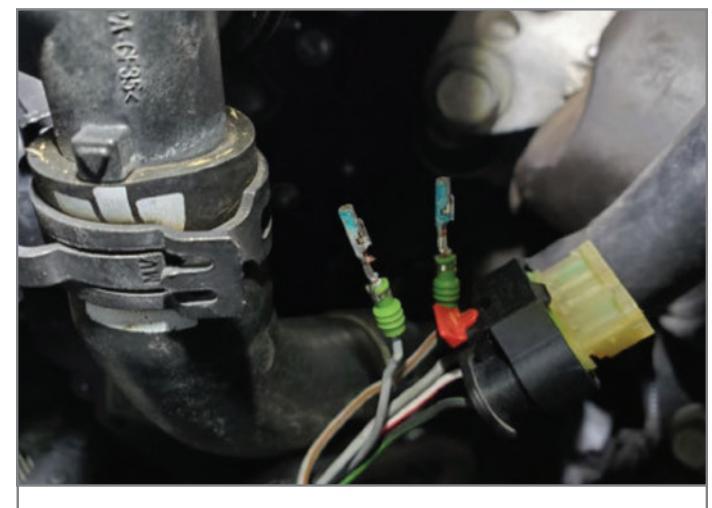
Flow control valve actuator pins

In addition, inspect the flow control valve actuator pins for any corrosion damage. If the actuator pins are corroded, replace the coolant control valve.
