Mid-September:, Volume 23, No. 19

Latest GM Global Electronic Parts Catalog Release

Warning Lamps Illuminate During Vehicle Turns

Squeak Sound When Turning Steering Wheel

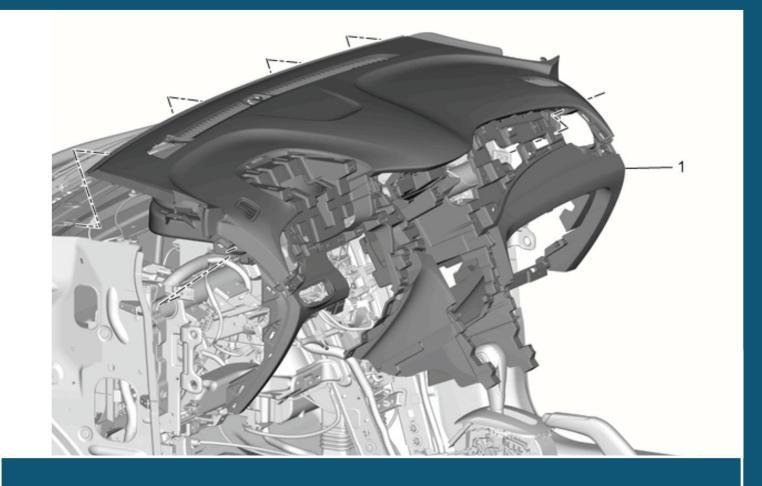
Some 2020 Trax models may have airbag, theft (security) and tire pressure warning lamps that turn on/off along with an illuminated Check Engine lamp during vehicle turns. DTCs U0078 (Control Module Communication Low Speed CAN Bus Off), U0140 (Lost Communication with Body Control Module), U0184 (Lost Communication with Radio), U0151 (Lost Communication with Inflatable Restraint Sensing and Diagnostic Module), and/or U0073 (Control Module Communication Bus A Off) also may be set.

If these conditions are present, check the instrument panel wiring harness retainer, which may have come loose from the tie bar assembly. A loose retainer may allow the wiring harness to rub against the power steering motor, resulting in the electrical conditions that cause the illuminated warning lamps.

Remove the instrument panel to access the wiring harness.

Access the instrument panel wiring harness by removing the instrument panel from the vehicle. Complete all steps in the Instrument Panel Assembly Replacement procedure in the appropriate Service Information to remove the instrument panel.

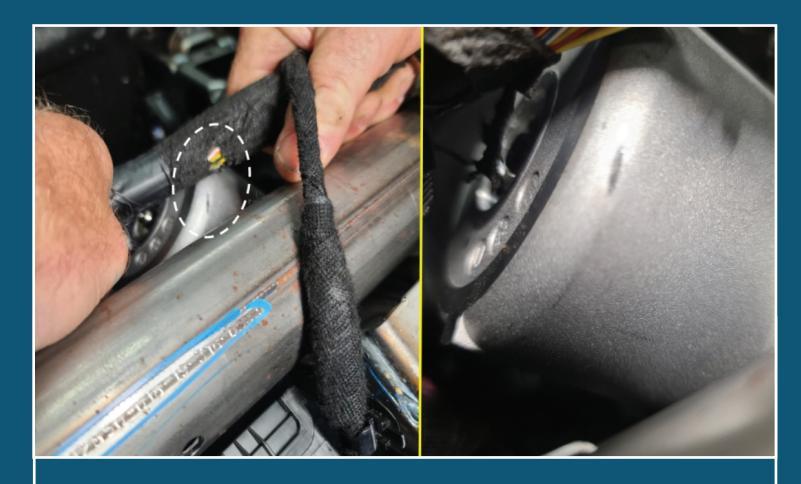
Repair any wiring damaged from rubbing against the power steering motor.

Inspect the wiring harness for any evidence of chafing, wear or damage. Repair the wiring as necessary. Add conduit over the damaged area to help protect the repaired harness and secure the harness to the tie bar assembly.

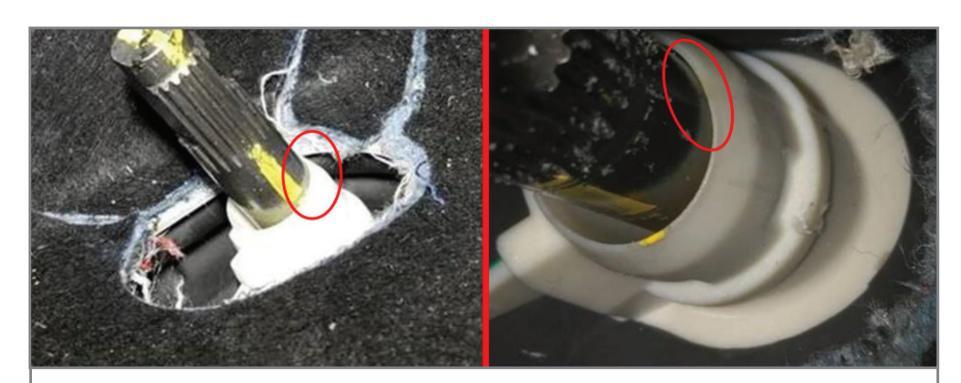
A squeak sound may be heard from the steering system when making turns in either direction on some 2017-2022 Bolt EV and 2022 Bolt EUV models. The sound may be caused by contact between the steering gear pinion shaft and the plastic top cap housing on the steering gear.

Contact between the steering gear pinion shaft and the plastic top cap housing.

To confirm the contact as the source of the squeak sound, disconnect the intermediate shaft, remove the intermediate shaft inner boot and observe the contact. If contact between the pinion shaft and plastic top cap housing is verified, lubricate the area of contact with GM Super Lube. Be sure to apply the lubricant to the inner area of the plastic top cap.
