November 2021, Volume 23, No. 21

### **TechLine Connect Software Update**

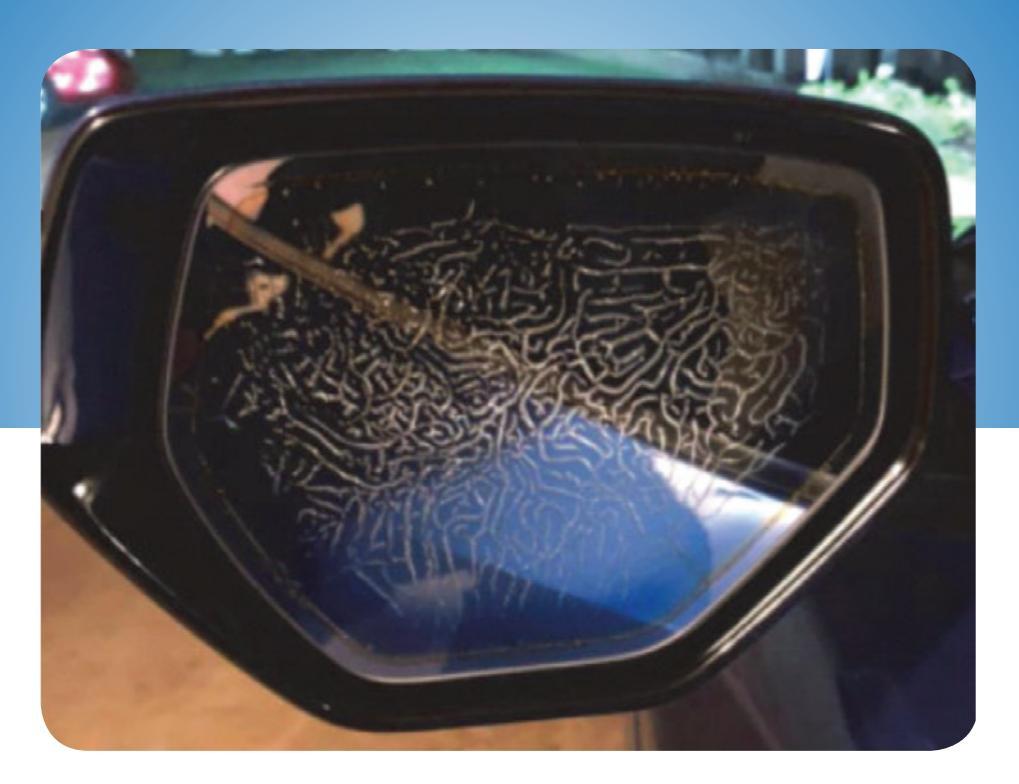
The driver's outside rearview mirror on some 2020-2022 Corvettes may have poor operation and appearance, including numerous lines shown in the mirror and a dim reflection at all times.

The poor appearance may be caused by the installation of an aftermarket radar detector in the vehicle. Depending on the installation location, the aftermarket electrical device may cause higher voltage to the mirror.

If the damaged mirror appearance is shown, check for the installation of a jumper harness to power the radar detector added to the mirror's X1 connector. The connector is located behind the front cover of the inside rearview mirror.

Disconnecting the jumper harness, and replacing the damaged outside rearview mirror due to the jumper harness, must be authorized by the customer. Vehicle damage resulting from aftermarket devices is not covered under warranty.

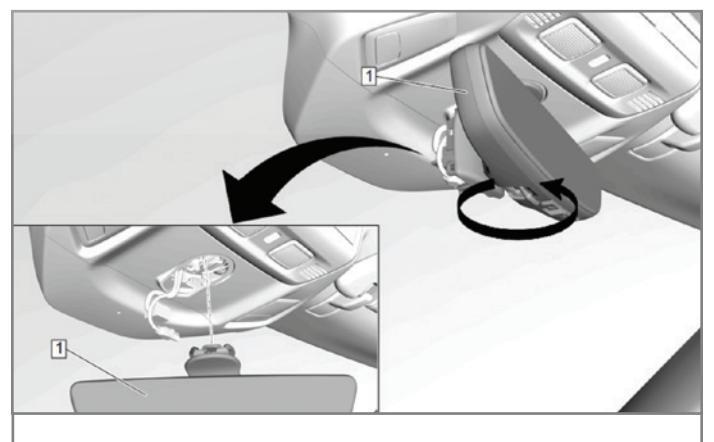
The X1 connector is located behind the front cover of the inside rearview mirror.

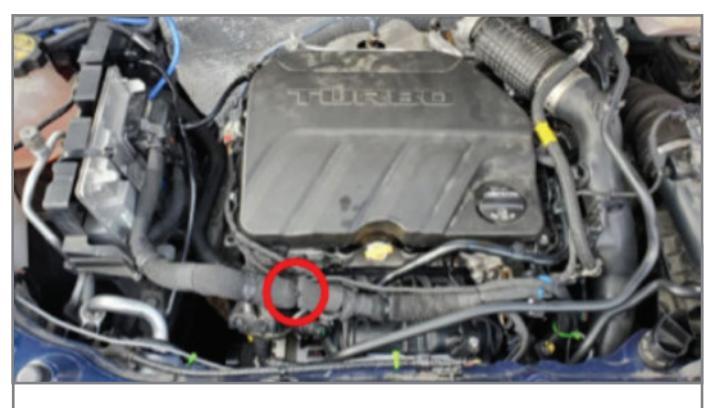
Move the engine wiring harness at the front of the engine back-and-forth.

A change in the engine oil pressure reading, either an increase or decrease in PSI, isolates the condition to this specific location on the engine wiring harness. A high resistance splice in the engine wiring harness above the EVAP purge pump may cause DTC P0521 to set.

Do not replace the oil pump or oil pressure sensor without first diagnosing the potential splice concern, as this may result in a return repair visit.

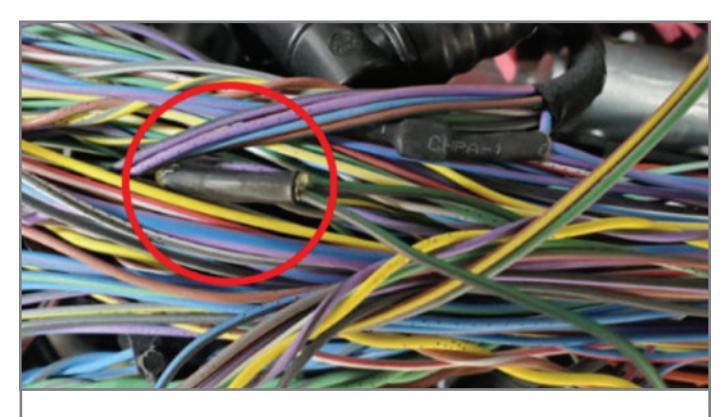
Three-wire splice located in the wiring harness above the EVAP purge pump assembly.

The Service Information may show only one splice for low reference circuit 548 (J114). An additional three-wire splice has been added to the low reference circuit 548 (BK/GN).

The three-wire splice is located in the main branch of the engine wiring harness above the EVAP purge pump assembly.

Open the engine wiring harness to access the three-wire splice and inspect each leg for broken wire strands. Repair any damaged wiring.

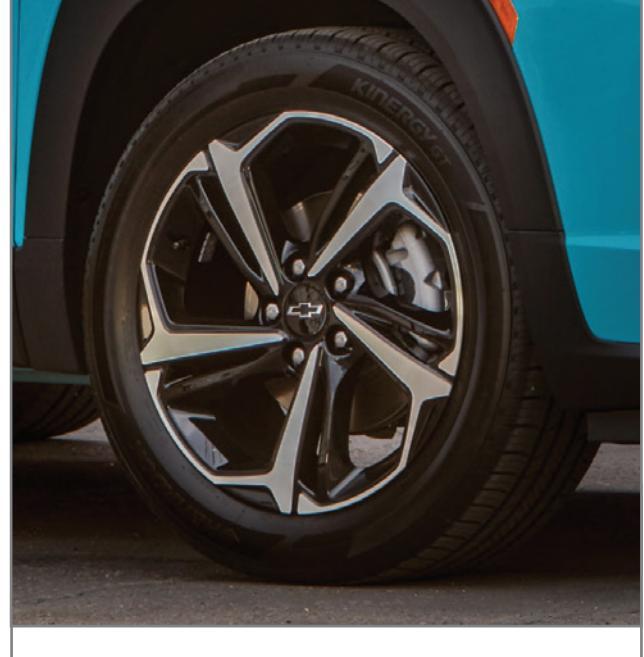
If a tire has been replaced with a tire size that is different than the original equipment manufacturer (OEM) tire size, the wheel speed discrepancy while traveling on a straight road will cause all driver assistance systems (B174W Frontview Camera Module) that rely on wheel speed sensor data inputs to be disabled. These system include:

All tires should be the same size as the original OEM tires.

If a tire has been replaced that is not the correct OEM size, it will have to be replaced with the correct OEM size tire as indicated on the vehicle tire placard, located below the driver's door latch. This is not a warrantable repair.

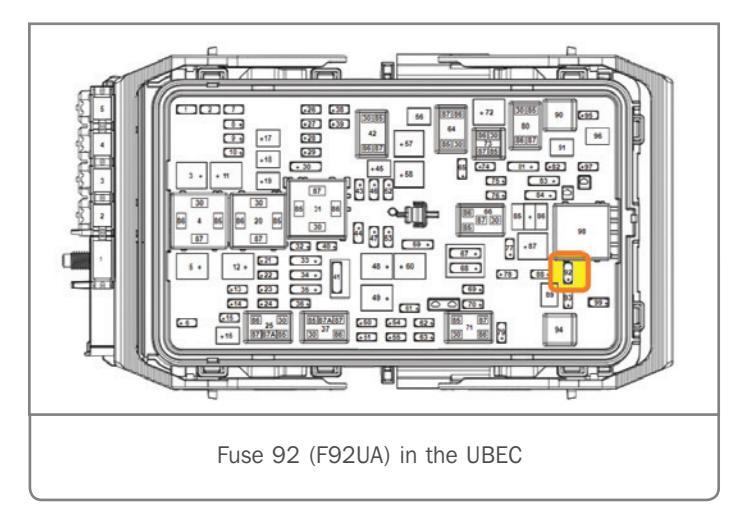
Some 2020 Malibu models equipped with the 1.5L engine (RPO LFV) and the VT40 automatic transmission (RPO MRG) may have an illuminated Check Engine MIL and/or the engine stop/start feature may be inoperative. DTC P2796 (Auxiliary Transmission Fluid Pump Control Circuit) and DTC P2798 (Auxiliary Transmission Fluid Pump Relay Control Circuit Low Voltage) may be set in the Transmission Control Module (TCM).

During diagnosis, 0 (zero) volts may be measured at the auxiliary fluid pump. In addition, fuse 92 (F92UA) may not be found in the UBEC.

If the fuse is missing from the UBEC, look for fuse 12 (F12DA) in the instrument panel fuse block to be either open and/or missing. If the fuse is missing from the instrument panel fuse block, a 20 Amp fuse should be installed into the fuse 12 (F12DA) location.

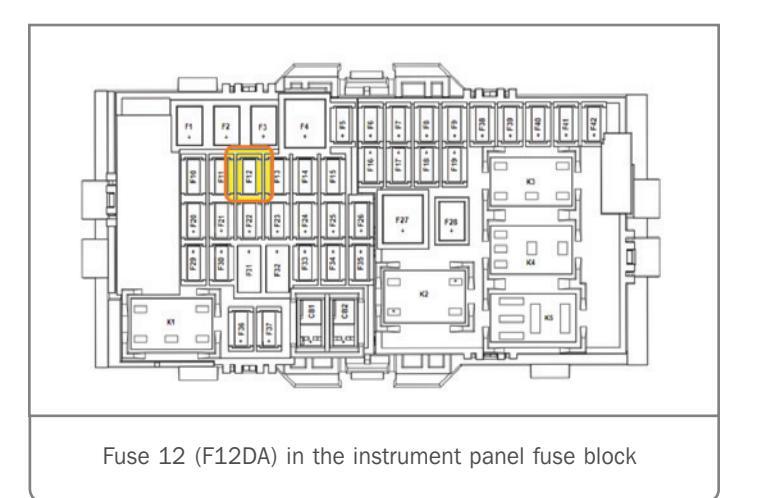
Some Malibu models may still have the fluid auxiliary pump powered by fuse 12, G5 Transmission Fluid Pump (Electric/ Auxiliary, MRG, F12DA). This fuse may be missing or open, and the fuse box label may read "Not Used."

With the fuse installed, check for voltage at the pump. If voltage is present, the vehicle should be driven to verify the DTCs do not reset and that the engine stop/start system operates properly.
