Mid-June 2023, Volume 25, No. 12

| Meet the New Buick Envista1 |
|---|
| Upfitter Auxiliary Switch LED Indicators4 |
| Maintaining Seat Belt and Retractor Guide Cleanliness5 |
| Clean Head Bolt Holes Before Cylinder Head Installation6 |

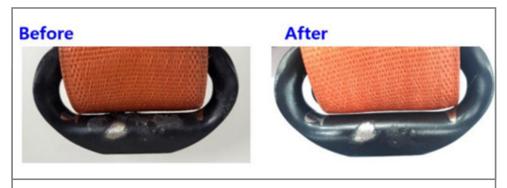
Some fleet drivers of BrightDrop EV vans may notice proper seat belt operation is affected by the cleanliness of the belt and retractor guide. Due to the high amount of seat belt cycles that occur on a daily basis on these vehicles during commercial use, the seat belts may come in contact with dust, dirt and debris more frequently than a non-fleet customer.

The seat belt webbing and the retractor guide must be clean and free of dust, dirt and debris to maintain the proper operation of the restraint system.

Seat belts with extensive use (left), should be cleaned regularly (right).

To improve the operation of a dirty seat belt, the seat belt retractor guide should be cleaned using the hook side of plastic hook and loop tape or equivalent. Lift up the seat belt to access the retractor guide on the B pillar.

Gently rub the retractor guide with the plastic hook side of the tape to remove any contamination buildup. Move the seat belt to clean each side of the guide surface.
