2024 Battery Ratings Chart

AND BATTERY MAINTENANCE UPDATE

TECH LINK

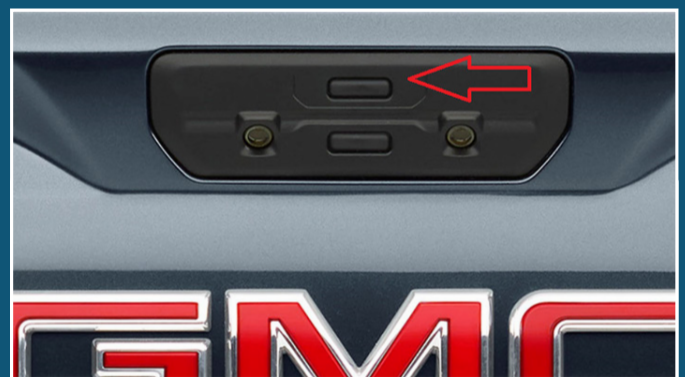
The multifunction tailgate offers a disabling procedure to prevent the inner gate from being lowered. If the inner gate disabling procedure is inoperative, check that the vehicle is equipped with Passive Entry (RPO AVJ). If it is not equipped with RPO AVJ, it will not have the rear bumper antenna that allows disabling of the inner gate.

To disable the inner gate from opening, press and hold the upper button on the tailgate for 3 seconds

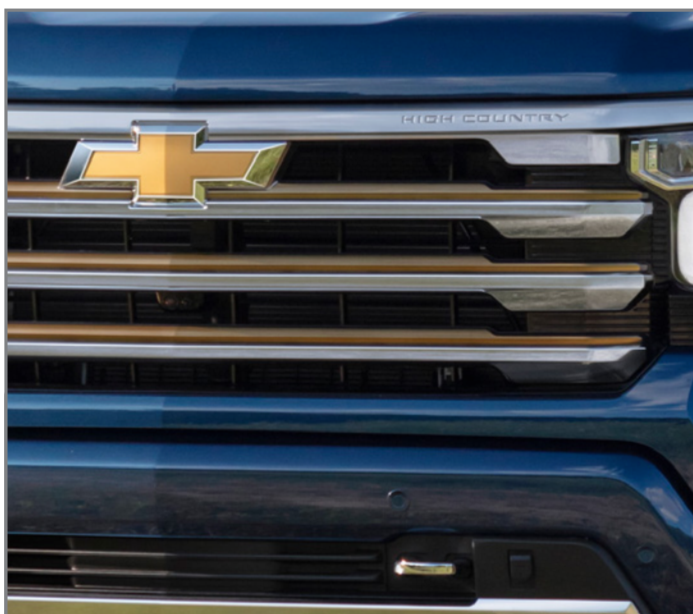
The front-view camera washer nozzle may be leaking washer fluid on some 2022-2023 Silverado 1500 and Sierra 1500 models.

Front-view camera and washer

If no other cause is found, replace the windshield washer hose, which will include a new check valve.

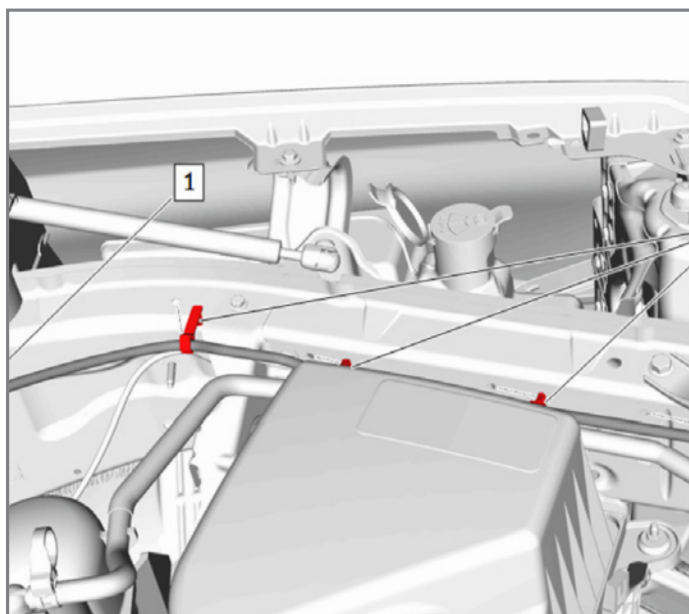
Service Information or the Electronic Parts Catalog does not show that there is a one-way check valve built into the windshield washer hose that connects to the washer pump. The check valve is designed to prevent washer fluid from leaking.

Windshield washer pump hose
