Power Doors OTA Update Released for 2025 Escalade

Power Doors OTA Update
Released for 2025 Escalade..... 2

TCSC Top Issues This Week..... 4

TECH LINK

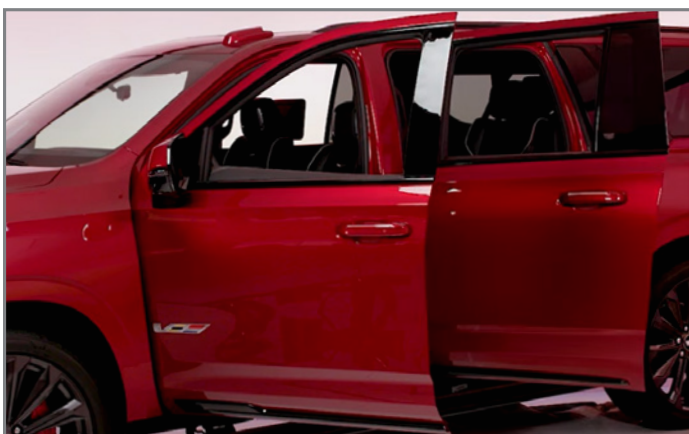
The OTA update enables full power open/close door operation.

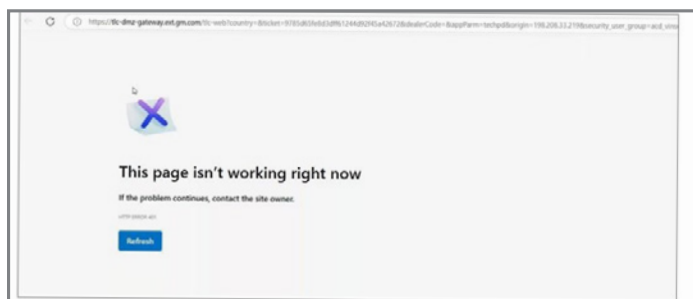
The message indicates the current ID is blocked from accessing Global Connect. This can be for a multitude of reasons but typically is due to a counterfeit MDI device.

The message indicates the current ID is blocked from accessing Global Connect.

To unblock the account, reach out to TCSC via Dealer Case Management (DCM) with the following information:

TCSC will be able to reach out to the Cybersecurity team that will be able to determine the cause of the block and may be able to unblock the account. In the case of a counterfeit MDI, the counterfeit tool must be destroyed, and a legitimate Bosch device must be used to ensure the ID is not blocked again. Repeat offenders may not be unblocked from access.

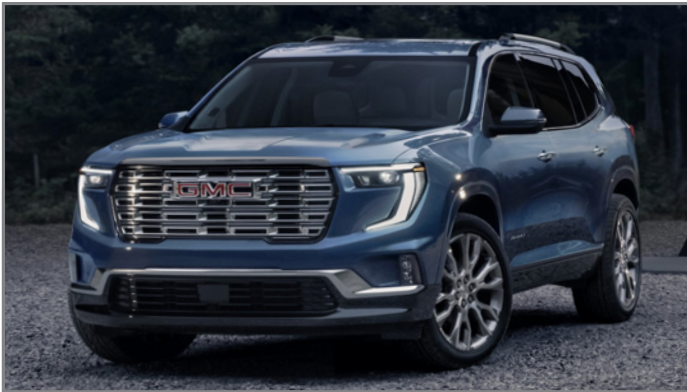
The exterior lights will illuminate when approaching the Acadia with the remote key fob.

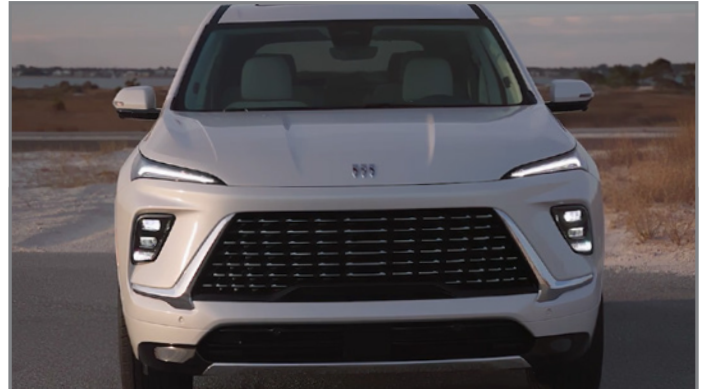
Exterior lighting animation only occurs on the Enclave when locking and unlocking the vehicle.

No parts should be replaced for these conditions.

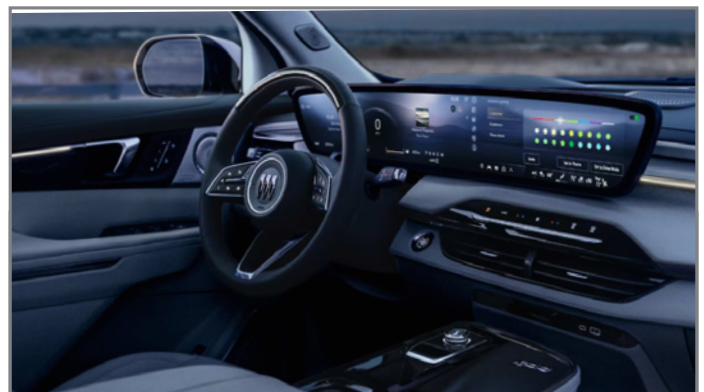
Interior lighting animation occurs on Enclave models equipped with the interior dynamic ambient lighting package
