Questions About Labor Times? Answers to the Latest FAQs in Service Information.....	2
Do Not Swap Control Modules.....	4
TCSC Top Issues This Week.....	6
New SAVI Manager Release Updates USB Driver.....	8

Do Not Swap Control Modules

TCSC Top Issues This Week

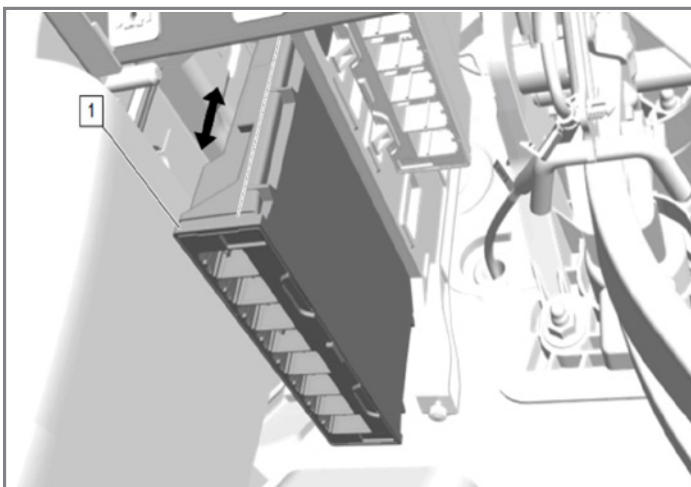
GM diagnostic strategy does not support the practice of swapping control modules during the course of diagnosis or to expedite a repair. Features in today's vehicles are increasingly software configurable. They can affect vehicle safety systems, anti-theft systems, performance components and customer personalization information.

Problems can occur on these models when attempting to swap a control module configured for one vehicle into another. Symptoms such as no-start conditions and DTCs that cannot be cleared are to be expected. Issues also may be introduced into vehicles that exhibit no symptoms until a later date, adding to the complexity of diagnosing the vehicle. These "sleeper issues" may be triggered only after multiple key cycles or only after battery power has been removed from the BCM. Such issues can be time-consuming to rectify, driving up unnecessary warranty expenses and leading to customer dissatisfaction.

Global electrical systems do not allow control modules, such as the BCM (#1) to be swapped between vehicles.

On today's vehicles, the electrical architecture plays a significant role in how a vehicle is equipped and operates. The best diagnostic path for all vehicles, regardless of equipment, is to follow the procedures outlined in the appropriate Service Information.

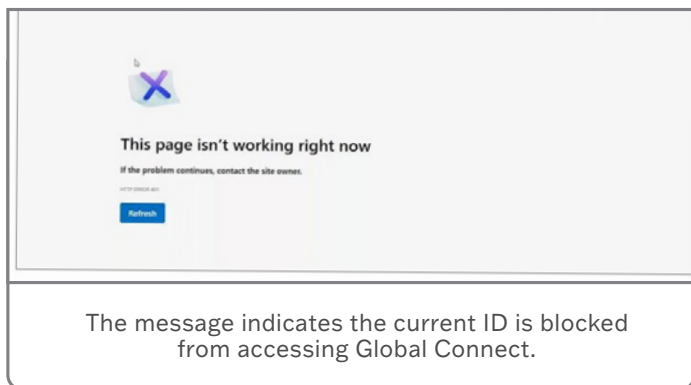
The following message may be seen when attempting to access Techline Connect:

The message indicates that the current ID is blocked from accessing Global Connect. This can be for several reasons but

typically is due to a counterfeit MDI device.

To unblock the account, reach out to TCSC via CX Connect with the following information:

TCSC will be able to reach out to the Cybersecurity team that will be able to determine the cause of the block and may be able to unblock the account. In the case of a counterfeit MDI, the counterfeit tool must be destroyed, and a legitimate Bosch device must be used to ensure the ID is not blocked again. Repeat offenders may not be unblocked from access.

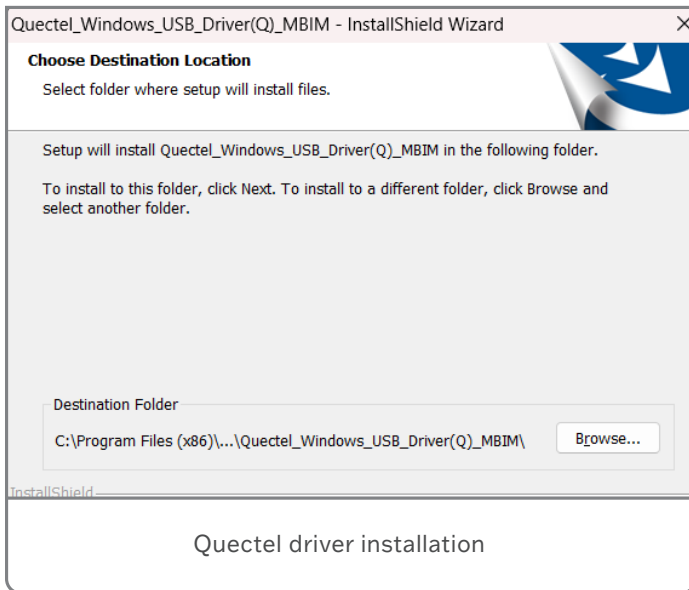
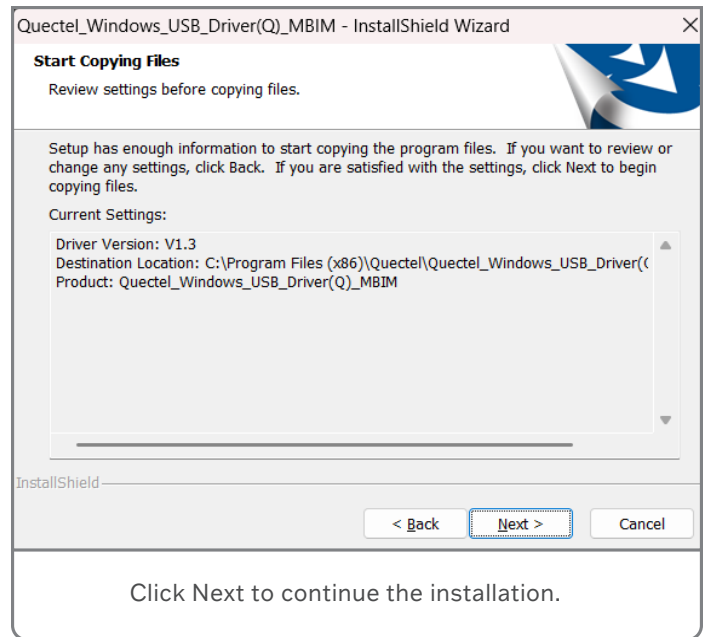
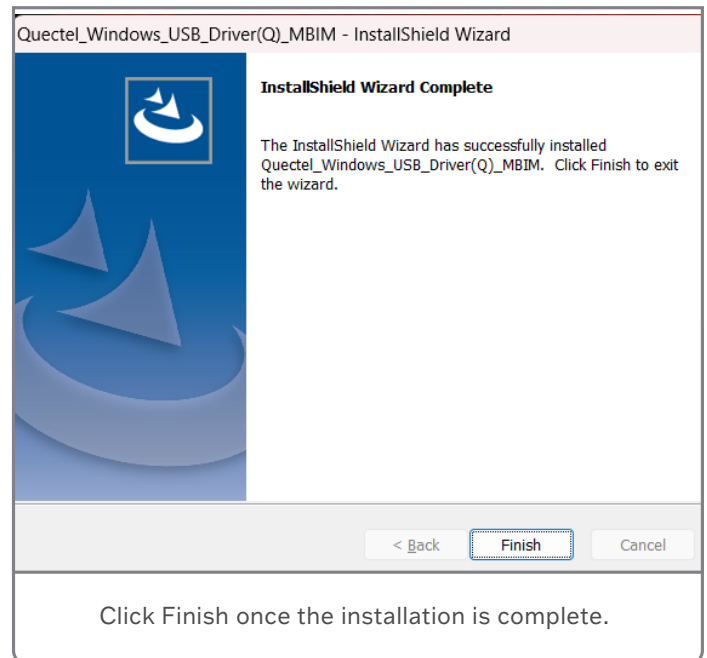
The new SAVI Manager v2.29.0 release provides an update to address USB driver failure. The latest release will correct the issue of the Quectel driver failing to install by automatically starting the manual installation process.

Follow the prompts for the Quectel driver installation. Click Next.

Click Next to begin copying program files.

Once the installation is complete, click Finish.
