All-New Chevrolet Trax Gets Bigger and Bolder

Fluid Leak Between the Transmission and Transfer Case

TECH LINK

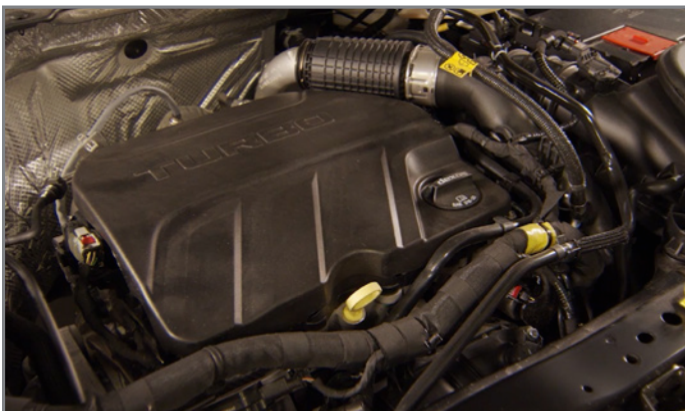
The Trax pairs a 1.2L turbocharged engine (RPO LIH) with the Hydra-Matic 6T40 6-speed automatic transmission (RPO MNH). The engine, also available on Trailblazer and Encore GX models, generates a GM-estimated 137 horsepower and 162 lb.-ft. of torque.

The DOHC, direct-injected 1.2L engine features an aluminum block and cylinder heads for lightweight, efficient operation. For the 2024 model year, it has a new, stiffer crankshaft and a

retuned harmonic balancer for enhanced refinement. The engine cooling system uses an Active Thermal Management strategy to maintain an ideal engine operating temperature during all engine speeds and operating conditions.

1.2L turbo engine

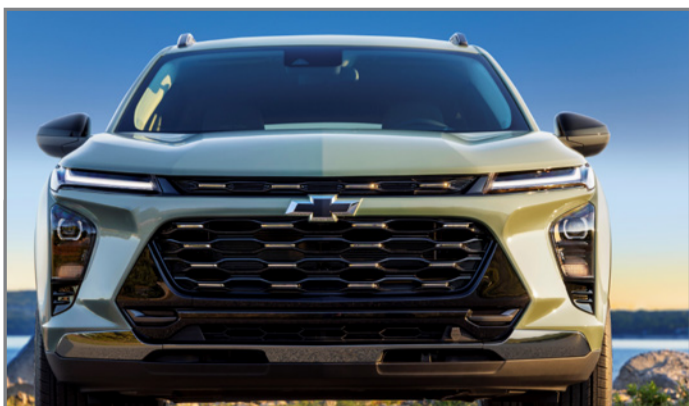
The Engine Control Module (ECM) controls the air shutter in the lower grille and will open or close the shutter based on the ambient temperature and other operating conditions. A winter cover for the grille in cold climates is not available.

The ECM controls the air shutters in the lower grille.

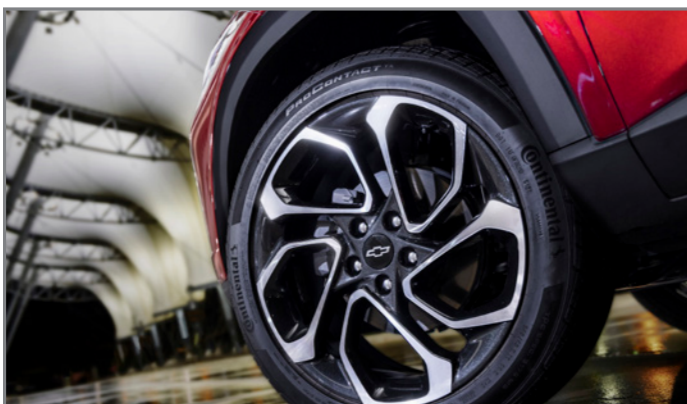
- LS and LT – 17-inch wheels.
- RS – 18-inch wheels on the 1RS and 19-inch wheels on the 2RS.
- ACTIV – 18-inch wheels.

RS with 19-inch wheels

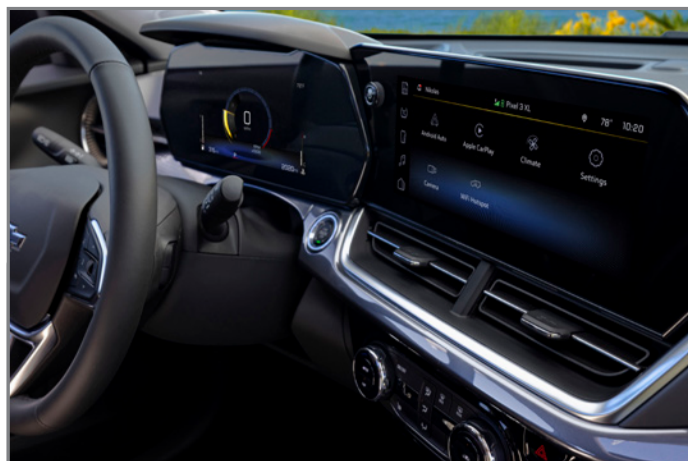
The uplevel infotainment system (RPO IOS/IOT) has a new design with only one module for the instrument cluster and radio. It connects to the cluster display using an LVDS cable. The infotainment system features standard Apple CarPlay and Android Auto capability.

The new design features only one module for the instrument cluster and radio.

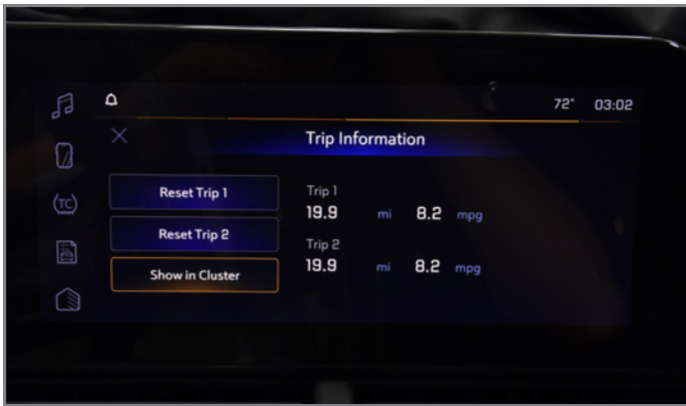
In addition, the infotainment system can display the status of a number of vehicle systems, including maintenance items and gauges, which also can be set to be viewed on the cluster display. To view the Maintenance, Gauges and Trip menus, select the Vehicle Status icon on the infotainment screen. And then to show an item on the cluster display, select the arrow icon for the item and then select Show in Cluster.

Select Show in Cluster to view information on the instrument cluster display.

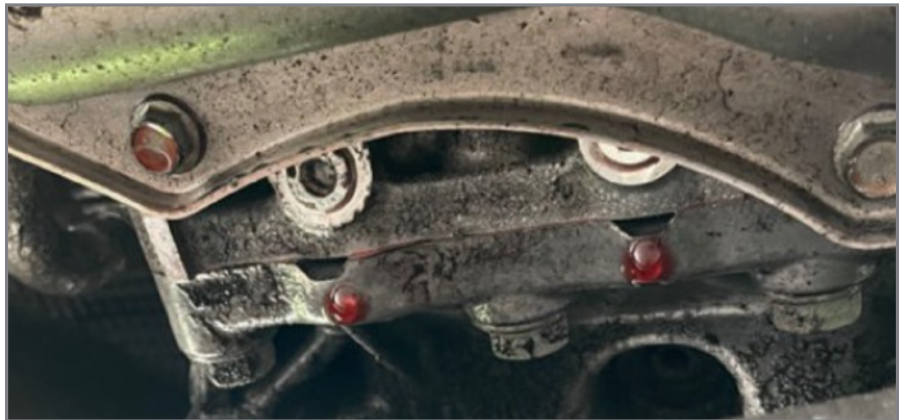
The cavity between the transmission and transfer case is a wet cavity by design. The transfer case input shaft seal is a double seal to prevent transmission fluid and transfer case fluid from intermixing with each other. If either side of the seal leaks, fluid will leak from the weep holes between the transmission and transfer case.

Fluid leaking from the weep holes.

To help determine if the seal depth is incorrect, add dye to the transfer case or transmission. If the seal is installed too deep, the fluid leaking is transmission fluid. If the seal is not installed deep enough, the fluid leaking is transfer case fluid. Either condition will cause fluid to leak out of the weep holes between the transmission and transfer case.

If diagnosis indicates that the seal depth is incorrect, replace the transmission case extension seal and transfer case input shaft seal.

Review the latest version of #PIP5810 for proper transfer case input shaft seal installation. There are two design transfer case front case halves, and the seals install at different depths between design 1 and 2. Improper seal installation will result in repeat leaks.

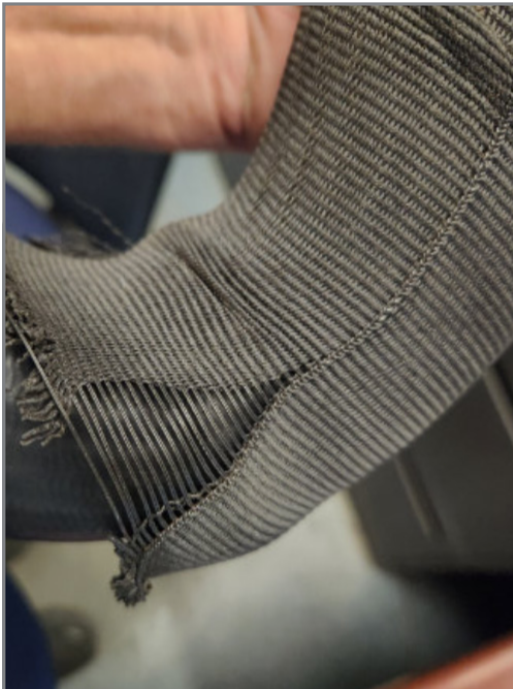
If these conditions are found, inspect the anti-abrasion sleeve on the charge air inlet pipe at the turbocharger for any splitting or other damage.

Anti-abrasion sleeve on the charge air inlet pipe

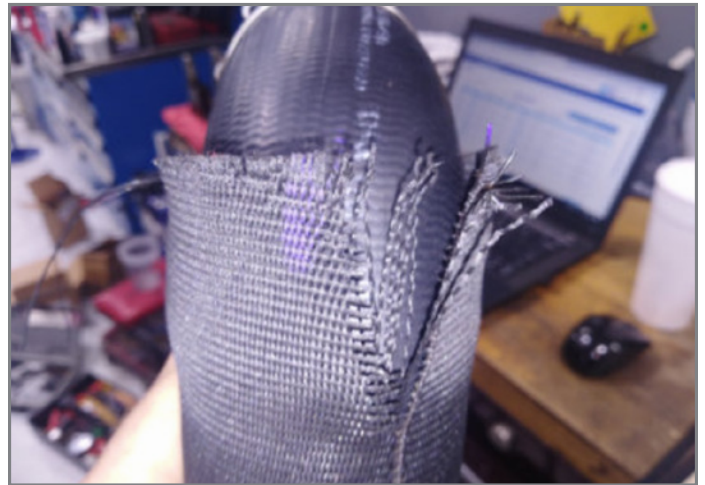
If the sleeve is damaged, remove the charge air inlet hose assembly and check the charge air inlet hose beneath the

anti-abrasion sleeve for signs of splitting or damage that would allow the hose to swell under pressure. Damage to the hose may cause the anti-abrasion sleeve to split and alter the readings within the boost control system or create a potential air leak.

Check for any splitting or damage to the anti-abrasion sleeve.

Damage to the hose beneath the anti-abrasion sleeve will require the charge air inlet pipe assembly to be replaced.

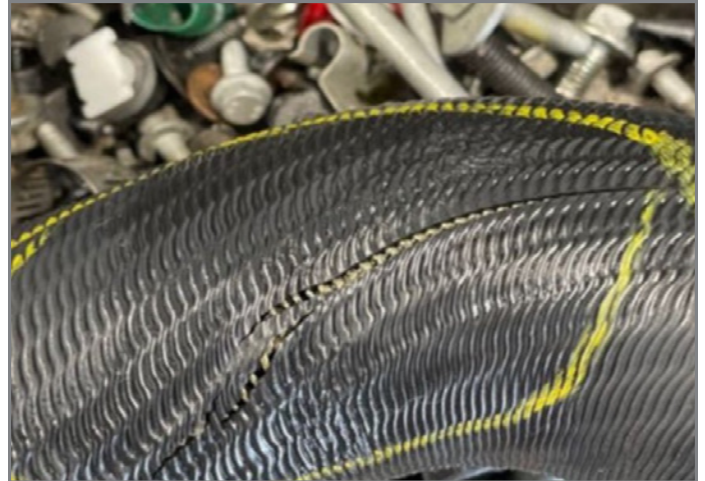
Area shows damage to the inner hose beneath the anti-abrasion sleeve.

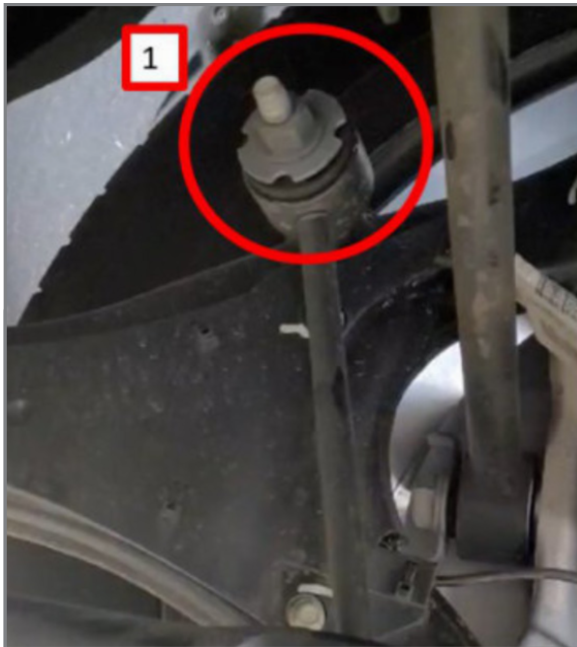
Rear sway bar link upper mounting

Some 2021-2023 Tahoe, Suburban, Yukon and Escalade models may have a pop, clunk, rattle or click sound from under the vehicle while turning. In most cases, the sound can be duplicated by making full left turns followed by full right turns, at slow speeds, in an open parking lot. Although the sound may seem to be coming from the front of the vehicle, it may be a loose rear sway bar link upper mounting.

At the rear of the vehicle, inspect the rear sway bar link upper mounting bolt/nut. Check the bolt/nuts for proper torque and, if necessary, torque to 74 lb. ft.
