Electrical Issues Due to Backup Lamps

Leaking Evaporator Core Seal

Incorrect Object Sensor Module Operation

Shifting Conditions Due to Undersized Spacer Plate

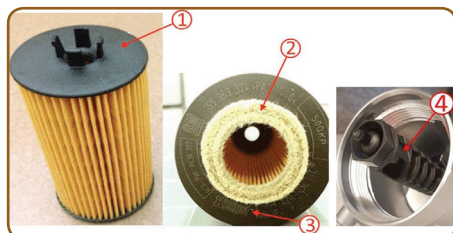
Oil filter housing identification for ACDelco filter PF2257G:

1. Black cap
2. Supplier name: Hengst
3. Smooth circumference of housing
