GM Loan Tool Program

TECH LINK

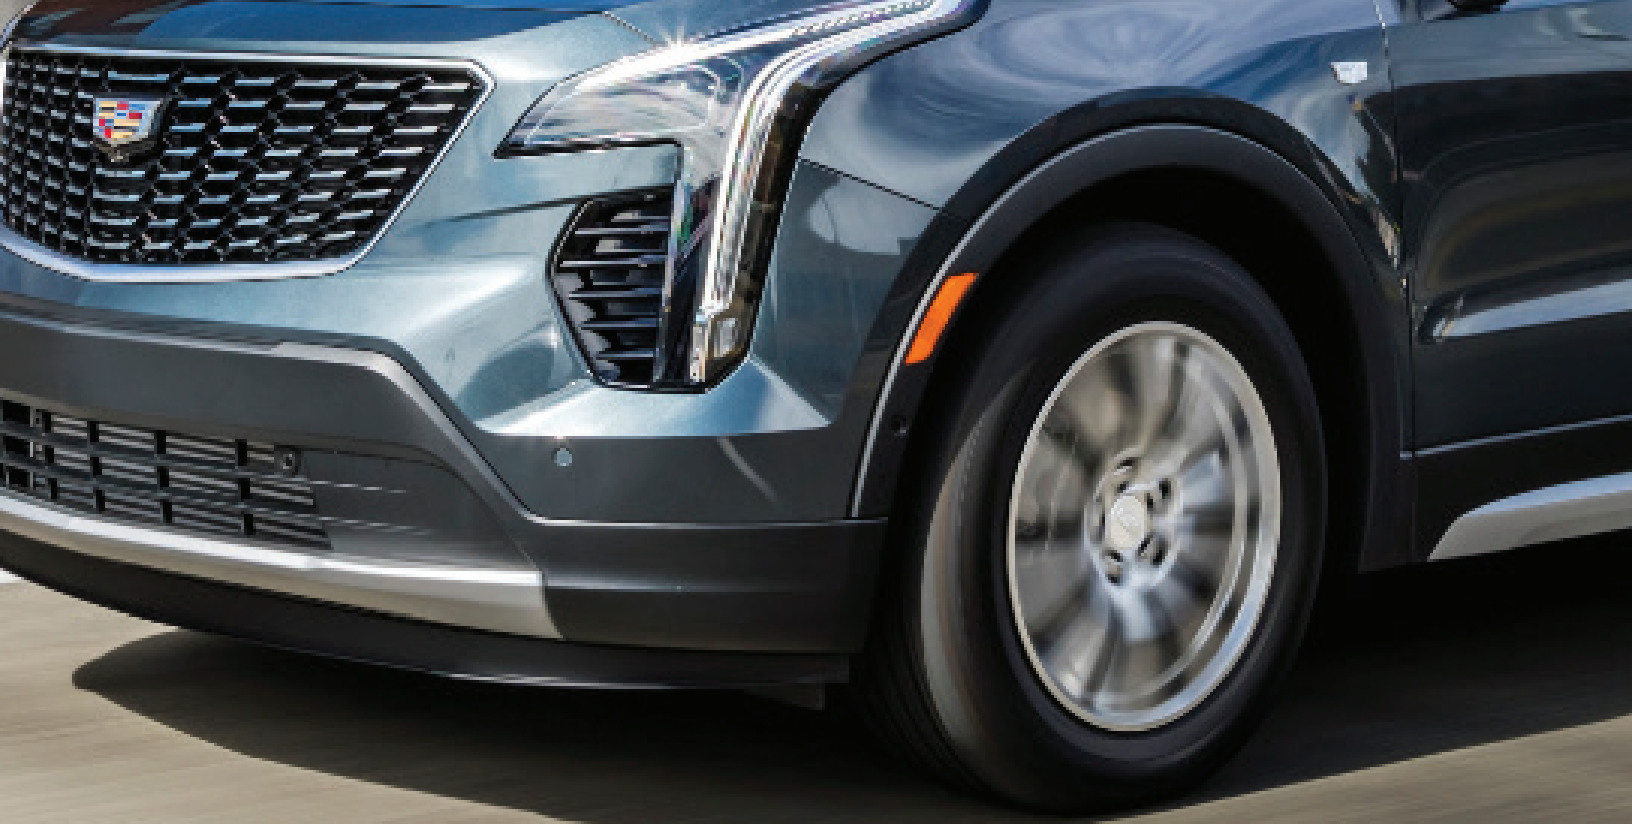
Front Brake Squeal Sound

Some 2020 XT4 models may have a brake squeal sound at low speeds. The front brake pads on some models may be susceptible to producing brake squeal.

Confirm the brake squeal is coming from the front brake pads. If verified, replace the front brake pads with a new design brake pad. Refer to Front Disc Brake Pads Replacement in the appropriate Service Information.

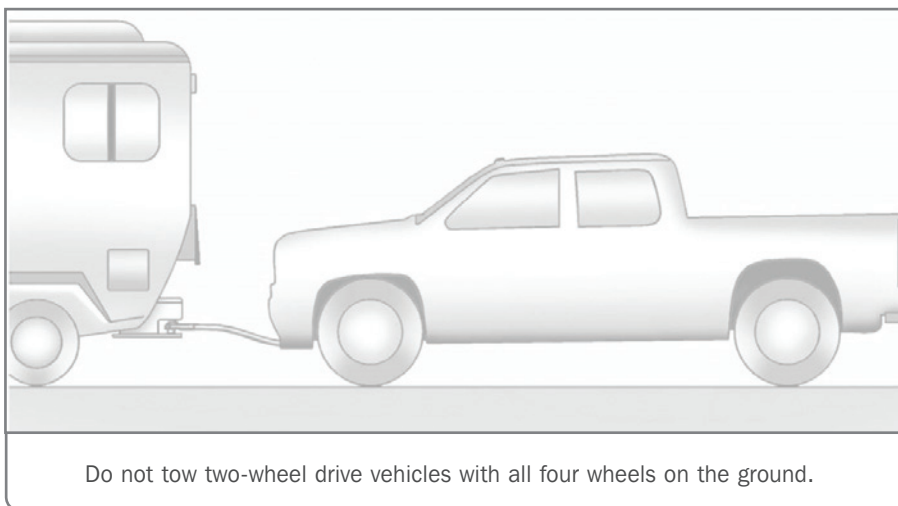
The dinghy towing procedure may not be clear in the Owner's Manual of the 2017-2020 Colorado and Canyon. If the vehicle is not towed correctly, damage may occur to the transmission.

Two-wheel drive vehicles should not be towed with all four wheels on the ground (dinghy towing). If a two-wheel drive vehicle is towed with all four wheels on the ground, drivetrain damage may occur.

Before dinghy towing a four-wheel drive vehicle, with the parking brake applied and the engine running, shift the transfer case to Neutral (N). Check that the vehicle is in Neutral by shifting the transmission to Reverse and then to Drive. There should not be

any movement of the vehicle while shifting. Shift the transmission to Park.

Also disconnect the negative battery cable at the battery and cover the negative battery post with a non-conductive material to prevent any contact with the negative battery terminal. Keep the ignition in the Accessory position to prevent the steering column from locking. The steering column may be damaged if it is locked.
