Power Folding Top

Diagnostic Tips

TECH LINK

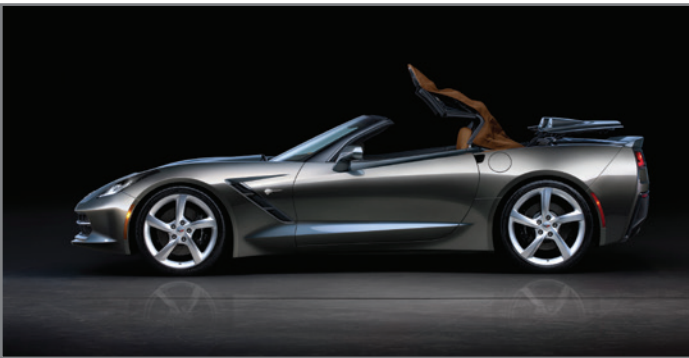
Corvette convertible power top in operation.

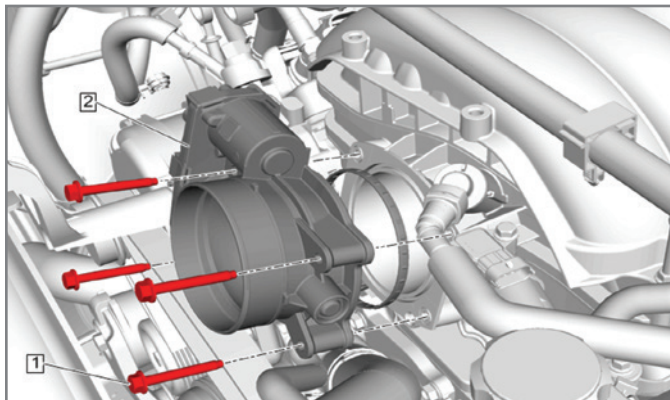
Throttle body assembly

A 2020 Silverado HD or Sierra HD equipped with the 6.6L V8 engine (RPO L8T) may have a rough idle or reduced engine power in very cold climates (-10°F or -23°C). The Check Engine lamp may be illuminated along with DTCs P0123 (Throttle Position Sensor 1 Circuit High Voltage) and P0222 (Throttle Position Sensor 2 Circuit Low Voltage) set. These engine performance conditions may be caused by an internal circuit fault within the throttle body.

If these conditions are found on a vehicle exposed to extreme cold, replace the throttle body assembly following the service procedure in the appropriate Service Information. In addition, add a ground wire using two 8 mm ring terminals and one 8-inch piece of 14-gauge wire.

To install the ground wire, remove the oil cap and engine cover from the rocker cover on the left bank of the engine. Attach one end of the ground wire to the lower-right throttle body fastener with the crimp side of the ring terminal facing the bolt head.

Once the ground wire is installed and secure, clear any DTCs and road test the vehicle to verify the repair.

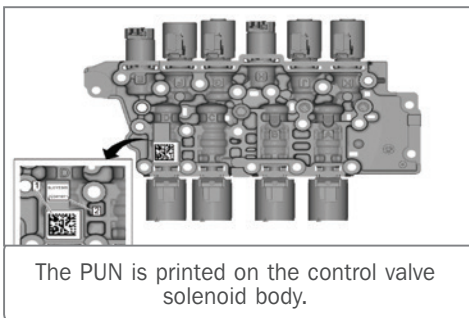
When installing the replacement solenoid body assembly, it may not be possible to perform the shift characterization reprogramming due to the Part Unique Number (PUN) printed on the service solenoid body only having 11 digits.

The PUN should be documented before installing the control valve solenoid body onto the transmission. On the SPS MCVM (Mechanical Characterization and Virtual Matching) Operation Selection screen, a prompt will request the PUN.

If only 11 digits are printed on the service solenoid body assembly, use a QR code reader to obtain the full 16-digit PUN.
