August 2020, Volume 22, No. 15

The Diesel Exhaust System

DPF Soot ccumulation

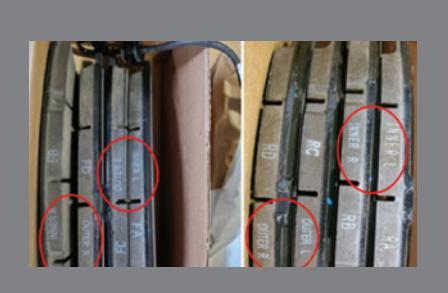
Silverado HD/Sierra HD Brake Squeal

Some 2020 Silverado 2500/3500 and Sierra 2500/3500 models may have a brake squeal condition caused by the low scorch friction material used on the original brake pads.

New brake pads are available that have a high scorch friction material to reduce the potential for noise. Replace the front and rear brake pads with the new pads.

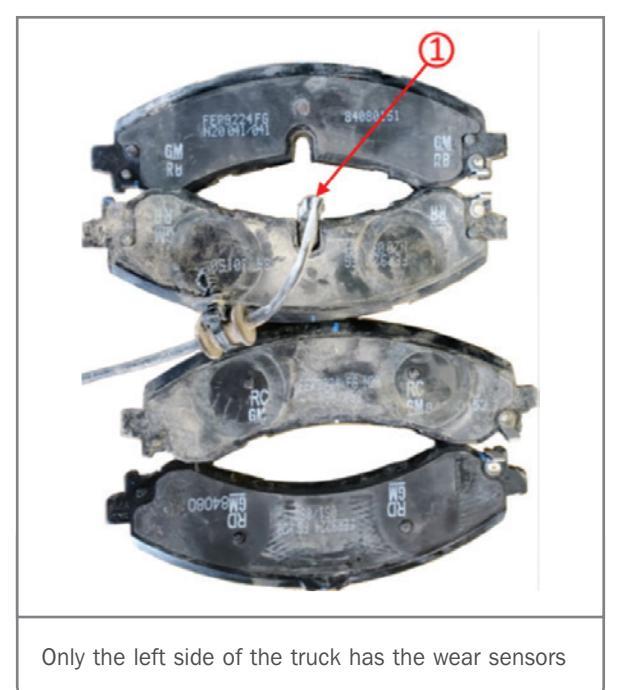
If the pads are replaced and the squeal sound continues, check the orientation of the pads. If the inboard and outboard designation on the pads indicate the pads are installed in the wrong location, the squeal sound may persist.

Refer to Bulletin #20-NA-020 for additional information and part numbers.

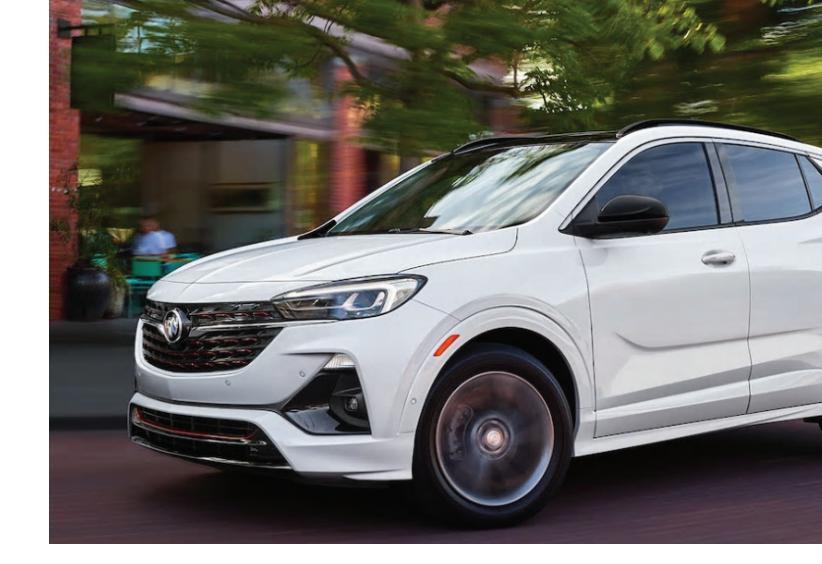
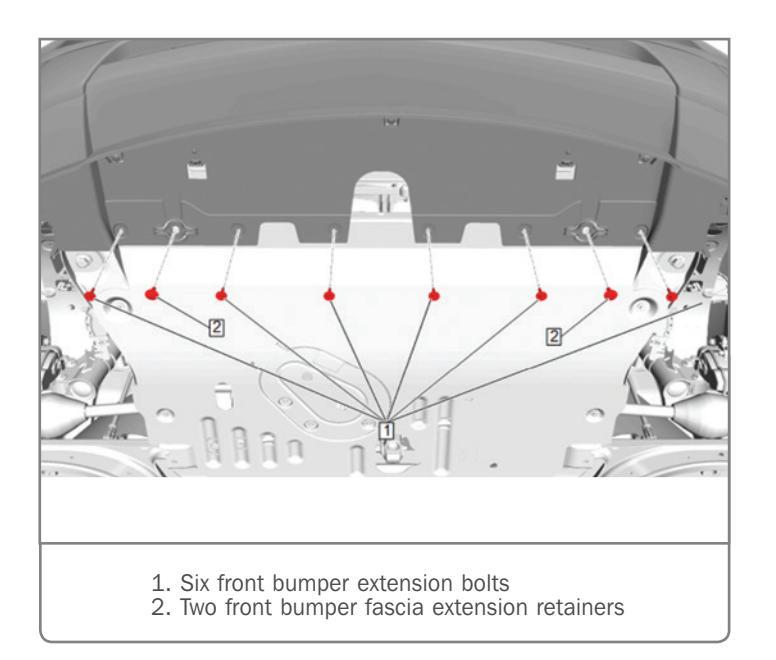
Boom Sound or Flutter Under Light Throttle

A boom sound or flutter vibration may be noticed on some 2020 Encore GX models equipped with the 1.3L engine (RPO L3T) at low speeds with light throttle input. If these conditions are found, replace the lower radiator mount bushings.

To replace the bushings, first remove the front compartment insulator. With the insulator removed, remove the six front bumper fascia extension bolts and the two front bumper fascia extension retainers.

The lower radiator mounts can now be removed and replaced. Be sure to tighten the fasteners for the new mounts to 22 Nm (16 lb.-ft.).
