## GE-52250 PowerSmoke Diagnostic Leak Detector

## TECH LINK

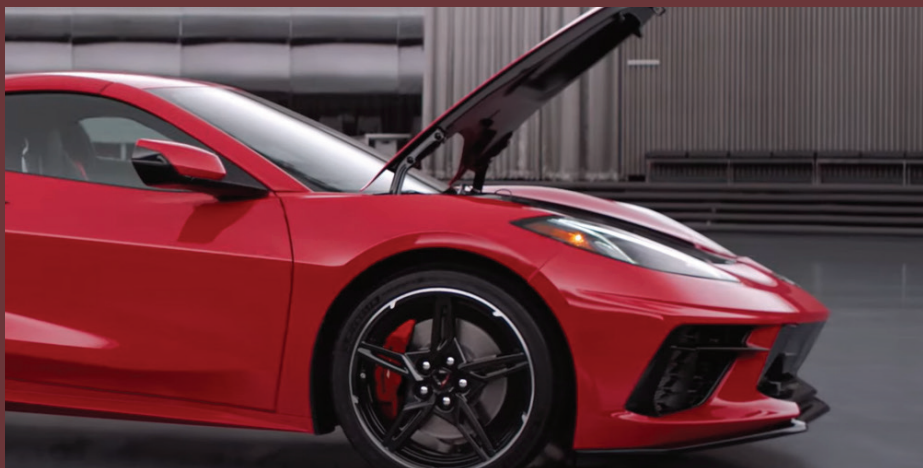
An Over-The-Air (OTA) update for the 2020 Corvette was sent out recently that changed the Body Control Module (BCM) calibration for opening the hood (or front trunk) using the Remote Keyless Entry transmitter (key fob) as well as the hood access button on the driver's door. The update changes the functionality of the buttons.

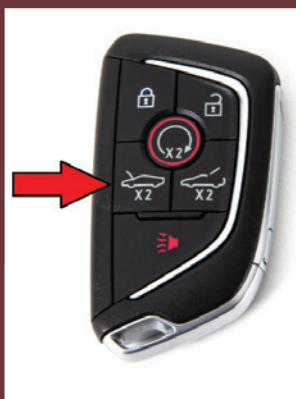
Key fob

To open the hood after the update using the key fob, the hood release button must be pressed and released once and then pressed and held a second time. If the button is not held down on the second button press, the hood will not open.

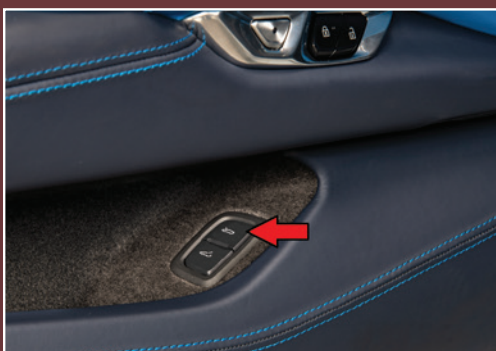
Interior hood release button

To open the hood after the update using the hood release button on the driver's door, the button must be pressed and held until the hood unlatches. The

transmission also must be in Park. An audible sound should be heard when the hood latch releases. Quickly pressing and releasing the button will not actuate the hood release.

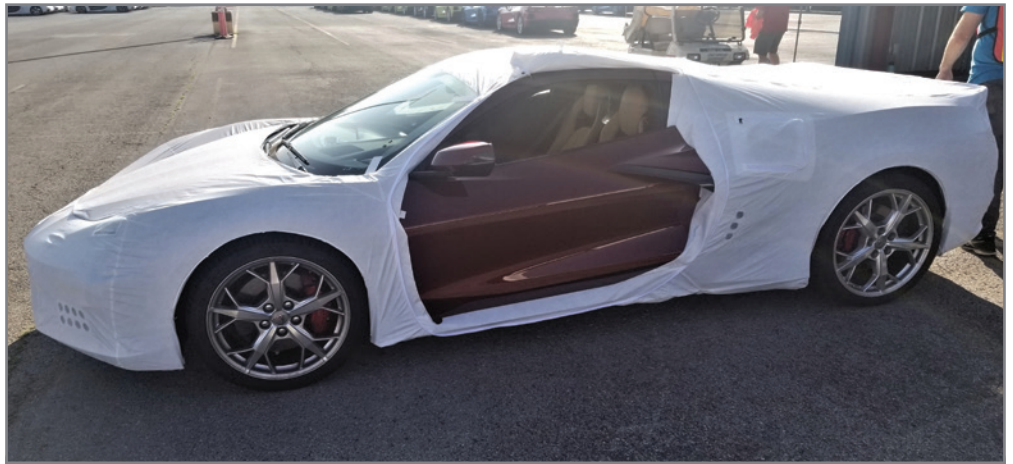
Corvette exterior protective cover must be removed before customer delivery.

Many GM vehicles come with protective coverings, foam blocks and other preventative measures applied before vehicle shipping to aid in vehicles being delivered in the best possible condition. The exterior protective cover must be removed completely in order to perform a proper pre-delivery inspection (PDI). The PDI includes time for the complete removal of the cover.

ping cover during transportation only. Once removed from the vehicle, any debris that gets trapped in the cover when removing or reinstalling it may cause possible damage.

Exterior protection devices such as the plastic shipping covers and foam block door protectors should be left in place up to the time of the customer delivery except for vehicles on prominent display such as the showroom floor. These protective devices help to minimize lot damage, reduce dealer expense and increase customer satisfaction.

For additional information on proper vehicle storage and new vehicle PDI, refer to the latest versions of Bulletin #09-00-89-002 and Bulletin #03-00-89-006.
