TECH LINK

GM TechLink is published for all GM retail technicians and service consultants to provide timely information to help increase knowledge about GM products and improve the performance of the service department.

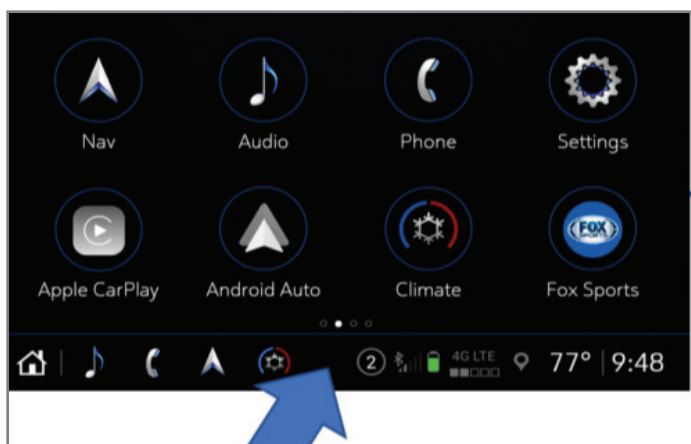
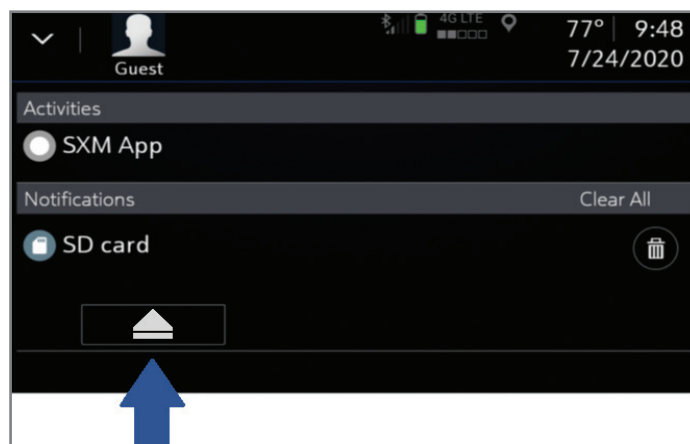
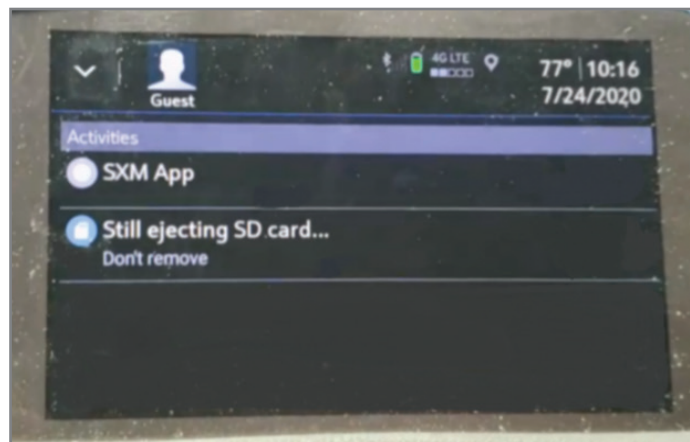
SD CARD EJECTION PROCESS

1. On the infotainment screen, touch the bottom of the Home page near the Notifications indicator (circled number), if available. The number indicates the number of current notifications. If there is not a notifications number shown, touch the center area of the screen, right of the Application Tray.
2. The Notifications page will display showing that an SD card is installed. Touch the Eject symbol.

3. A "Still ejecting SD card..." message will display on the screen. The card can be removed from the card slot when the "Safely Ejected" message is displayed.

If the SD card is not ejected properly, the card may not be able to be read by the navigation system the next time the system is used. If anything is being written to the card when it is removed, there is a risk that permanent data corruption may occur.

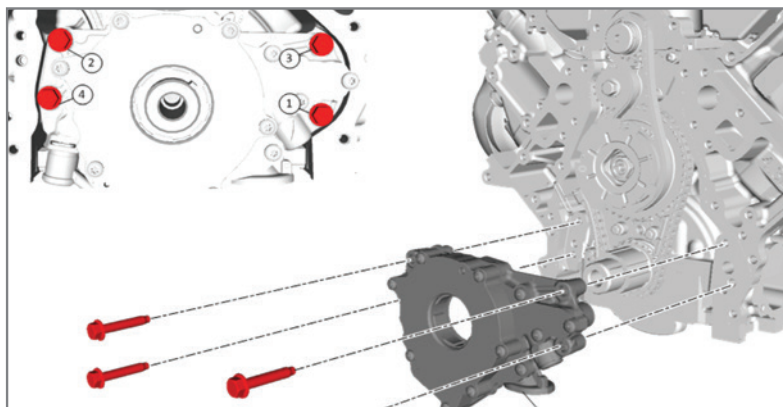
Engine oil pump on V8 engines (RPO L82, L84, L87)

When the solenoid valve is commanded Off, oil pressure is higher. When the solenoid valve is commanded On, oil pressure is lower.

TIP: On the 2.7L engine (RPO L3B), oil pressure may be as low as 26-28 psi (179-193 kPa) under normal operating conditions at road speed. The oil pressure at this level is normal and is not associated with any engine durability issues. If the oil pressure is not correct for current conditions, as commanded from the ECM to the variable oil pump, a DIC message will be displayed.
