## PROPER Terminal Testing AND DIAGNOSIS

# PROPER Terminal Testing AND DIAGNOSIS

# Delayed Transmission Engagement

# The Importance of Using the Correct Fasteners

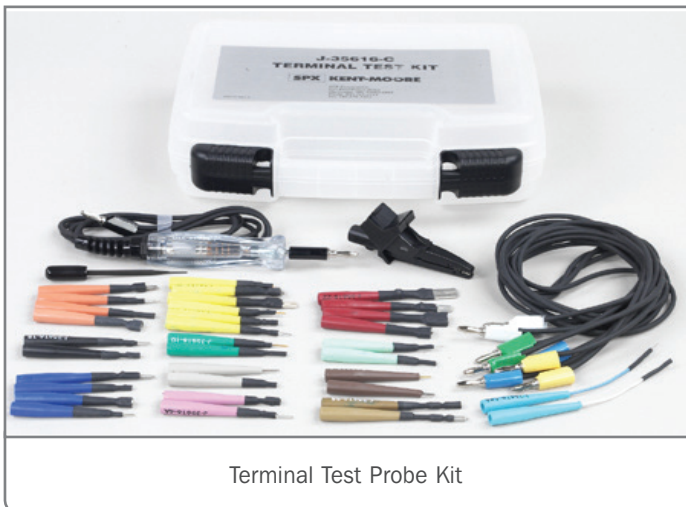
## TERMINAL TEST PROBES

Terminals are becoming increasingly smaller and more complex in design. Using an improper test kit probe may cause damage to the terminals being probed and result in false readings during a diagnostic procedure. Using an instrument other than the correct probe will, in most cases, cause irreversible damage to the terminal by enlarging or deforming it to the point that it will no longer mate correctly.

Do not visually choose the terminal test adapter because some connector terminal cavities may appear larger than the actual terminal in the cavity. Using a larger terminal test adapter will damage the terminal.

The J-35616-F Terminal Test Probe Kit includes probes that are sized to fit the various terminal sizes and their shapes properly. There are also several smaller kits available.

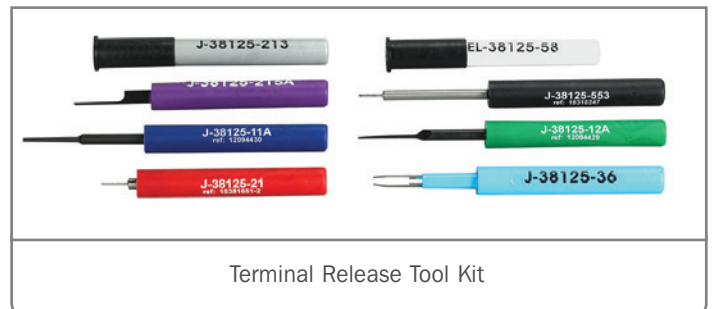
## TERMINAL RELEASE TOOLS

The J-38125-580 Terminal Release Tool Kit contains various tools designed to release terminals from the connector. The terminals have a metal arm or tang that locks into the connector body. When the release tool is inserted into the canal, it moves the tang against the terminal, which allows the connector body to be released and moved outward. Tangless terminals are released in a similar fashion with the tool pushing the arm of the connector body to release the terminal.

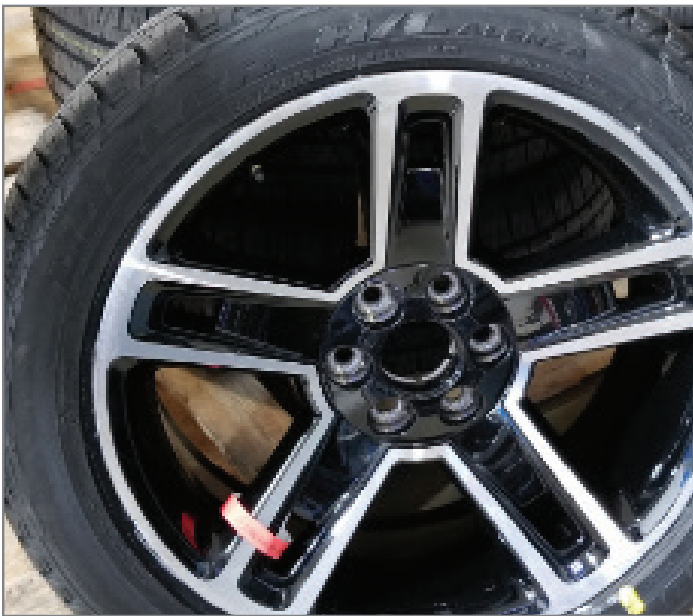
LPO wheels

It's important not to miss the learn procedure during the installation process. LPO accessory wheels have a red 'wrist band' tag on one of the wheel spokes as a reminder that a TPMS learn is necessary. Labor for the learn procedure is included as part of the accessory installation procedure.

GM recommends using the EL-52545 TPMS and RF tool to perform the learn procedure.

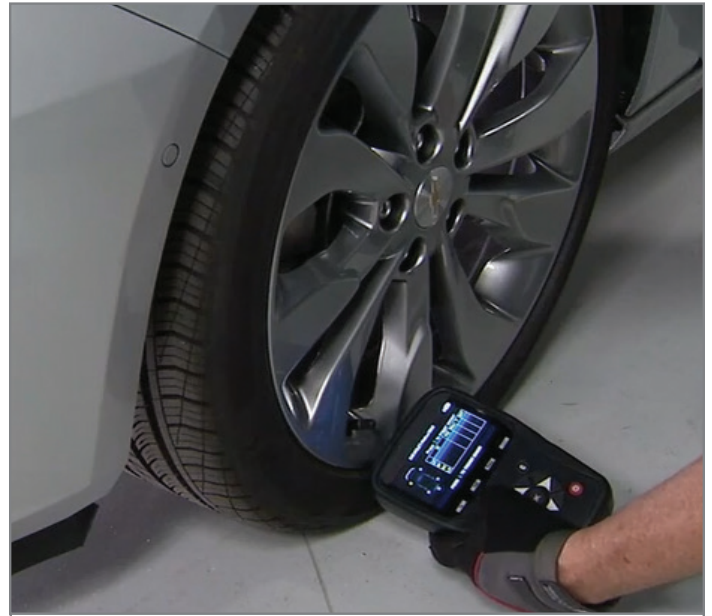
Use the EL-52545 tool to perform the learn procedure.

Before delivering the vehicle to the customer, be sure to check that no DTCs are set and that the TPMS lamp on the instrument cluster is not illuminated.

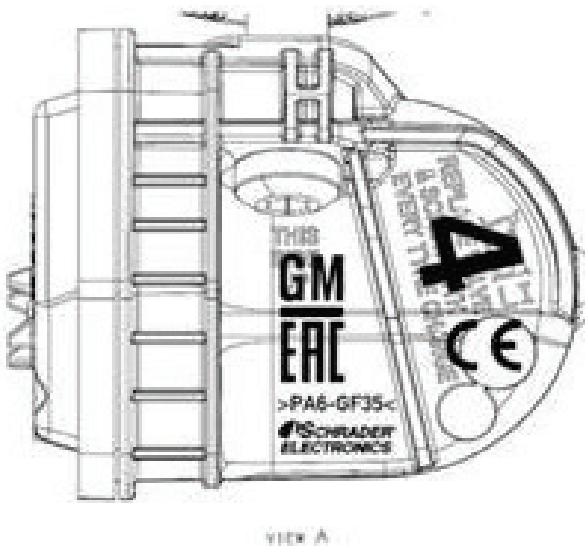
SUV sensors have a “4” on the body.

Both sensor types use the same sensor body, so they look the same. However, they cannot be interchanged. Be sure to look for the correct identification before installing them. The EL-52545 tool will not recognize the 4C sensor from a full-size truck if it is installed on a 2021 SUV model.

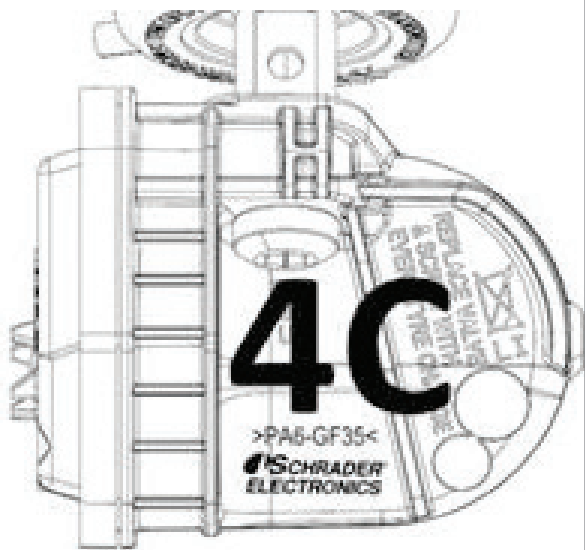
2020 Silverado and Sierra models use the Global 'A' Architecture electrical system. The sensor, PN 84413357, is identified with a “4C” printed on the sensor body.

Truck sensors have a “4C” on the body.
