October 2020, Volume 22, No. 19

Potential Oil Leak from Camshaft Carrier Gasket

PARTICULATE MATTER SENSOR

Loose Turbocharger Actuator Bolts

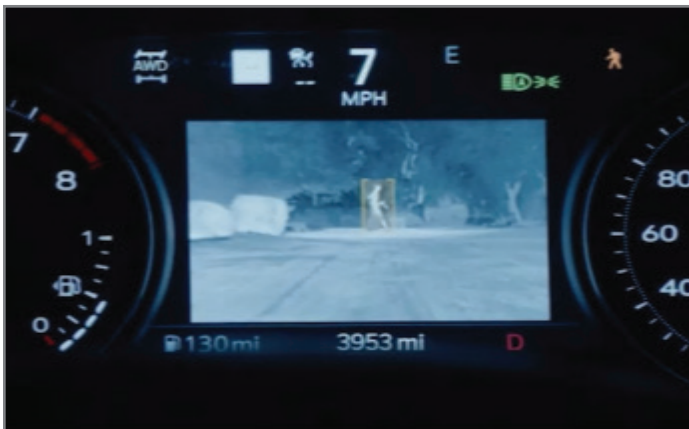
Night Vision display

Some 2020-2021 XT5 and XT6 models equipped with Night Vision (RPO UV3) may show a green, pixelated display in the Driver Information Center when Night Vision is selected.

There are two LVDS/USB connectors on the back of the instrument cluster. The gray connector is an output going to the Head-Up Display. The black connector is the input from the Night Vision Camera Control Module.

The Night Vision Camera Control Module sends the processed image output directly to the instrument cluster via a dedicated cable. The Active Safety Control Module communicates via serial data to the night Vision Camera Control Module from the BCM and Motion Sensor Manager, which the Night Vision Camera Control Module uses to turn on if the conditions are correct (ambient light and temperature), and perform detections (vehicle path and speed). The Night Vision Camera Control Module will

All the video signal circuits are twisted and shielded to prevent any interference that may lead to a loss of video signal resolution and cause a degraded video image. These circuits must not be spliced/removed from shielding or will cause image degradation.
