Battery Condition Prognostics Integrated into Techline Connect

TECH LINK

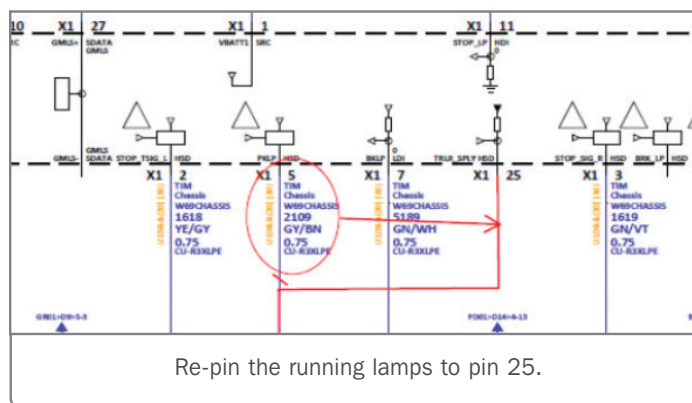
These conditions may be caused by a trailer with incandescent running lamps that may have in-rush current that exceeds the Trailer Lamp Control Module limits for current flow. On trailers with LED lighting, the monitoring voltage may illuminate the LED lights even when the trailer theft deterrent feature is not enabled.

2019 model year trucks equipped with the Trailer Information Indicator (RPO U1D) use the K68 Trailer Lighting Control Module to control all trailer lighting through pulse width modulated (PWM) voltage. The Trailer Lamp Control Module has a current handling capability on the running lamp circuit of about 9 amps. On a trailer with a large number of incandescent lights, in-rush current can exceed 20 amps before it settles back to around 8-9 amps. During this in-rush or "marriage" current period, the Trailer Lamp Control Module identifies the current as an overload and goes into protection mode.

The update requires a terminated lead to be inserted into cavity 25 on the chassis harness X1 connector. Wiring connected to pin 5 on the X1 will need to be cut and reconnected to pin 25. The terminal in cavity 5 will remain, but must be blunt cut and sealed with a closed-end Duraseal splice to prevent water intrusion through pin 5.

For 2020 model year trucks, a change was made to allow 16 amps of continuous current flow by routing the current through an internal relay in the Trailer Lamp Control Module. 2019 models can be modified to operate in the same way with the use of the 2020 design software and a re-pin of the running lamps to pin 25 using the internal relay to operate the running lamps.

To review the service procedure to move circuit 2109 on the Trailer Lamp Control Module from X1 cavity 5 to X1 cavity 25, and program new software from SPS into the Trailer Lamp Control Module, refer to Bulletin #20-NA-198.
