## GDS2 Transitioning from TIS2Web to Techline Connect

Global Diagnostic System 2 (GDS 2)

# WIRING HARNESS CONDITIONS ON THE 2.8L Diesel Engine

# Damaged Crankshaft Position Sensor and Reluctor Ring

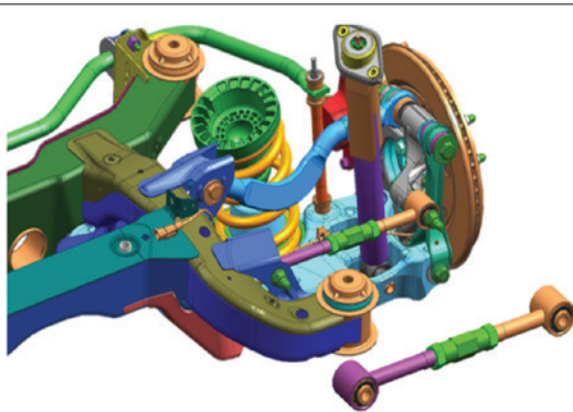
Rear suspension toe link

When servicing the rear suspension on 2010-2016 Cadillac SRX and 2011-2012 Saab 9-4X models, the Service Information has been updated recently to require the replacement of both right and left rear toe links if a rear alignment is needed. The original toe links should not be adjusted.

not be adjusted again. If the rear toe requires alignment later, new rear toe links should be installed followed by a rear toe alignment. When the rear toe links are serviced, always verify that the adjustment link jam nuts are tightened to the proper torque specification.

The rear toe links from the supplier are pre-torqued to 20 Nm (14 lb.-ft.), not the final torque specification of 150 Nm (110 lb.-ft.).

Hold the adjustment collar with a 26mm open-end wrench and verify the jam nut torque using a 26mm crow's foot attachment on a calibrated torque wrench. Check the torque by pulling the torque wrench handle. Tighten to 150 Nm (110 lb.-ft.). Ensure the jam nuts are properly torqued.

Recheck the toe setting and readjust the toe specifications if necessary.

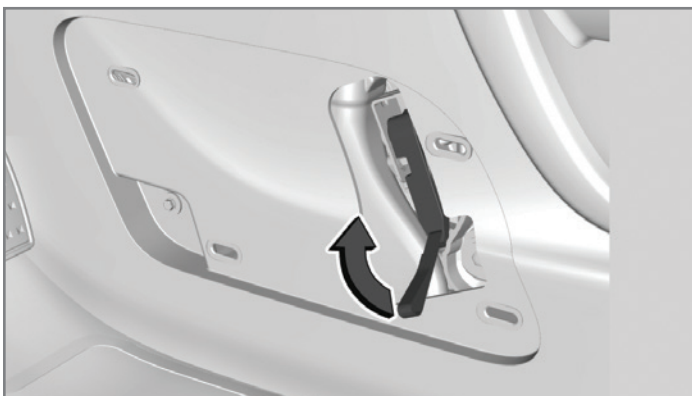
The manual park release cable and handle have been removed on some 2021 models.

Do not order parts to install a manual park release cable and pull handle on these 2021 models. No repairs are necessary.

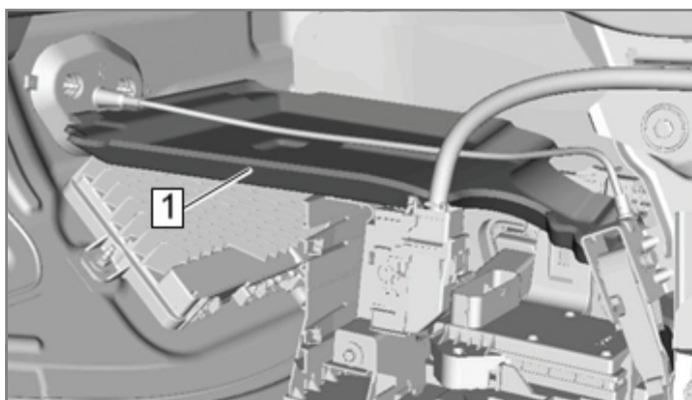
Manual park release cable under center console.
