Mid-November 2020, Volume 22, No. 22

Battery Testing Guidelines Using the GR8 Battery Tester/Charger or
Diagnostic Charge Battery Station 2
Check the Sales Order Guide Before
Changing Tire and Wheel Sizes5
Hood Latch Replacement 7
FSE Technician Recognition
Awards – 4th Quarter 2020 8
Fuel Odor from Engine
Compartment
Coolant Flow Control Valve Actuator
Harness Connector Corrosion 11

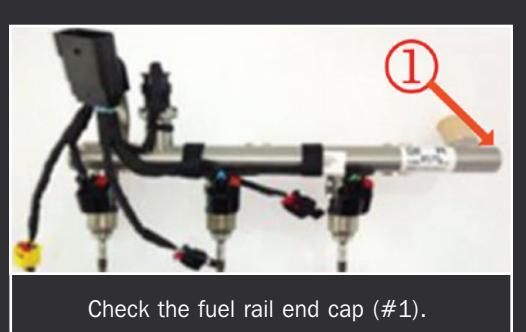
A fuel odor from the engine compartment may be found on some 2020-2021 Encore GX and 2021 Trailblazer models equipped with the 1.3L engine (RPO L3T).

Inspect the high pressure fuel rail feed pipe and fuel injector connections.
