UNEVEN OR LEANING AIR RIDE ADAPTIVE SUSPENSION

<i>Uneven or Leaning Air Ride Adaptive Suspension</i>	<i>2</i>
<i>Rear Axle Clunk Sound</i>	<i>5</i>
<i>Sunroof Drain Hose Extensions</i>	<i>6</i>
<i>Exhaust Charge DTC Diagnostics</i>	<i>7</i>
<i>Knock Sensor Inspection</i>	<i>7</i>
<i>Installing a Rearview Camera Kit</i>	<i>9</i>
<i>Transmission Shift Conditions</i>	<i>10</i>

TECH LINK

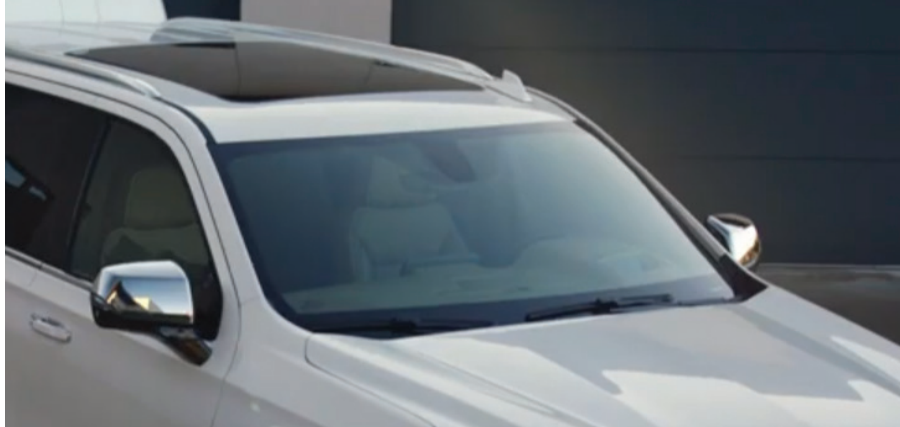
Sunroof Drain Hose Extensions

There may be a gurgle or sloshing sound heard on some 2021 Tahoe, Suburban, Yukon, and Escalade models equipped with a panoramic sunroof (RPO C3U). The sound may be coming from both front-right and front-left sunroof drain hose areas.

The sound is usually present while driving the vehicle at approximately 50-70 mph (80-112 km/h) after a soaking rain or car wash. The sound may be more evident with the HVAC system off or with the HVAC system on and in the Recirculation mode setting.

If the sound is heard, check the condition of the sunroof front drain hose grommets where they exit in the plenum. The pressure in the plenum may potentially be too high to allow water to exit as designed.
