Programming Radio Software

TECH LINK

GM TechLink is published for all GM retail technicians and service consultants to provide timely information to help increase knowledge about GM products and improve the performance of the service department.

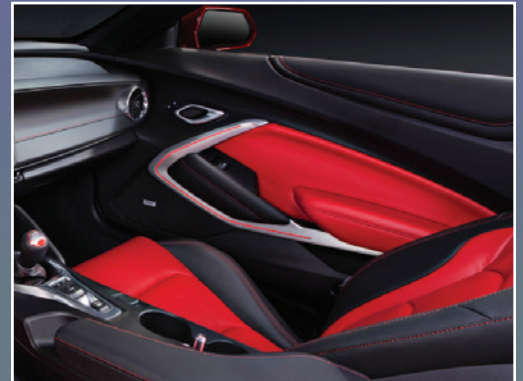
Interior door handle

If the chrome trim is starting to peel, the interior door handle should be replaced. The front side door trim must be removed to access the door handle. Also disconnect the electrical connectors from the inside handle.

To replace the interior door handle, the four heat stakes need to be drilled out to release the assembly. Do not drill too deeply or the hole in the substrate will become too large. Drill only enough to release the handle assembly and then use a suitable tool to remove the remaining heat stake material.

Drill out the four heat stakes to release the handle assembly.

For complete details on the repair procedure as well as a service parts list, refer to Bulletin #21-NA-008.
