Updated PAINTED ALUMINUM WHEEL Refinishing Guidelines

Updated Painted Aluminum Wheel Refinishing Guidelines 2

GM TechLink is published for all GM retail technicians and service consultants to provide timely information to help increase knowledge about GM products and improve the performance of the service department.

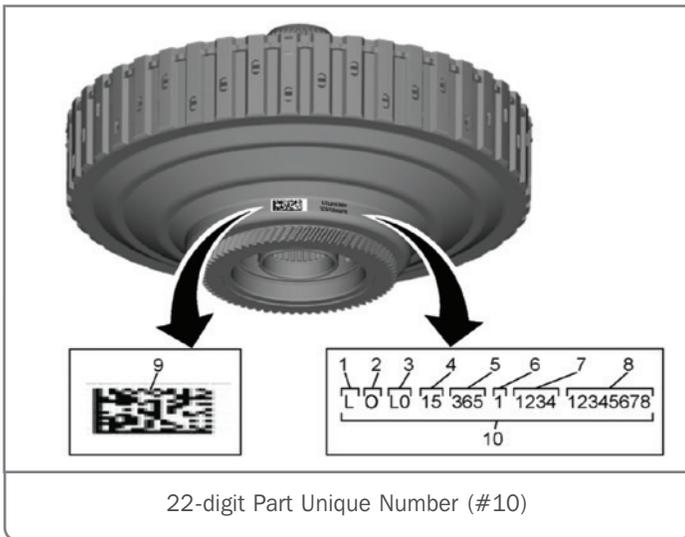
Service Information is very detailed in specifying that the 22-digit PUN is needed. There is a 21-digit and 22-digit PUN on these parts. The 21-digit PUN is for supplier use only and should not be entered when TCM programming.

TIP: Take a photo of the 22-digit PUN or document or record the PUN in some way to ensure that it is properly identified before installing the part on the transmission.

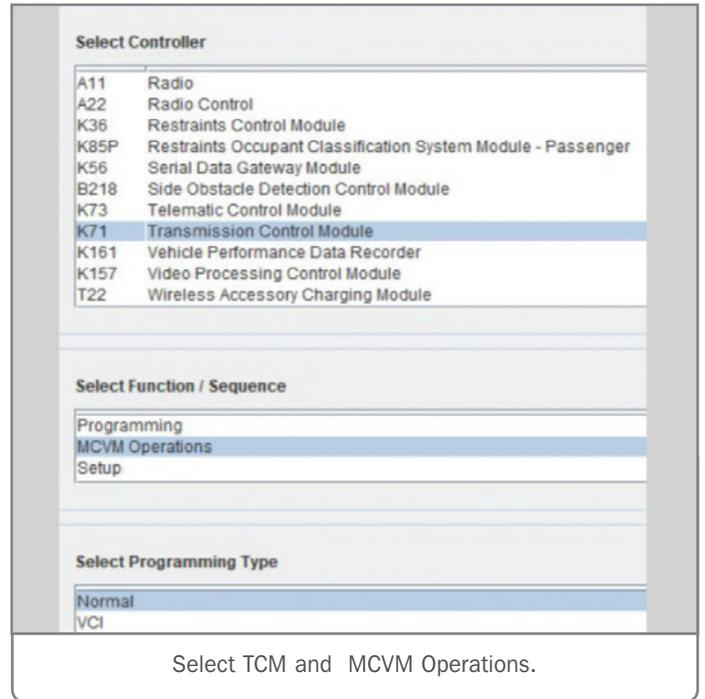
After selecting the MCVM operation – Replace Characterized Transmission Components, the next SPS characterization screen states, "Please enter valve body assembly PUN." There is not an

option for the clutch or SAV. Enter the PUN from the component that was replaced and the PUN will be mapped to the correct information. Be sure to complete all steps in the programming procedure in Service Information.
