## Replace, Don't Repair, Coaxial Cables

# Replace, Don't Repair, Coaxial Cables

GM TechLink is published for all GM retail technicians and service consultants to provide timely information to help increase knowledge about GM products and improve the performance of the service department.

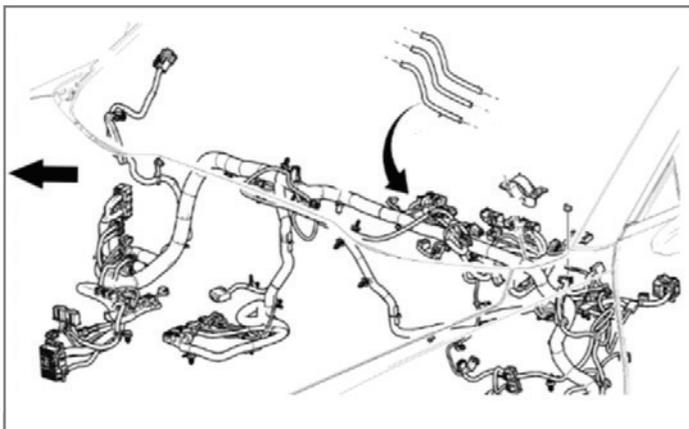
Identify the main harness and needed cables in the EPC.

**TIP:** LVDS, USB and Coax cables can be found in the Electronic Parts Catalog (EPC) by first identifying the main harness that contains the needed cable and then looking for the cable references in the accompanying graphic.

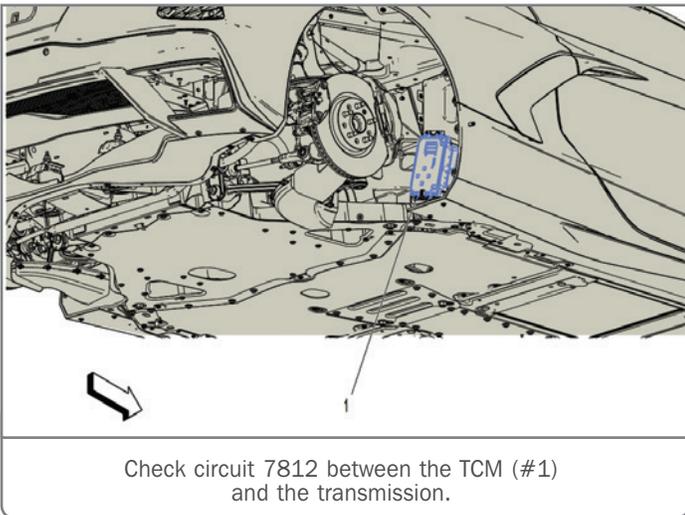
In any instance where the vehicle has a current or history DTC P1955 and P0867 stored, the transmission fluid level should be checked and cleaning procedures followed according to Bulletin #21-NA-033. If DTCs P1955 and P0867 return, it is related to a loss of system pressure condition that is being investigated by Engineering.

**TIP:** DTC P1955 usually will not set as the only code. If it is among several codes stored, it is likely the cause of the other DTCs. A Main Control Valve (MCV) replacement will not repair vehicles with DTC P1955 set.

If any combination of these DTCs have set (current or in history), check circuit integrity on circuit 7812 between the Transmission Control Module (TCM) and the transmission. Check the terminal tension as well for a possible short to ground.

If any issues are found, repair as needed and verify proper vehicle operation. If no issues are noted, the transmission would need to be replaced as anything related to the Odd Sensor Module (OSM) is not serviced.

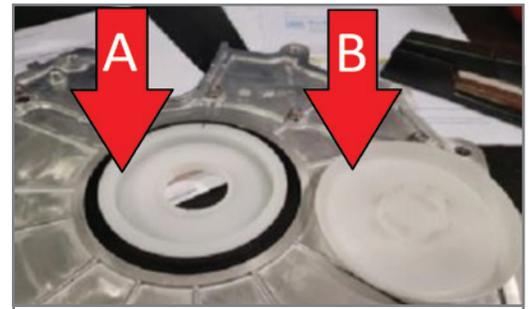
A. Inner piece acts as installation tool  
B. Outer piece provides protection during shipping

The inner piece acts as an installation tool substitute for the EN-52466-2 seal protector and fits over the bevel on the end of the crankshaft. Be sure that the inner lip of the seal slides over the rear of the crankshaft without rolling during installation or a repeat oil leak may occur. The protector/installer (shown without cover) will have a snug fit to the pilot of the crankshaft.
