Bolt EV

Battery Cell Inspection

GM TechLink is published for all GM retail technicians and service consultants to provide timely information to help increase knowledge about GM products and improve the performance of the service department.

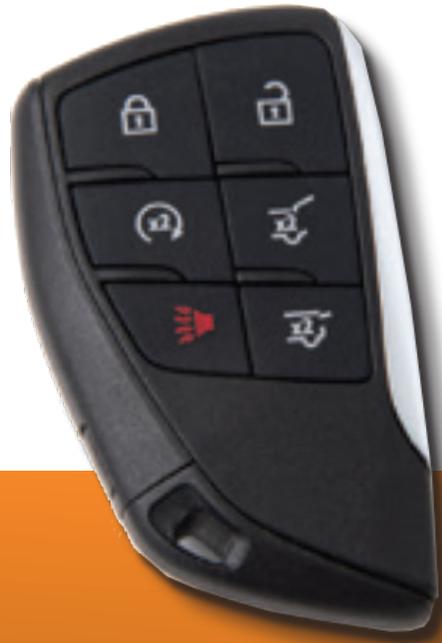
Some 2021 Tahoe, Suburban, Yukon and Escalade models may have a no crank/no start condition with a No Fob Detected message on the Driver Information Center. The Remote Keyless Entry (RKE) transmitter, or key fob, also is not detected when placed in the backup pocket in the center console.

If this condition is present, the key fobs will work manually (with a button press), but not passively (detected by the vehicle). No current passive antenna or immobilizer DTCs will be set in the Body Control Module (BCM).

These conditions may be due to an internal BCM fault that causes the key fobs to not be recognized and a loss of the immobilizer.

If all questions can be answered as "yes," the BCM should be replaced.

TIP: It may be possible to recover the vehicle from this condition by performing a battery disconnect/reset, allowing the vehicle's modules to completely power down.
