## New 9T65 Transmission

### Replacement Pilot Program Bulletin Information

## TECH LINK

GM TechLink is published for all GM retail technicians and service consultants to provide timely information to help increase knowledge about GM products and improve the performance of the service department.

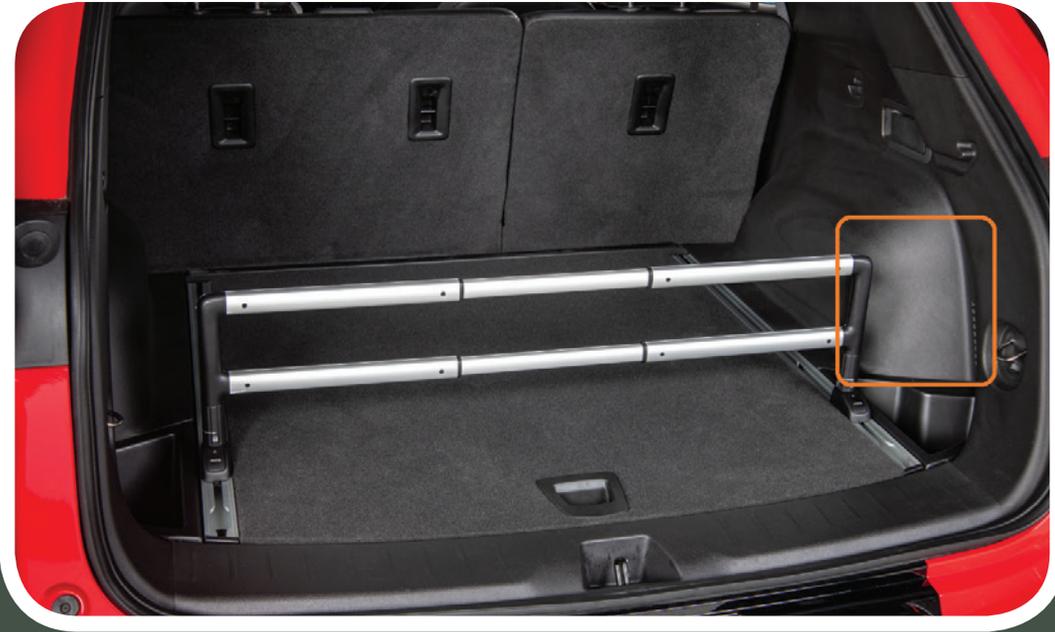
Some 2020-2021 Blazers may have a number of various conditions occurring, such as multiple instrument cluster indicators illuminated, instrument cluster gauges dropping out, door locks cycling, inoperative passive entry and other concerns. The following DTCs also may be set: B280D, B3978, B3979, B3980, B3981, C0293, C0800, P057C, P0650, P2122, P2127, P2128, U023A, U026A, U0078, U0100, U0101, U0121, U0131, U0140, U0146, U0151, U0159, U0168, and U0186.

If these conditions are present, they may be the result of terminals that are loose or not attached at G401.
