TECH LINK

# Exhaust Control Valve Actuator Replacement

Several exhaust-related DTCs may be set in the Engine Control Module on some 2020-2021 CT4 and CT5 models equipped with the 2.7L engine (RPO L3B) or 3.0L engine (RPO LGY). These DTCs may include P31D4 (Exhaust Flow Control Valve - Position Signal Exceeds Upper Limit — Bank 1), P31DB (Exhaust Flow Control Valve Stuck Open — Bank 1), P31E2 (Exhaust Flow Control Valve - Position Signal Exceeds Upper Limit Bank 2), and/or P31E8 (Exhaust Flow Control Valve Stuck Open Bank 2).

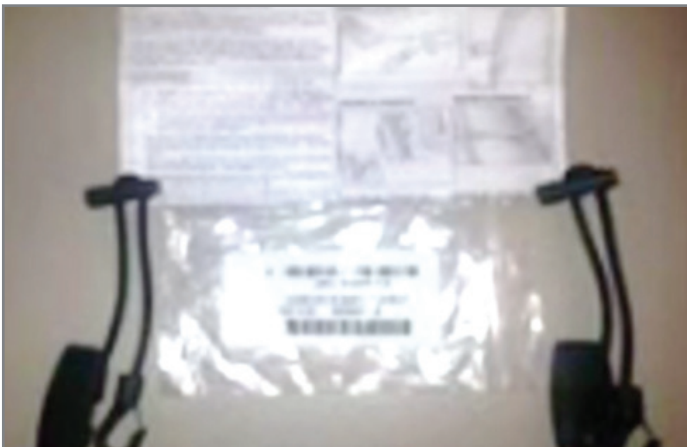
Rear Seat Belt Comfort Guide package

Rear Seat Belt Comfort Guide packages for the second- and third-row seats, if equipped, are now available to order for 2022 XT4, XT5, XT6, Blazer, Traverse and Acadia models. These models do

not include rear seat belt comfort guides, which were previously shipped in the glove box for installation by customers.

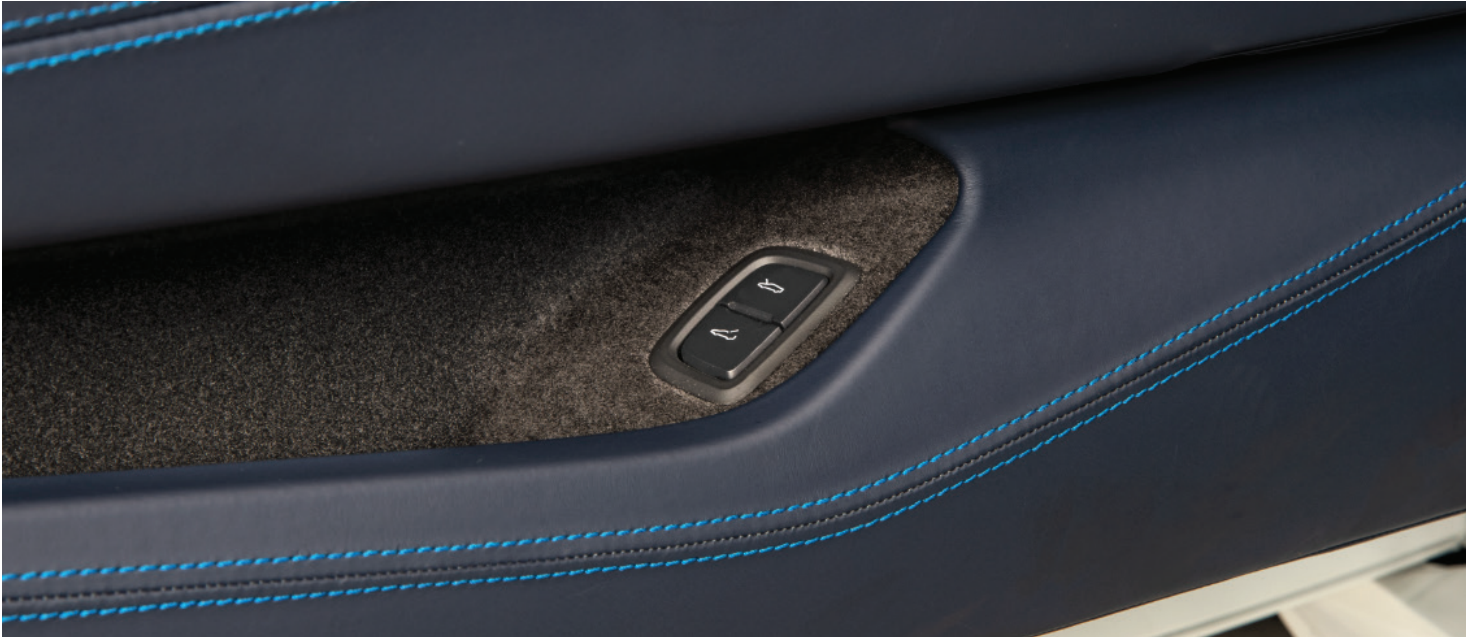
***The electrical hood release buttons may be inoperative and a Hood Ajar message may be displayed on the Driver Information Center on some 2020-2021 Corvette models. The hood can be opened using the manual release cable.***

These conditions may be caused by possible water intrusion and terminal corrosion in connector X103, water intrusion in the hood latch actuator or failure of the auxiliary hood latch release switch. Check each of these components to determine the repair needed.

Remove the front compartment front panel to inspect connector X103. If corrosion is found in the connector, replace the connector as necessary.

If there is not any corrosion in connector X103, access the hood switch connector X102, remove the left horn and test the auxiliary hood latch release switch with an ohmmeter. The switch should be open when it's not pressed, and resistance should be no more than 0.2 ohm when the switch is pressed. If the switch is not operating correct, replace the switch.

If the auxiliary hood latch release switch is not faulty, reinstall the left horn and then replace the hood latch actuator.
