Know Your Shipping Guidelines

When Returning Parts to the Warranty Parts Center

*Engine Misfire Detected without
Drivability Concerns 7*

Wiring Harness Damage 9

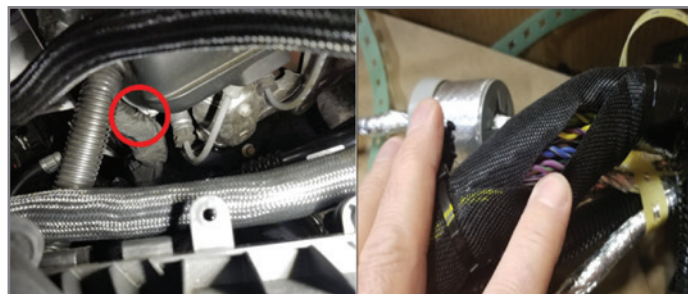
When submitting photos, show the location on the vehicle along with a clear picture of the damaged area.

An example of an EI Lite currently requiring additional information from dealership technicians is #PIE0547, which applies to 2020-2021 XT5 and XT6 models with possible wire, connector or terminal damage or incorrect wiring harness routing.

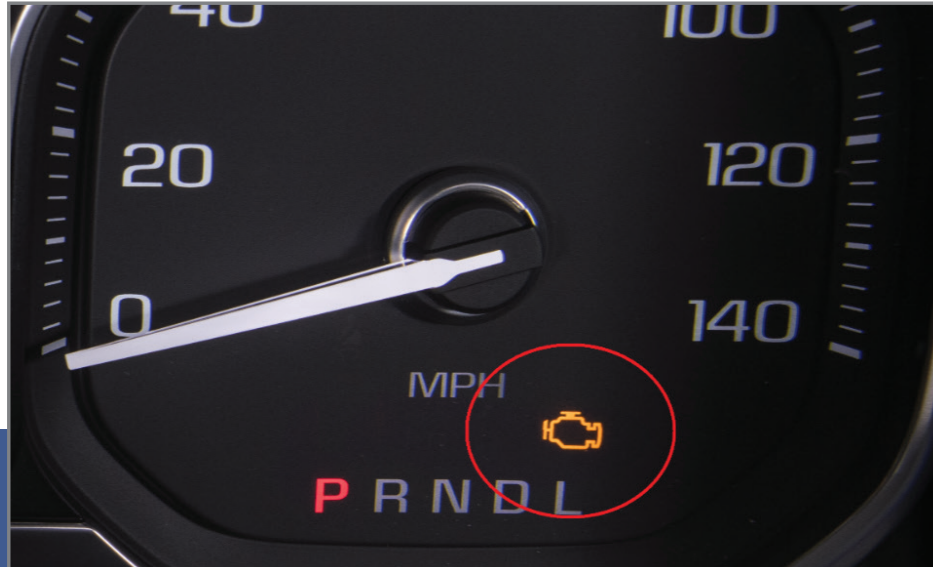
An engine misfire DTC may be set on some 2020-2021 Silverado 1500 and Sierra 1500 models equipped with the 5.3L V8 engine (RPO L84). However, the misfire may not be noticed by the driver or the vehicle may not have any drivability concerns. The Check Engine MIL may be illuminated or may have been flashing while driving up a long grade or a smooth road with steady throttle input. DTC P0300 (Engine Misfire Detected) may be set as active or history in the Engine Control Module (ECM).

The detected misfire condition may be the result of the P0300 diagnostic falsely setting the DTC under certain driving conditions. GDS2 data may show misfires being recorded on any cylinder, but they may be more noticeable on cylinders 1 and 6.

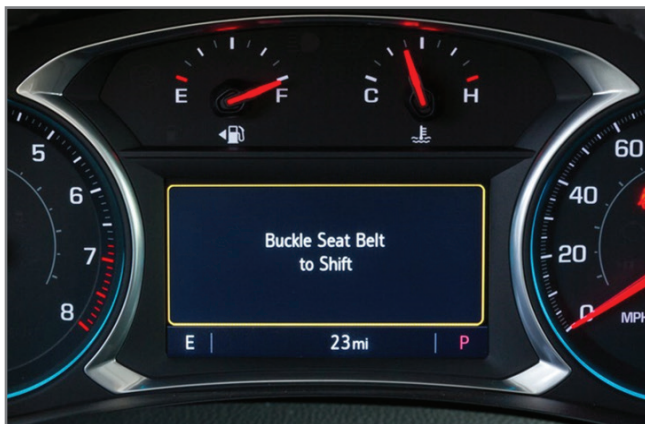
Buckle to Drive message on the DIC.

The driver cannot shift out of Park until the driver's seat belt is buckled. If the seat belt remains unbuckled, the vehicle can be shifted out of Park once the feature times out and the DIC message is no longer displayed. The feature will remind driver's to buckle up once during each ignition cycle.

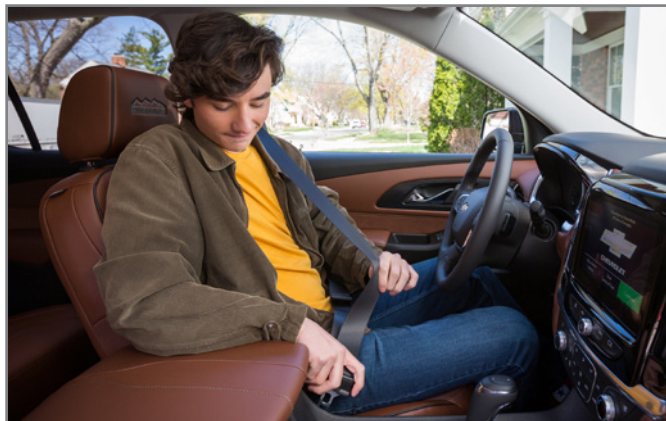
Buckle to Drive requires the driver to buckle the seat belt. The feature can be turned on/off in the Settings menu.

TIP: If there is a concern about the transmission not shifting out of Park intermittently, check the Buckle to Drive setting before performing other diagnostic procedures.
