## Trailer App

## Functionality and Diagnostic Tips

# Trailer App Functionality and Diagnostic Tips

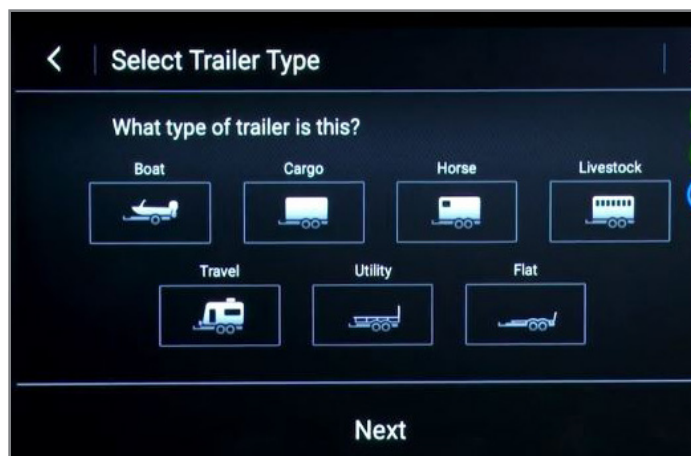
A customized trailer profile can be set up in the trailer app.

If the trailering app is set up incorrectly for the connected trailer, several DTCs or Driver Information Center messages may appear. For example, if a trailer does not have any reverse circuit loads, yet a reverse circuit load is expected in the trailering app, the Trailer Lighting Control Module will set DTC B3890 (Trailer Backup Lamps Circuit). If the trailer does not have reverse lamps or any loads on the reverse circuit, change the trailering app profile settings and clear any DTCs. Do not replace the Trailering Lighting Control Module.

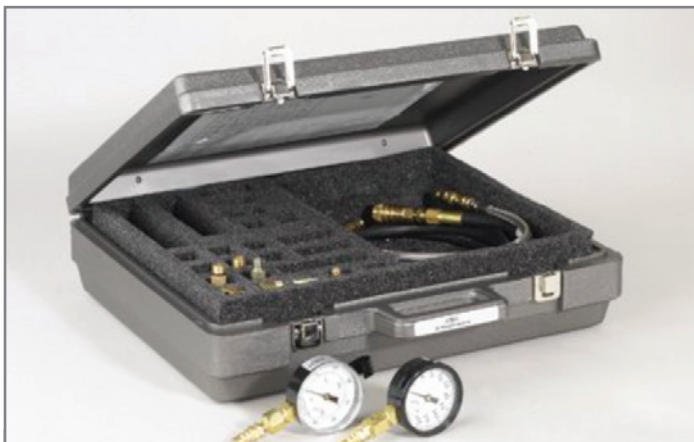
GE-21867 Pressure Gauge

If pressure is below 50 psi, follow the procedure for Fluid Pressure High or Low in the appropriate Service Information. If pressure is above 50 psi, continue diagnosis with a road test.

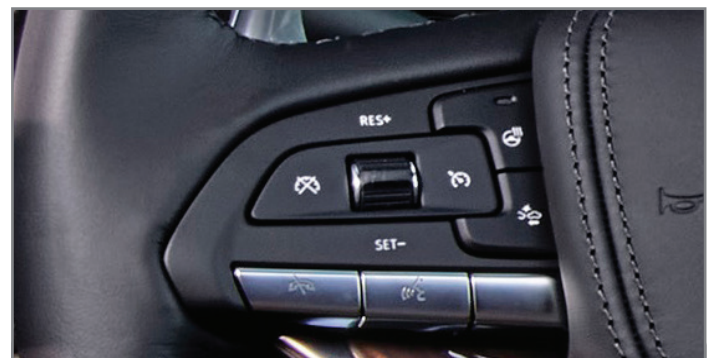
Adaptive Cruise Control switches

If these conditions are found, check for any concerns with the front seat belts, which may cause DTC U0422 to set.

belts change when buckled and unbuckled. If the status of the seat belts does not change when buckling the belts, diagnose any seat belt concerns prior to investigating any Adaptive Cruise Control conditions.
