The Blackwings Take Flight

<i>The Blackwings Take Flight</i>	1
<i>VT40 CVT Transmission Slipping Condition</i>	6
<i>Fuse Block or Junction Block Terminal Retention</i>	8
<i>Inoperative Steering Wheel Thumbwheel Select Control Reset</i>	9
<i>New Inserts Address Rear Leaf Spring Sounds</i>	10
<i>9th Gear Operation on 9-Speed Transmissions</i>	11

TECH LINK

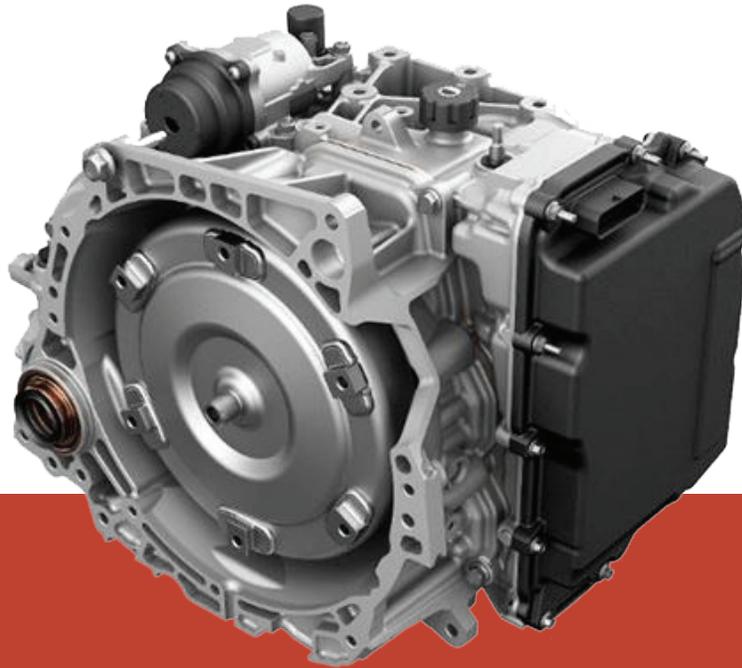
The pilot replacement program (U.S.) for the 9T65 9-speed automatic transmission (RPO M3V, M3W) on 2018-2021 Enclave, Traverse; 2019-2021 Blazer; and 2020-2021 Acadia, XT5, and XT6 models, which began in July 2020, will be ending soon.

The program is designed to reduce the number of days needed to complete vehicle repairs by favoring transmission replacement over internal repairs. After diagnosis of an internal fault, technicians are directed to replace the transmission assembly (following the necessary guidelines). All of the program details are covered in the latest version of Bulletin #20-NA-136.

If diagnosis determines internal components are the root cause or if parts are needed to complete repairs internal to the transmission, the transmission assembly should be replaced and not repaired. The repair order for the transmission replacement should include the condition, cause, and correction information as well as details on any DTCs, transmission fluid level, and fluid pressure testing.

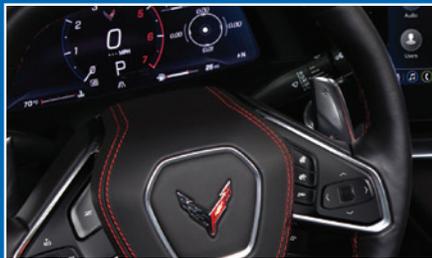
The Driver Information Center (DIC) thumbwheel control on the right side of the steering wheel on some 2021 Corvettes may not work when selecting any Information tiles, radio stations, or Tire Pressure Monitoring or Oil Life system resets. The thumbwheel control is used to move through and select several instrument cluster menus and features. The thumbwheel control is rotated to scroll through information on the instrument cluster and is pressed to select various features.

The thumbwheel control is used to move through and select several instrument cluster menus and features.

To reset the selection operation of the thumbwheel control, start the vehicle and wait for the Buckle Seat Belt message to time out on the Driver Information Center on the instrument cluster.

Press the right arrow on the steering wheel control until the DIC screen displays "Press ✓ to Simplify Display."

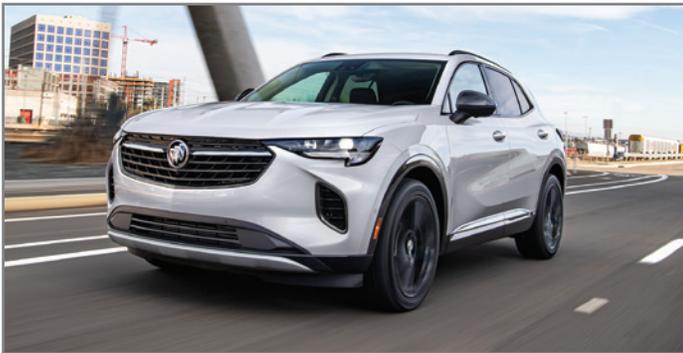
Transmission operation on some 2018-2022 Terrain; 2019-2022 XT4; 2020-2022 Encore GX, XT5, XT6, Acadia; and 2021-2022 Envision and Trailblazer models may not be fully understood by owners, especially at highway speeds. These models feature the 9T45, 9T50, or 9T60 9-speed transmission (RPO M3F, M3G, M3H, M3T, M3U). In some cases, drivers may feel that the transmission doesn't shift into 9th gear or maintain 9th gear operation as expected.

The 9-speed transmissions shift to 9th gear when it is most efficient to do so.

The 9-speed transmissions use all nine gears when it is most efficient to do so. The vehicle's control system senses the operating conditions and determines the correct gear to deliver optimum performance and fuel economy.
