# Inadvertent Airbag Deployments

*Preventing Inadvertent Airbag Deployments . . . . . 2*

GM TechLink is published for all GM retail technicians and service consultants to provide timely information to help increase knowledge about GM products and improve the performance of the service department.

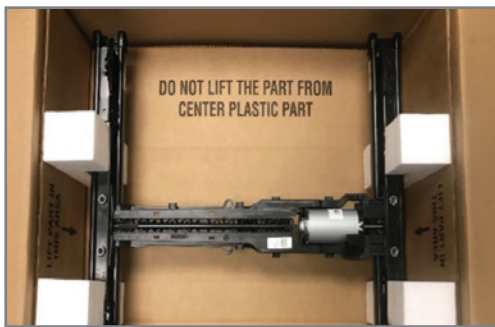
New H-frame assembly

Diagnosing front seat movement conditions on 2016-2022 Malibu and 2019-2022 XT4 models requires verifying the operation of the seat adjuster track. If there are issues with fore/aft movement, binding or other conditions, check for proper operation of the motor bridge as well as the flex shaft of the H-frame assembly. There should not be any excessive noise or any fore/aft travel restrictions when adjusting the seat position.

If diagnosis leads to the need to replace the front seat adjuster track, the H-frame assembly has recently been released as a service part. Do not replace the complete seat cushion frame assembly for a seat track movement condition.

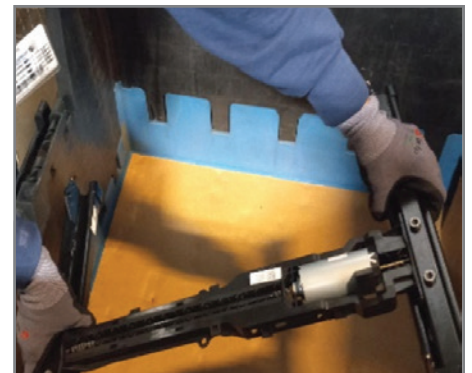
Lift the H-frame assembly with one hand on each track.

**TIP:** To remove the new H-frame assembly from the shipping container, lift it up with one hand on each track. Do not lift the H-frame by holding the bridge; it may cause damage to the material.

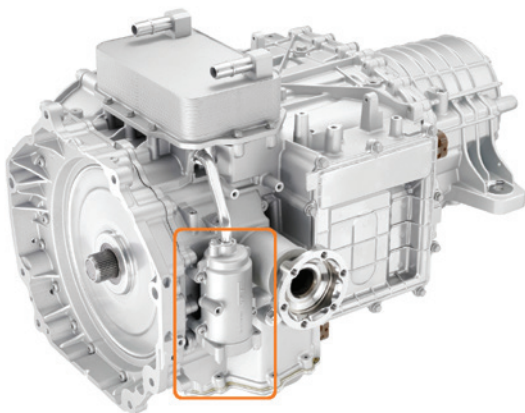
Tremec DCT TR9080 transmission cartridge filter

GM Engineering is conducting transmission filter inspections on 2020-2021 Corvette models (U.S. only). The Tremec DCT TR9080 dual clutch transaxle (RPO M1L) features a transmission cartridge filter that should be replaced at the initial 7,500-mile (12,000-km) maintenance service.

Service Information. In addition to a new filter, a new filter seal and new fluid filter cover bolts must be installed. Use Fuchs TITAN EG FFL-4 TREMEC transmission fluid only.

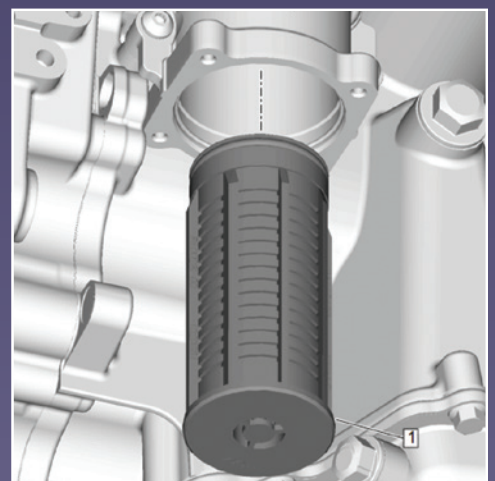
Transmission cartridge filter

Vehicles that have the first scheduled maintenance performed at 7,500 or within the first year of ownership should have the transmission filter carefully removed and double-bagged for return to the Warranty Parts Center.

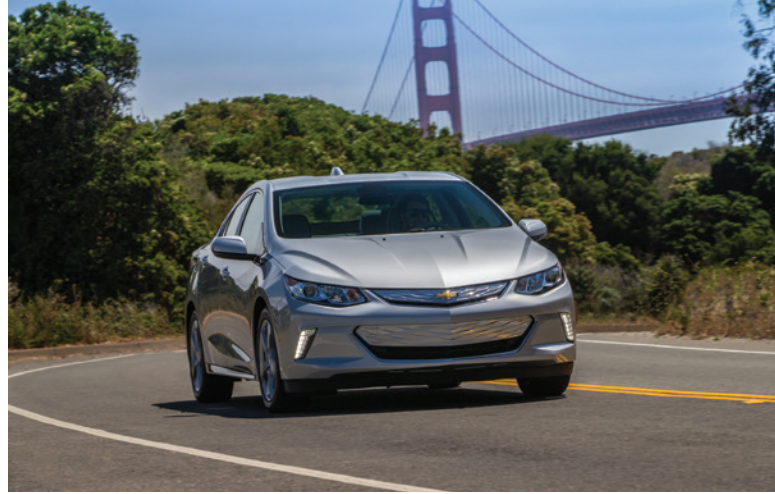
Some 2016-2019 Volt models may display a Speed Limited to X MPH or Reduced Propulsion Power message on the Driver Information Center (DIC) and limited vehicle propulsion. These messages may be intermittent and displayed for a brief amount of time. Once the message clears, full propulsion power is restored to the vehicle. No DTCs will be set.

The limited propulsion and related DIC messages may be the result of a low transmission fluid level in the drive unit or a mismatch in the estimated battery pack capacity due to the customer's charging habits.

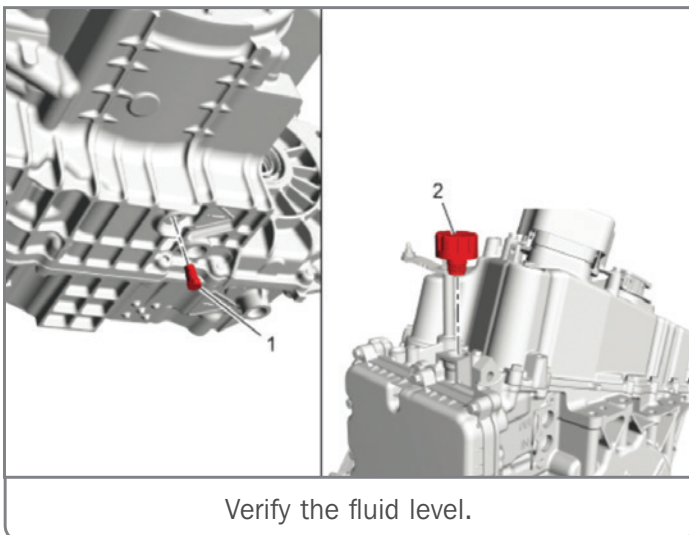
Due to the sensitive and complex nature of the drive unit, there are many inputs that the high-voltage (HV) modules and drive unit take into consideration while propulsion is active. In certain instances, such as while taking a sharp corner on a road, a DIC message may display if there is a low fluid level condition in the drive unit.

If these DIC messages are displayed intermittently, inspect for any transmission fluid leaks and verify the fluid level. If the fluid level is low or a leak is found, follow the appropriate Service Information procedures to correct the condition.

**TIP:** The transmission fluid level must be checked with the transmission fluid temperature at 45–55°C (113–131°F). An under-filled transmission will cause premature component damage. An over-filled transmission may result in overheating and a loss of vehicle propulsion.
