Program Radio Updates

TECH LINK

GM TechLink is published for all GM retail technicians and service consultants to provide timely information to help increase knowledge about GM products and improve the performance of the service department.

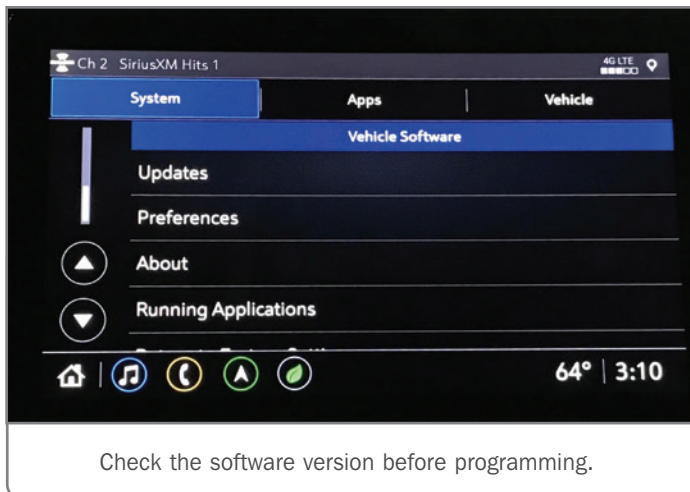
Be sure to verify the radio software level before beginning programming. To verify the current radio software version in the vehicle, go to Settings > About > Build Number > Information “i” on the infotainment screen.

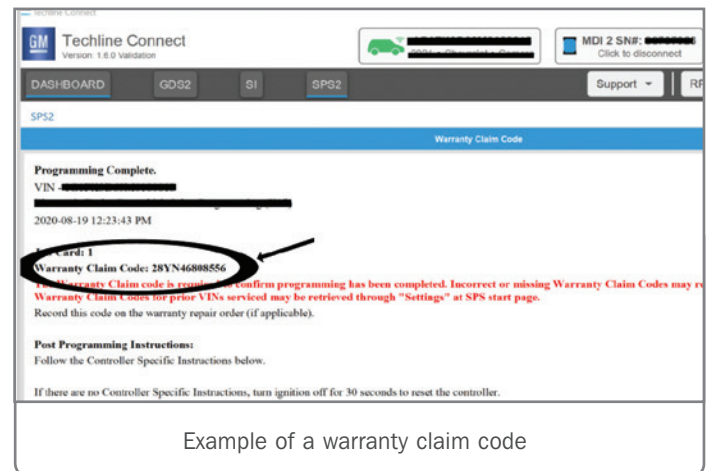
After a successful programming event, a warranty claim code will be located in the SPS dialogue box of the SPS Summary screen. For warranty claims, it's necessary to document the warranty claim code provided. The warranty claim code must be accurately entered in the warranty transaction.

When more than one warranty claim code is generated for a programming event, document all codes in the Correction field on the job card (repair order). It is a best practice to enter the final code provided by SPS.

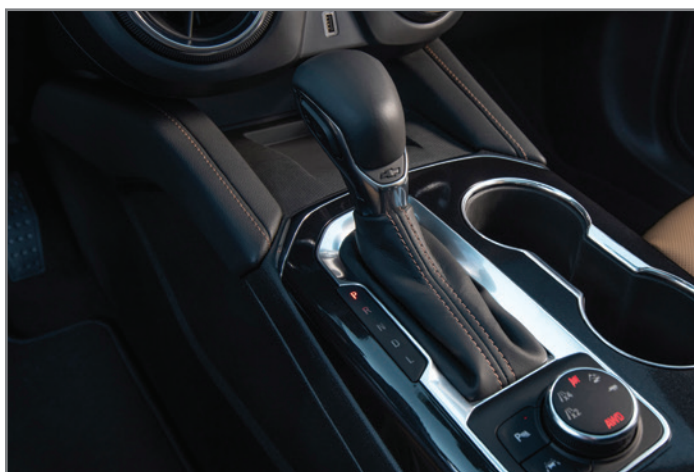
Diagnostic and repair procedures for the 9T65 9-speed automatic transmission have been updated.

Updated Bulletin #20-NA-136 provides an enhanced diagnostic and repair strategy that has been developed through the information and learnings gathered from the teardowns and inspections of transmissions returned as part of the program. The intent of the new procedures, as with the pilot program, is to reduce the number of days to complete the vehicle repair and reduce the potential for repeat repair visits.

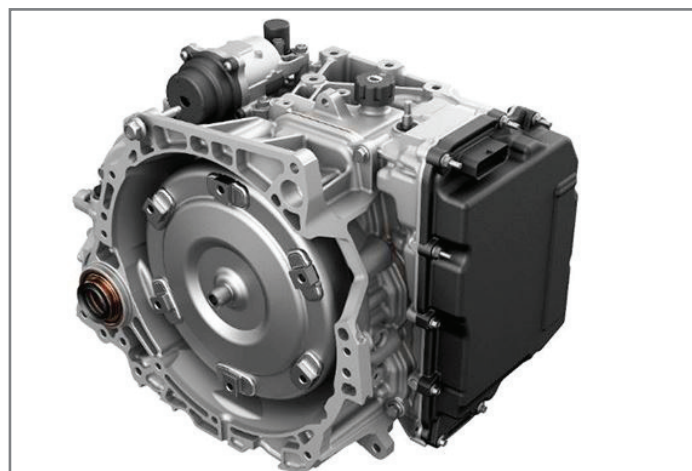
9T65 9-speed automatic transmission

To determine the repair strategy on a 9T65 transmission, begin diagnosis by first reviewing several previously released bulletins covering 9T65 transmission operating and performance conditions, including shift, sound and vibration concerns. For a complete list of the bulletins as well as other Service Information documents to review, refer to Bulletin #20-NA-136.
