November 2021, Volume 23, No. 21

### **TechLine Connect Software Update**

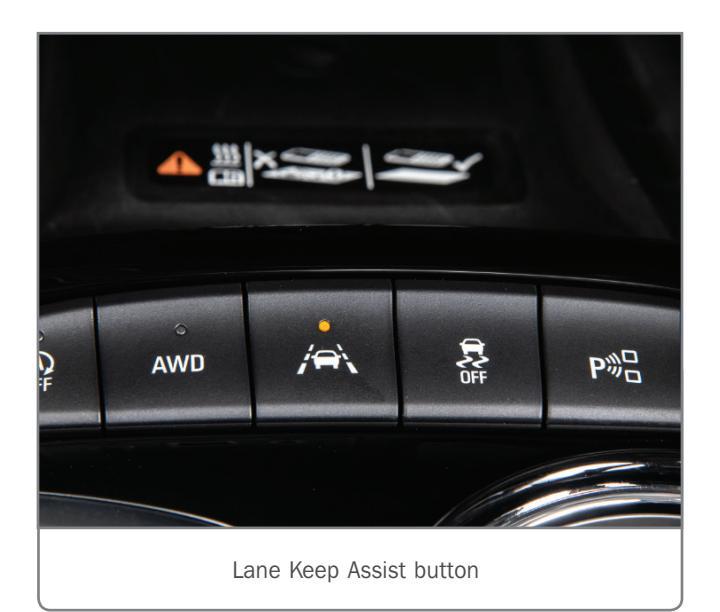
The Lane Keep Assist and Forward Collision Alert systems may become inoperative on some 2020-2022 Encore GX and 2021-2022 Trailblazer models. While driving, the Lane Keep Assist and vehicle detection icons may flash and a System Unavailable message may be displayed when the Lane Keep Assist button on the center console is pressed.

If a tire has been replaced with a tire size that is different than the original equipment manufacturer (OEM) tire size, the wheel speed discrepancy while traveling on a straight road will cause all driver assistance systems (B174W Frontview Camera Module) that rely on wheel speed sensor data inputs to be disabled. These system include:

If a tire has been replaced that is not the correct OEM size, it will have to be replaced with the correct OEM size tire as indicated on the vehicle tire placard, located below the driver's door latch. This is not a warrantable repair.

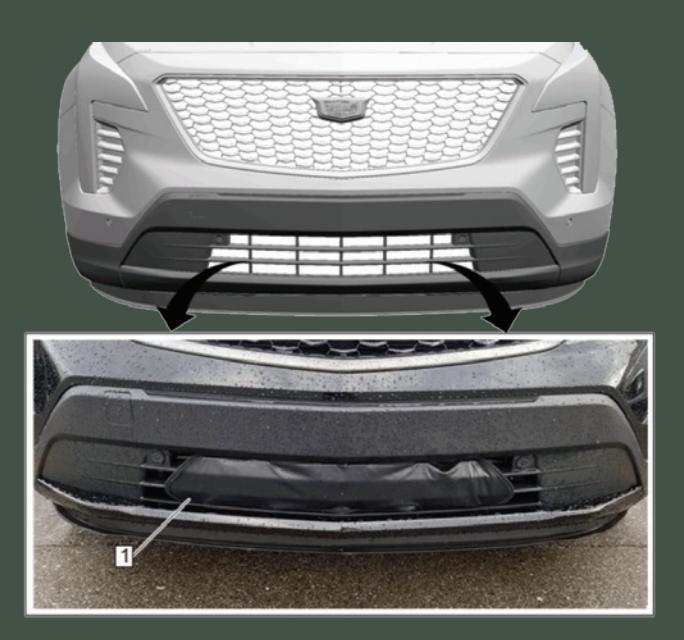
When driving in extreme cold weather conditions (0°F or less / -18°C or less), a winter grille cover should be installed on 2019-2022 XT4 models equipped with the 2.0L turbo engine (RPO LSY). The winter grille cover is needed to prevent any possible charge air cooler icing in extremely cold temperatures. Ice accumulation may restrict air flow, resulting in a loss of power, hesitation on acceleration and other poor performance conditions. Any ice accumulation should be allowed to melt so that moisture can be drained from the induction system, including the charge air cooler, without component damage.

The winter grille cover is included on 2022 model year vehicles equipped with the engine block heater (RPO K03). It's recommended to review the installation and removal procedure for the winter grille cover with customers. Installation information is included in the grille cover instruction sheet and the Owner's Manual.
