## SiriusXM with 360L Connectivity

# Transmission Neutral Service Mode

# Poor Performance During High Ambient Temperatures

# Turbocharger

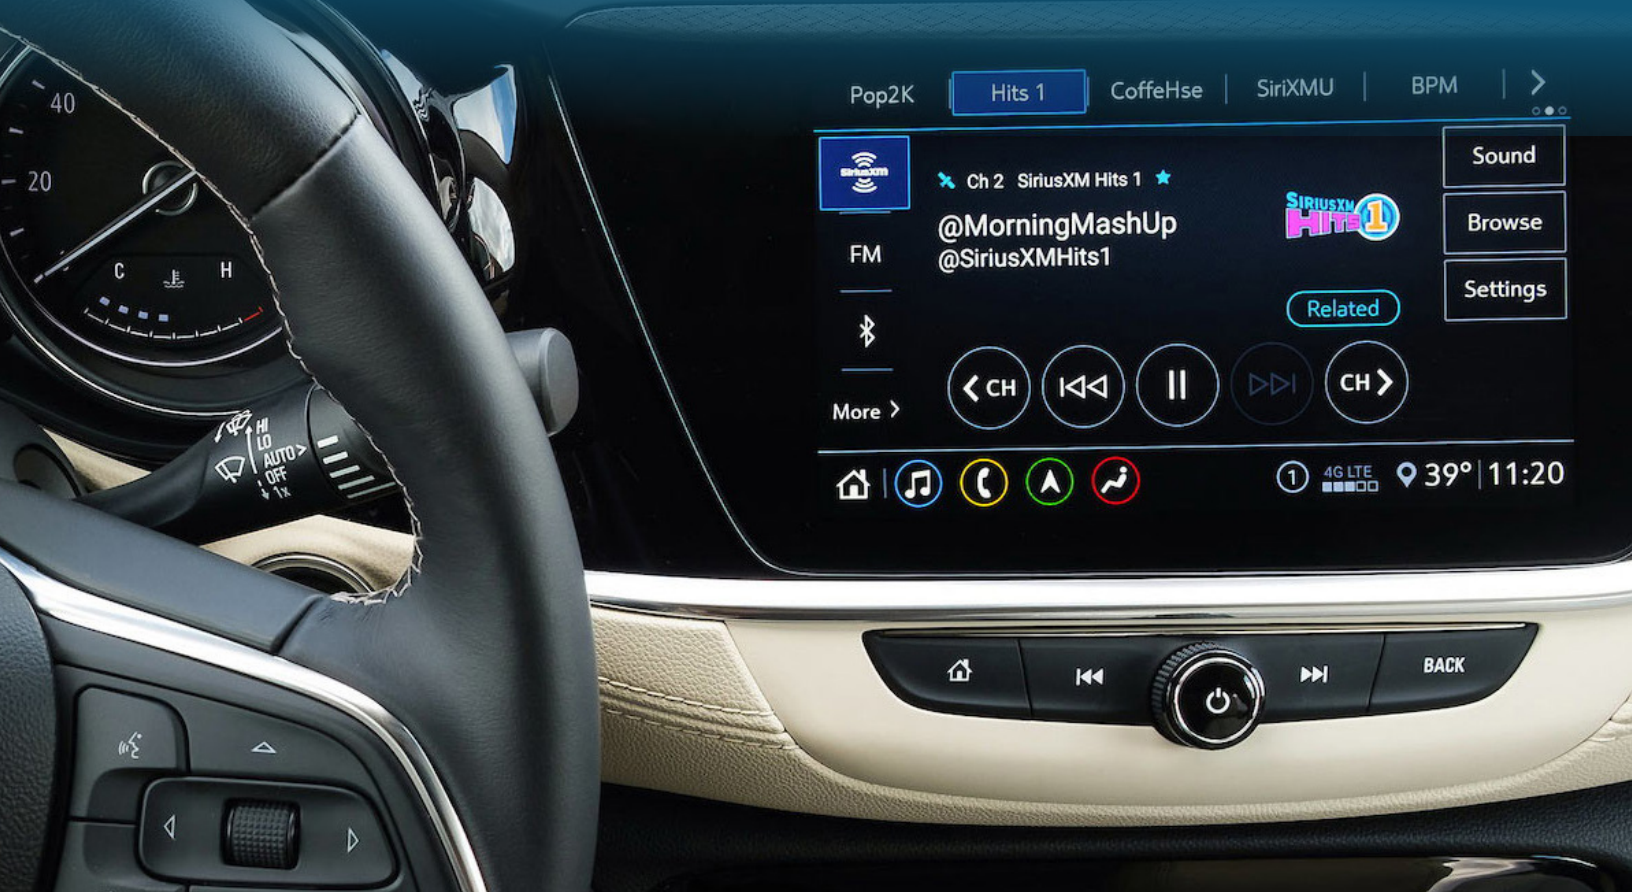
If the SiriusXM with 360L service is not performing properly due to the loss of the internet connection between the infotainment system and the SiriusXM servers, the "Connection

unavailable, please call OnStar agent." message will display on the infotainment screen. The message will be displayed when the vehicle is started or when SiriusXM is selected as the audio source. The "Connection unavailable" message should only be displayed when the vehicle does not have any connectivity and SiriusXM is selected as the audio source.

A software update released in early 2021 corrected an issue where the SiriusXM app caused the "Connection unavailable" message to be displayed when there wasn't any connectivity, regardless of the audio source selected. Refer to Bulletin #21-NA-053 for more information.

It's important to explain to customers that the software update does not eliminate the message, but corrects the issue so the message will be displayed only when SiriusXM is selected as the audio source. SiriusXM with 360L still requires internet connectivity so the "Connection unavailable" message will still be displayed if there is not any connectivity.

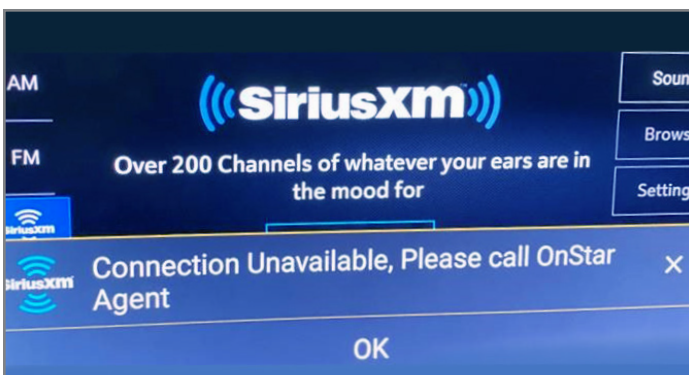
Another reason why the "Connection unavailable" message may be displayed is because of the vehicle's OnStar connection status. Internet connectivity will not exist if customers decline the OnStar Terms and Conditions (T&Cs). If a customer declines the Terms

and Conditions, a connection cannot be made with the vehicle in order to comply with the customer's wishes as well as state and federal privacy regulations. However, declining the Terms and Conditions will cause the loss of connectivity and prevent SiriusXM with 360L from operating properly.

To approve the OnStar Terms and Conditions, customers should press the OnStar button twice to initiate a call with an OnStar advisor to approve the OnStar Terms and Conditions for their vehicle. Approving the Terms and Conditions does not require or result in any subscription, but it does allow for connectivity to the SiriusXM servers and prevents the "Connection unavailable" message from being displayed.

Contact OnStar to approve the Terms and Conditions.
