# Global Wiring Harness

## REPAIR STRATEGY AND PARTS INFORMATION UPDATE

# Global Wiring Harness Repair Strategy and Parts Information Update

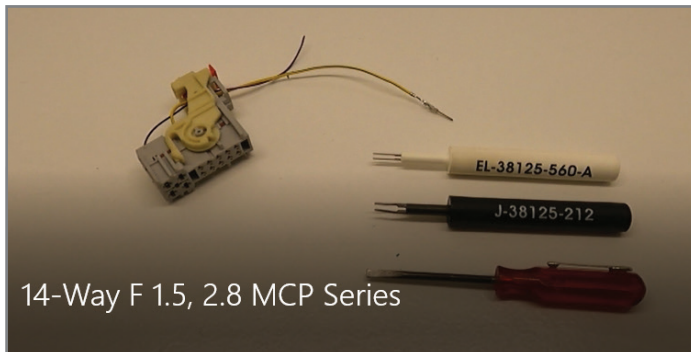
14-Way F 1.5, 2.8 MCP Series

Videos in SI show how to release terminals.

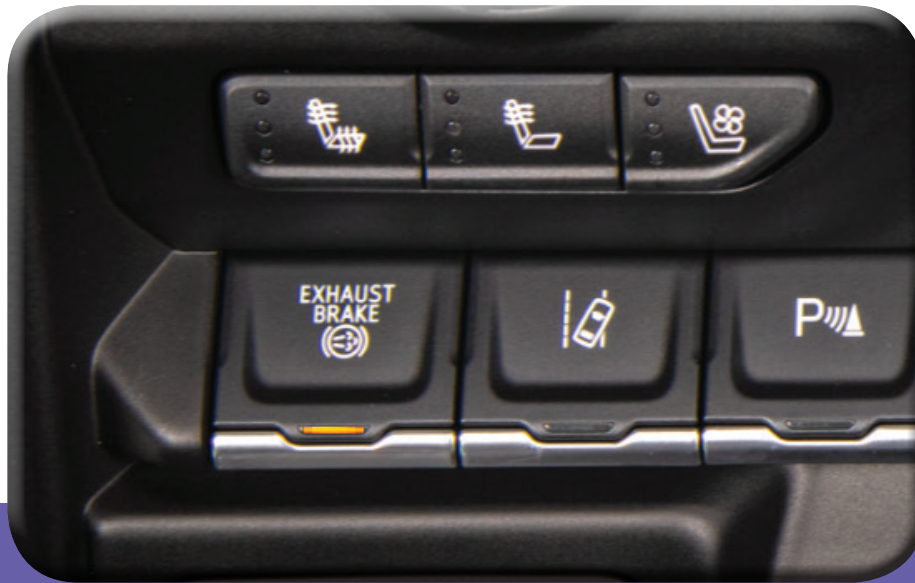
The exhaust brake may not seem to work properly on some 2020 Silverado and Sierra models equipped with the 6.6L Duramax diesel engine (RPO L5P). No DTCs will be set.

For the 2020 model year, the movement of the turbocharger vanes is slower than in previous models and, as a result, there may be a feeling that the exhaust brake is not operating correctly. If the exhaust brake does not seem to be working properly, check for any ECM or Transmission Control Module (TCM) calibration updates that may be available. For additional information, refer to Bulletin #21-NA-214.

If available, both ECM and TCM calibration updates should be performed in order to enhance the operating feel of the exhaust brake.

If the TCM is updated without updating the ECM, the enhancements to the operation of the exhaust brake may not be felt. In addition, if only the ECM is updated without updating the TCM, the vehicle may operate in reduced
