Disabling the Chevrolet Multi-Flex Tailgate & GMC MultiPro Tailgate Function

TECH LINK

GM TechLink is published for all GM retail technicians and service consultants to provide timely information to help increase knowledge about GM products and improve the performance of the service department.

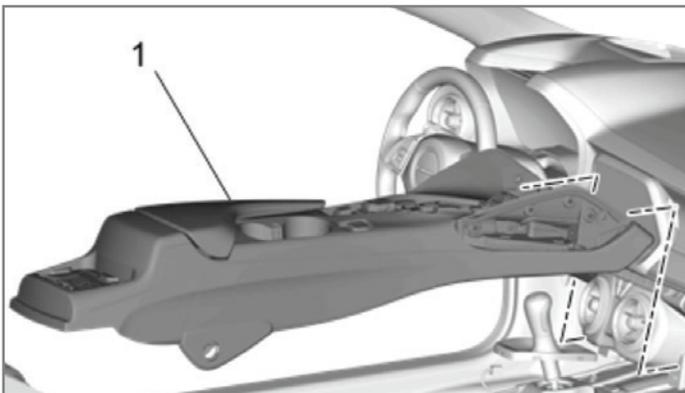
Front floor console

The Shift to Park message may be caused by the park switch being unable to pull the signal circuit low, telling the Body Control Module (BCM) that it is electronically in Park. If this condition is found, install a jumper harness and replace the transmission control assembly.

To install the jumper harness, first remove the front floor console and related components, and the transmission control assembly.

The jumper harness should be installed between the shift control and the console body harness connector. Be sure that the jump harness is not twisted or kinked when installed.

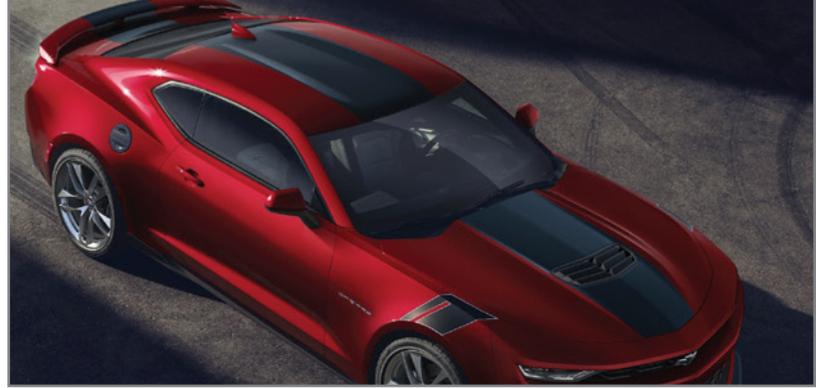
A wrinkle or bubble may be seen in the stripe decal or hood wrap around the outer edges of the hood air scoop on some 2019-2022 Camaro models.

The wrinkle or bubble may be caused by the edges on the bottom of the hood air scoop pressing deep into the stripe or hood wrap, causing air pockets to form over time.

To correct the wrinkle or bubble condition, first remove the hood air scoop from the hood. The hood air extractor water deflector must be removed before the hood air scoop. Follow the procedures under Hood Air Scoop Replacement (ZL1 with A1Y) in the appropriate Service Information.

For additional repair information, including part numbers, refer to Bulletin #21-NA-290.
