Brake Rotor Conditions

Corvette Brake Rotor Conditions

TECH LINK

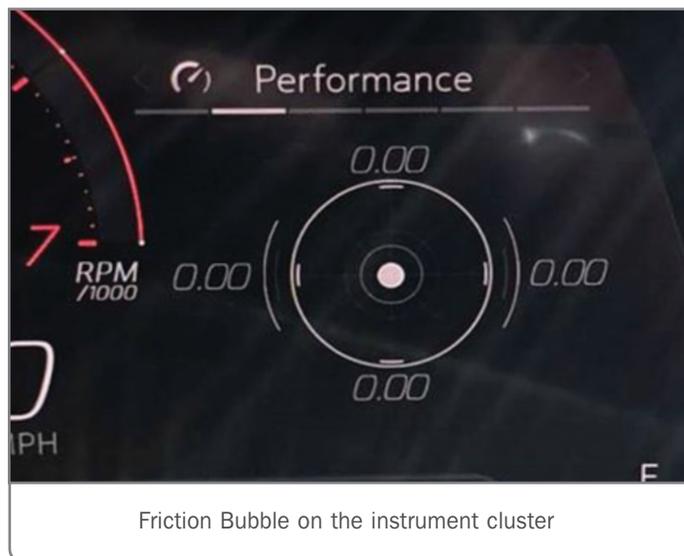
Friction Bubble on the instrument cluster

Refer to Bulletin #22-NA-026 and the Owner's Manual for the complete brake burnishing procedure. The procedure includes applying the brakes 10 times starting at 60 mph (100 km/h) to 30 mph (50 k/h) while decelerating at 0.4g, which is a medium brake application. The Friction Circle (or Friction Bubble), found under the Performance menu on the instrument cluster, can be used to monitor the g-force. Use the Driver Information Center (DIC) steering wheel controls to view the menus on the instrument cluster. Between brake applications, the vehicle should be driven for at least 0.3 miles (0.5 km).

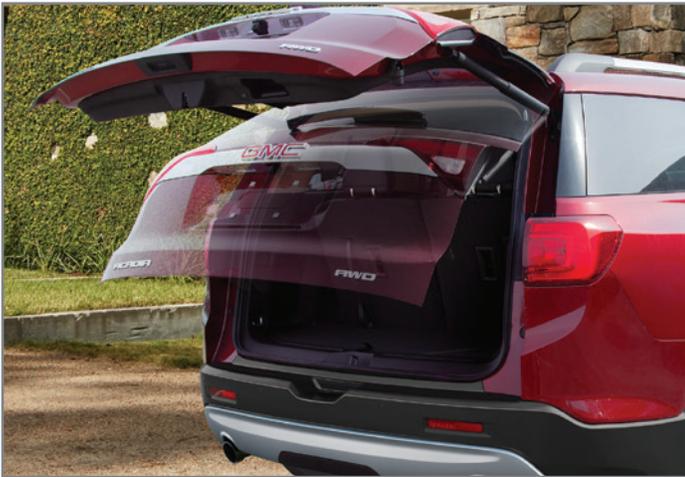
The power liftgate actuators from some 2018-2022 Acadia, XT5 and 2020-2022 XT6 models that have been returned to the Warranty Parts Center show damage due to improper removal.

Power liftgate

Not following the proper procedure to remove a power liftgate actuator, such as prying the actuator off the ball socket, may damage the actuator.

To properly remove the actuator, with the liftgate fully open, push the actuator ball socket onto the ball toward the liftgate edge.

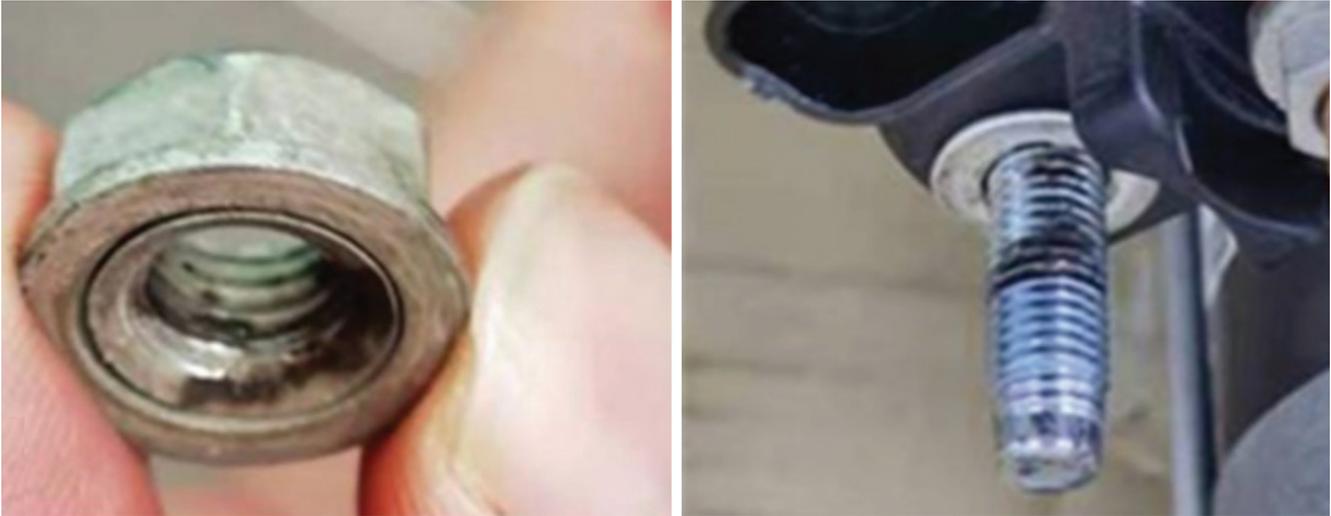
Some 2021-2022 Equinox and Terrain models equipped with the 1.5L engine (RPO LYX) may have an intermittent no crank condition, but the vehicle powers up normally.

If the intermittent power up, no crank condition is found, verify the BCM Power Mode Data shows Crank, the ECM Electrical Data shows an active Crank Request and Crank Relay command. If the data is correct, check for power at the B+ terminal at the starter. If there is power present, inspect the B+ stud on the starter for oxidation.

Replace the nut and clean the B+ stud terminals if oxidation is evident and then re-check starter function for proper operation. If the no crank condition is no longer present, repairs are complete. If not, continue with starter diagnosis following the appropriate Service Information.

Replace the nut and clean the B+ stud terminals if oxidation is evident.

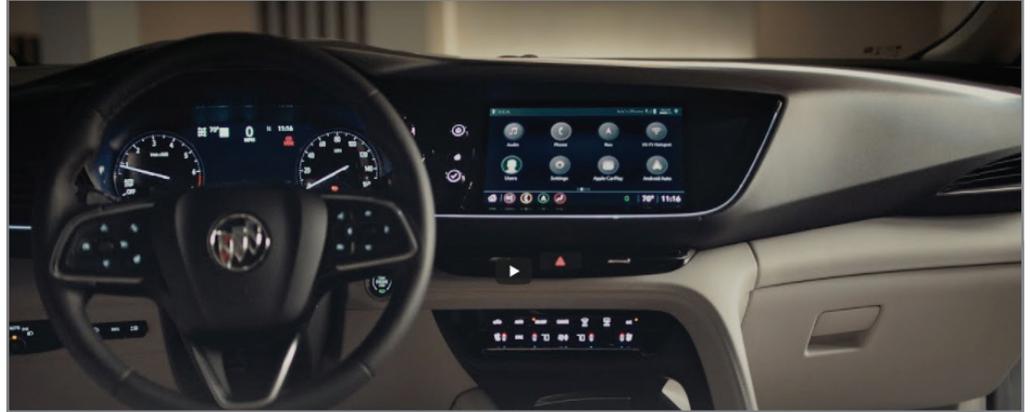
However, the far right chrome strip under the HVAC vent near the front-passenger door does not illuminate like the left and center sections of the instrument panel. This is the intended design of the instrument panel lighting and is a normal operating characteristic of the vehicle. Do not replace any parts or attempt any repairs to the far right chrome strip.

Instrument panel ambient lighting design.
