AERO SHUTTER DIAGNOSTIC TIPS

The aero shutters on some 2019-2021 Silverado 1500, Tahoe, Suburban, Sierra 1500, Yukon, Escalade; 2020-2021 Silverado 2500HD/3500HD and Sierra 2500HD/3500HD models may have several conditions that could potentially cause improper shutter operation. Several DTCs may be set, depending on the specific conditions.

TECH LINK

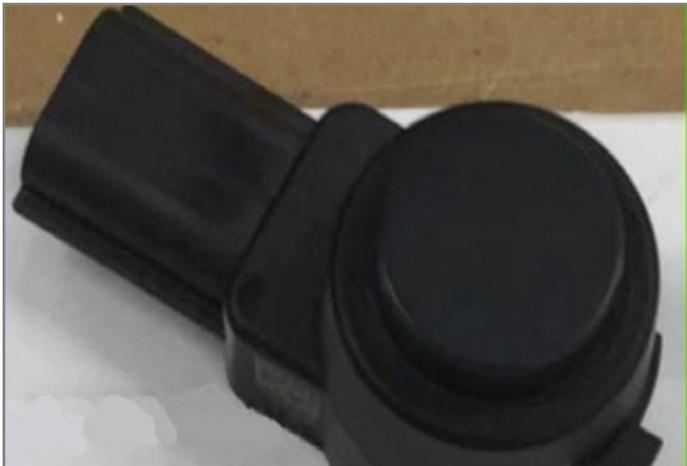
Good sensor without any damage.

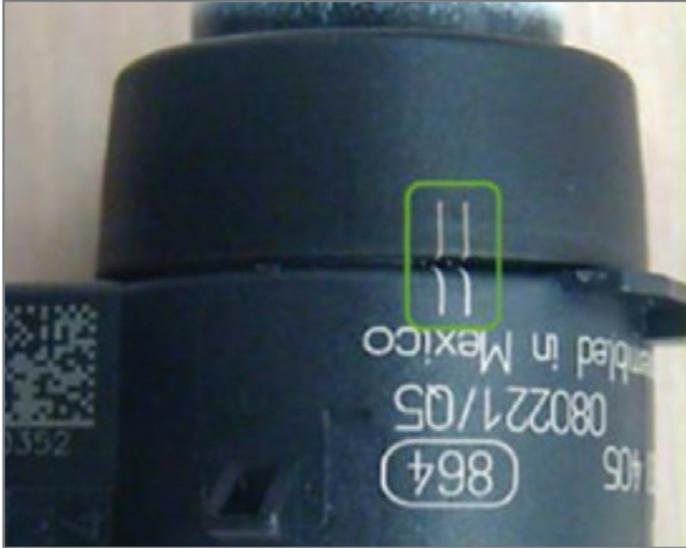
The double marks on the sensor should be aligned. Do not twist the sensor to try and remove the painted cap.

Correctly aligned sensor
