GM TECHNICAL ASSISTANCE CENTER (TAC)

Dealer Tips and New Information Newsletter

May 10, 2022

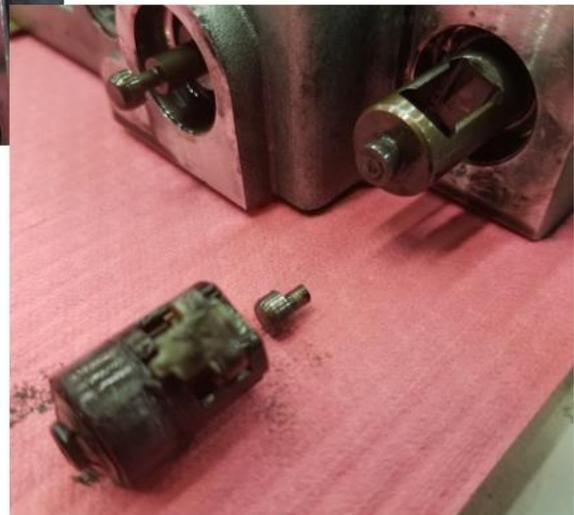
Switch
Magnet
Knob broken off valve
Valve

So the magnet hangs on the knob on the end of the valve. As you can see when the knob breaks off the valve that is when the magnet falls off. The magnet nor the valve are serviceable so when it breaks off the only repair is to replace the valve body.
