# DCBS Becomes Essential Equipment

## MIDTRONICS GR8 TO BE DISCONTINUED IN 2024

## TECH LINK

GM TechLink is published for all GM retail technicians and service consultants to provide timely information to help increase knowledge about GM products and improve the performance of the service department.

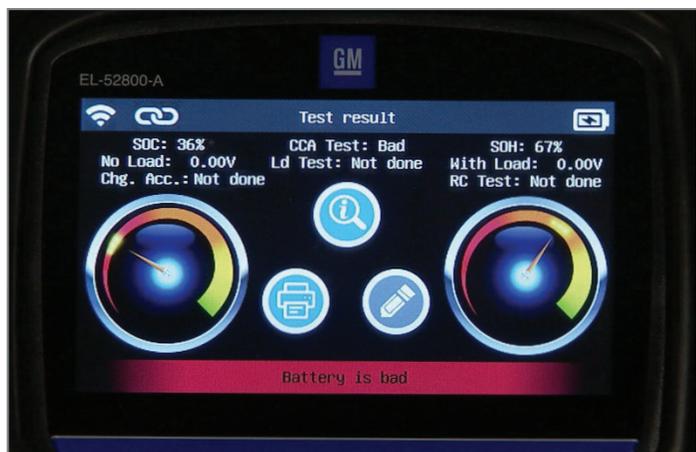
On-screen test results using the DCBS will show "Battery is good" if the battery has a good state of health or "Battery is bad" if the battery needs to be replaced. The tool will ask for the RO along

"Battery is bad" message

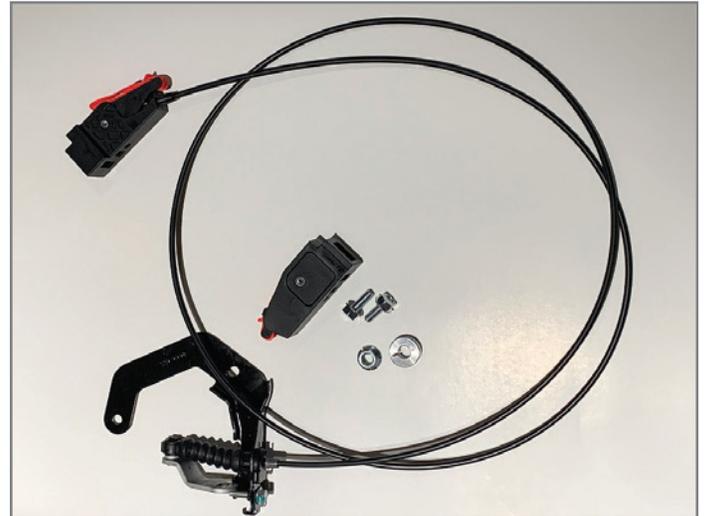
DT-52910 Manual Park Release tool

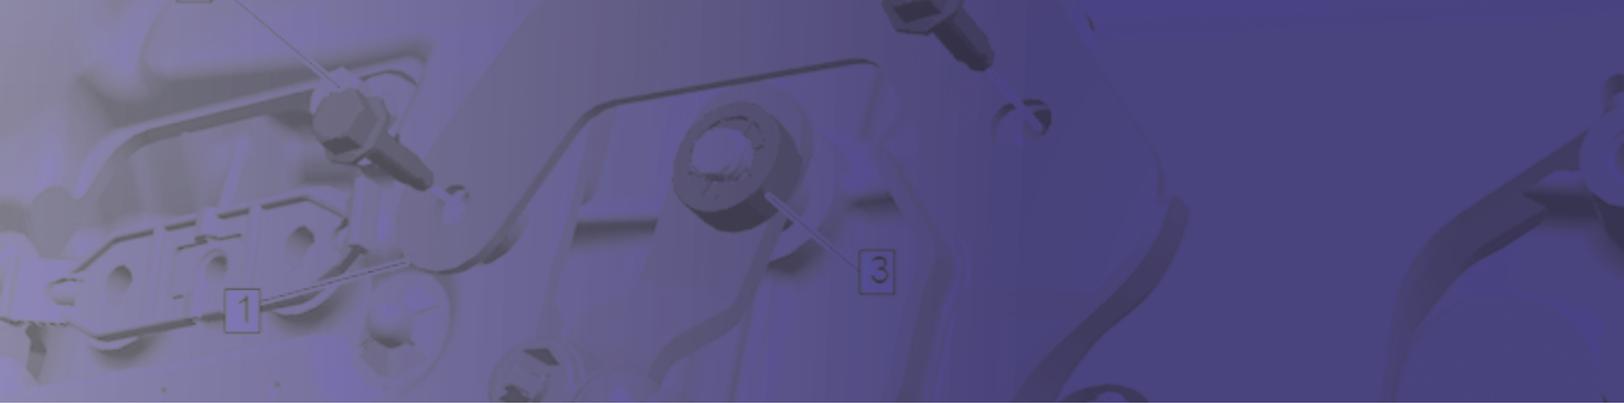
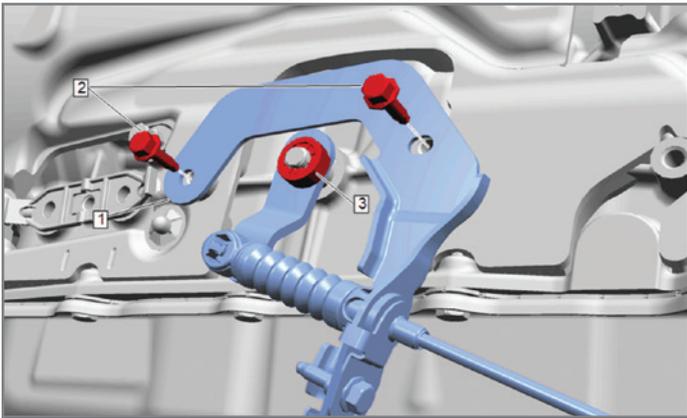
In cases where there is an ETRS system fault or a no start condition and the vehicle needs to be moved, the DT-52910 Manual Park Release tool can be installed to temporarily shift the vehicle into Neutral when the engine is not running. The manual park release tool is now available through the GM Special Service Tools website at [gmtoolsandequipment.com](http://gmtoolsandequipment.com).

Install the DT-52910 Manual Park Release tool to temporarily shift the vehicle into Neutral.

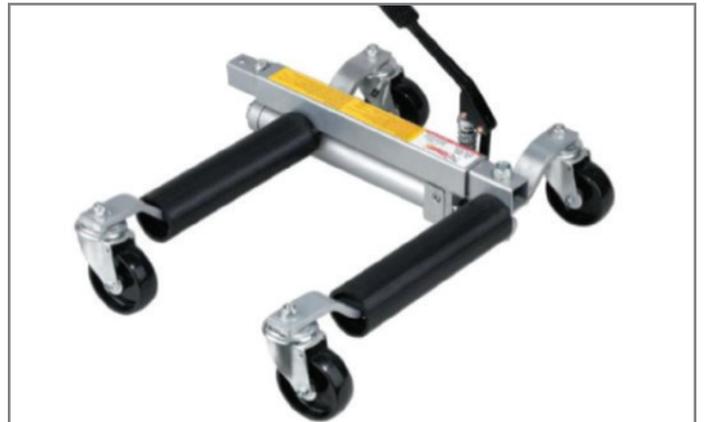
Wheel dolly

In addition to the DT-52910 Manual Park Release tool, wheel dollies or tire skates can be used to move the vehicle when there is an ETRS system fault or a no start condition.

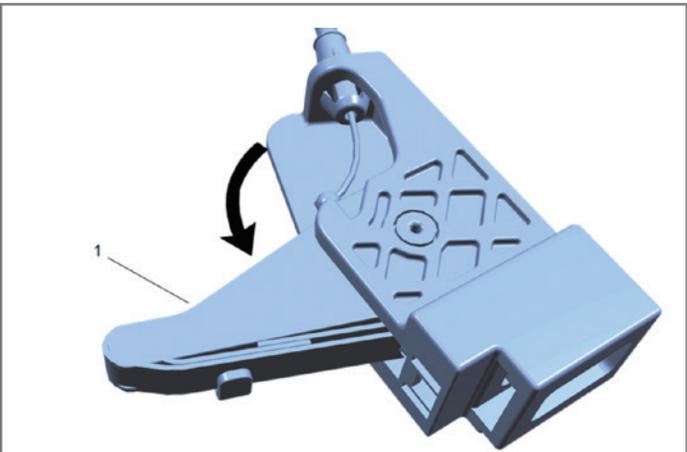
The transmission will be placed in Neutral when the manual park release is pulled.
