GM TECHNICAL ASSISTANCE CENTER (TAC)

Dealer Tips and New Information Newsletter

June 14, 2022

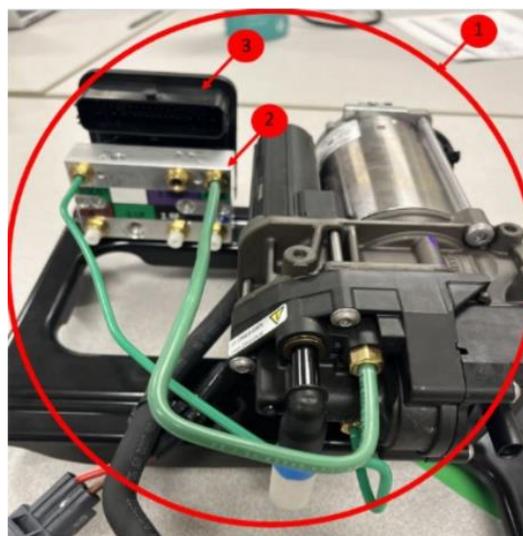
Item 1 includes everything shown in the red circle and is called the Automatic Level Control Module. The main reason this complete assembly would be replaced is if the air compressor itself needed to be replaced. Use labor operation 8020980 if this complete assembly is being replaced.

Items 2 and 3 can be replaced separately from the complete Automatic Level Control Module assembly; see below for more information.

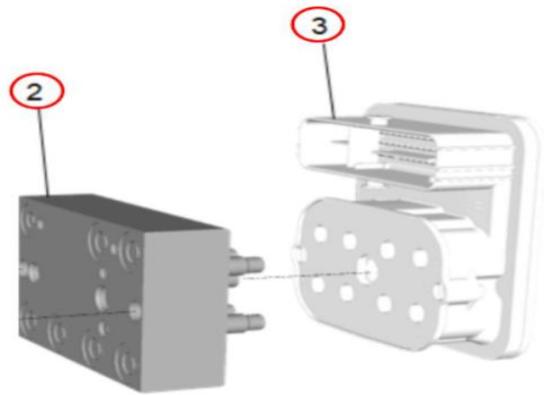
Items 2 and 3, shown above and below, can be replaced separately from the complete Automatic Level Control Module assembly.

Item 2 is the Air Suspension Controller and labor operation 8020710 should be used if it is replaced.

Item 3 is the Air Suspension Control Module and labor operation 8020700 should be used if it is replaced.

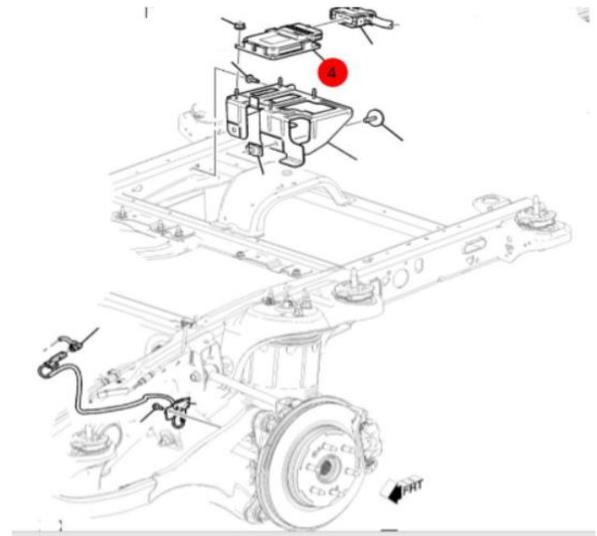
Electronic Suspension Control System RPO Z95 Component Naming and Labor Operation Code:

Item 4 is the Suspension Control Module and labor operation 8020010 should be used if it is being replaced.
