*Reducing Wi-Fi Interference
in the Service Department. 2*

*Common Customer
Trailer-Side Faults When
Using the Trailing App 8*

*Intermittent Click Sound at
the Front of the Vehicle. 10*

TECH LINK

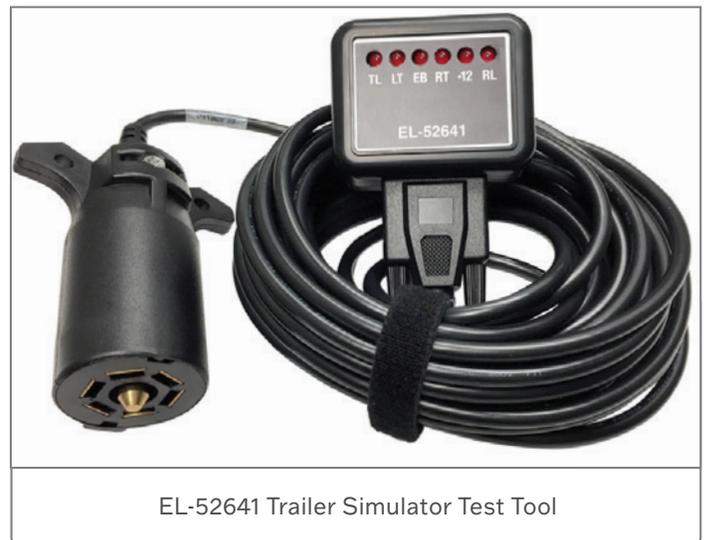
EL-52641 Trailer Simulator Test Tool

Some common electrical failures found on trailers include loose connections, faulty ground circuits and water intrusion.

For any intermittent electrical issues on the trailer, check the trailer connector as well as the trailer lamp assemblies for a loose or broken connection. Wire nuts should not be used to service trailer wiring. Wire nuts are not properly sealed for automotive use and will allow moisture and debris into the electrical connection.

Also check for corroded or weak ground connections. Ground circuits are usually connected to the frame of the trailer using

a screw or bolt. A faulty ground connection will not allow the flow of electricity through the circuit, resulting in defective lamp operation.

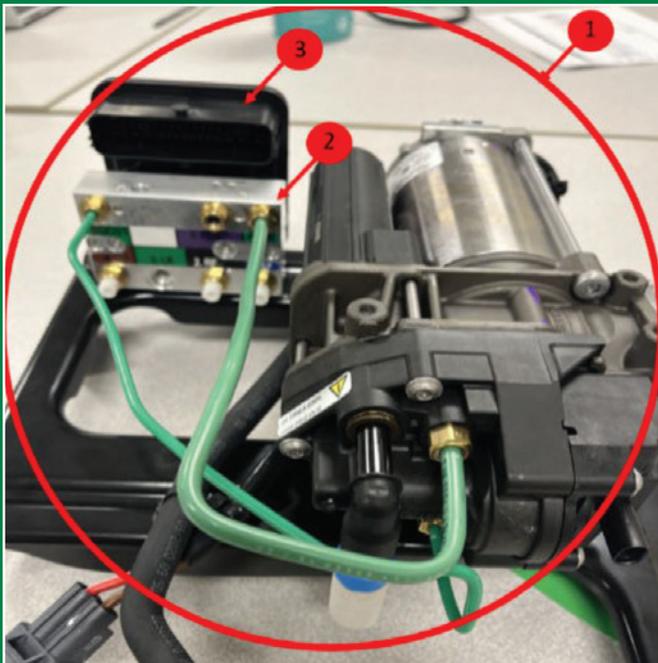
The Automatic Level Control Module of the Air Leveling Suspension is a complete assembly that would be replaced if the air compressor itself needed to be replaced. The Air Suspension Controller and Air Suspension Control Module are components of the Automatic Level Control Module and can be replaced separately.

Automatic Level Control Module (#1),
Air Suspension Controller (#2) and
Air Suspension Control Module (#3)

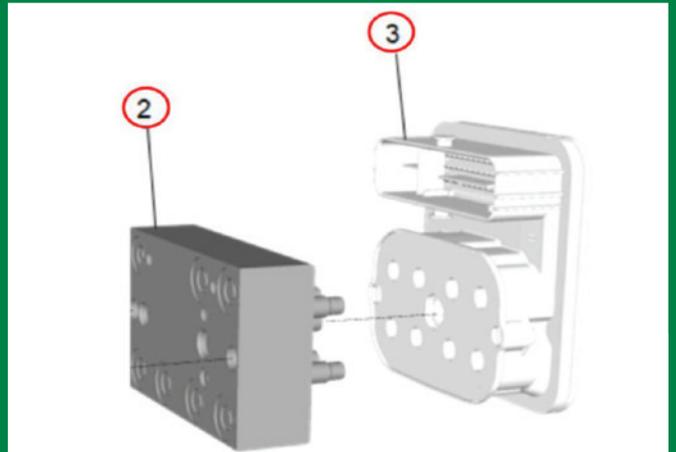
CAPTION: Air Suspension Controller (#2) and Air
Suspension Control Module (#3)
